DAM PERFORMANCE AND SAFETY EVALUATION

**A CASE STUDY OF LOWER USUMA DAM, USHAFA, BWARI L.G.A,
ABUJA-FCT**

**A PROJECT REPORT SUBMITTED TO POSTGRADUATE SCHOOL
IN PARTIAL FULFILLMENT OF THE REQUIREMENT FOR THE
AWARD OF POST GRADUATE DIPLOMA IN AGRIC ENGINEERING
(SOIL AND WATER OPTION).**

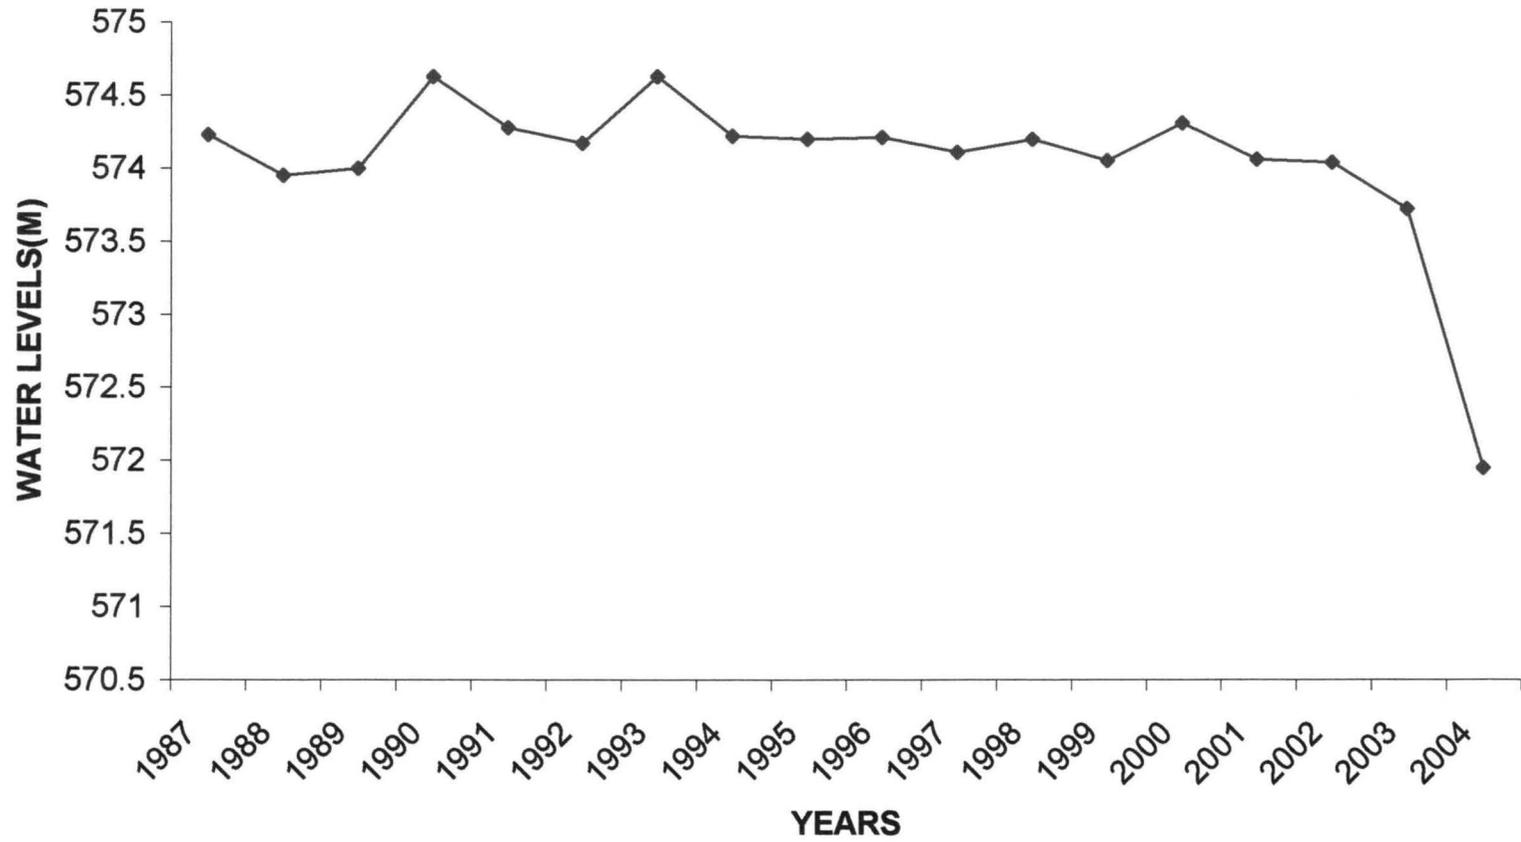
FIG. 3

maximum level of water in the dam for 2004 is 571.95m and this indicate a drastic fall in water level attributed to the corresponding drop in rainfall as shown in Table 3. In addition, the increase in water demand resulted to considerable withdrawal of water from the dam to meet this demand.
