12th National Conference
on Earthquake Engineering
Salt Lake City, Utah
27 June - 1 July 2022

SEISMIC PERFORMANCE OF NEPALESE SCHOOLS: A FULL-SCALE TEST OF A TYPICAL UNREINFORCED MASONRY WALL.

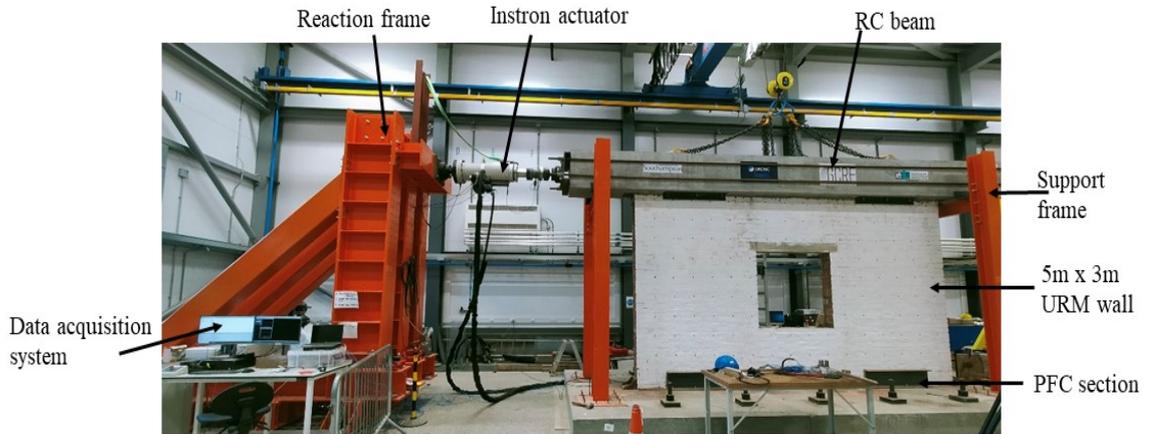
Figure 2: The experimental test setup

The test involved applying a two-way ramp cyclic load on the wall using a hydraulically powered 250kN Instron hydropuls linear actuator with a 250mm travel distance. The actuator is fixed laterally to a reaction frame and a 6.05tons reinforced concrete beam connected to the top of the masonry wall (Fig 2). The actuator is also connected to a data acquisition system with multiple channels to record the load and displacement from the actuator. At the same time, linear variable differential transformers (LVDT's) and video imaging are used to get the linear displacements of the wall. The base of the wall is confined at all the sides with six parallel flange channels (PFC) sections (three on both sides) and two angle sections (at the ends of the wall), fixed to the solid concrete base with anchor bolts and resins. The confinement restricts any form of sliding or lateral movement of the wall at the base. Also, the top of the wall is confined

with equal angle sections fixed to the bottom of the RC beam. This arrangement allows the masonry wall to move only in the direction of the applied displacement loads without any lateral movements. The wall is painted white with dots marks at approximately 300mm centers for the video imaging to measure the lateral displacements using the Davis imaging software. The images were captured with two cameras: the first one to capture the whole wall while the second focused on the upper edge of the opening on the wall.

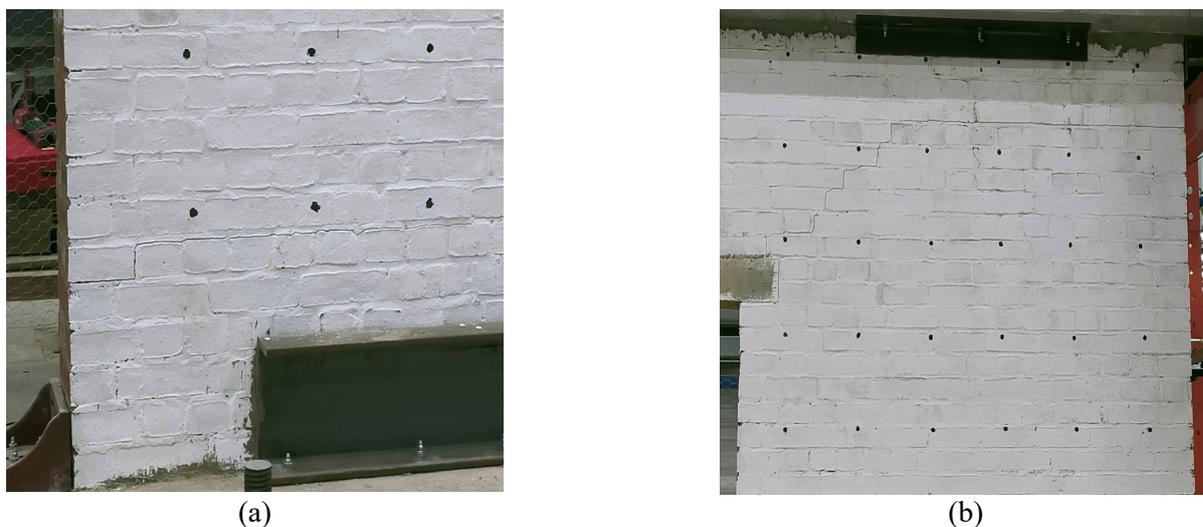
Figure 4. Failure modes of URM at different displacement loading. (a) Lateral crack at the base at 3mm (b) diagonal cracks at the edge of window opening towards the top at 4mm

The force arising from the applied displacement loading is shown in Fig 3 up to the 4mm displacement curve for the test. The ultimate load increased until about 3mm displacement cyclic loading when the lateral crack at the lower part of the wall occurred (Fig 4a). Then, it decreased further at the 4mm displacement loading with a more significant diagonal crack damage at the edge of the window (Fig 4b). The cracks all occurred in the mortar joints of the URM wall and are classed as shear failures [12,13] which further falls under the moderate damage Grade 2 class of failure according to the European Macroseismic Scale (EMS-98) [14]. The Grade 2 failure refer to a moderate damage with slight structural damage having many vertical and horizontal cracks.

The crack pattern and failure modes observed during the test are anticipated as they are consistent with the failure modes observed in several numerical and experimental studies on URM buildings [4,15-17]. Generally, most of the buildings in Nepal are constructed as non-engineered brick masonry with mainly poor quality materials and construction techniques, making them susceptible to damage under seismic loading.
