## Experimental qualification of seismic strengthening of URM buildings in Nepal

URM buildings  
 Seismic retrofit  
 Splints and bandages  
 Seismic performance

### ABSTRACT

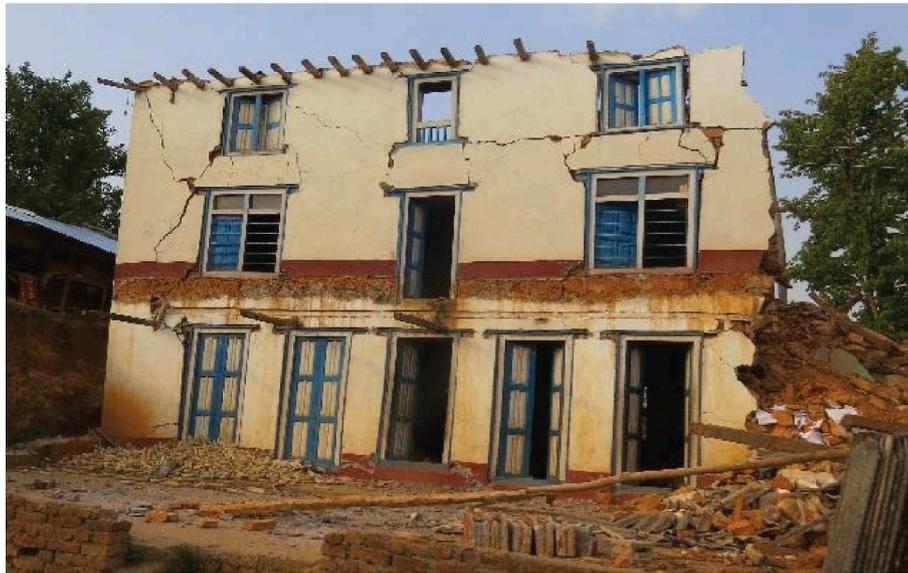
Fig. 1. Observed in-plane failure in piers and spandrels of an URM building [10].

The main problem, however, is that URM structures, being primarily designed to resist gravity loads, have low ductility and redundancy due to the lack of connections between the floor system and the walls, resulting in out-of-plane failure and collapse [20]. In addition, in-plane failure (Fig. 1) is also very common in the form of diagonal shear cracks in piers and spandrels, primarily along the mortar bed joints [10,21,22].

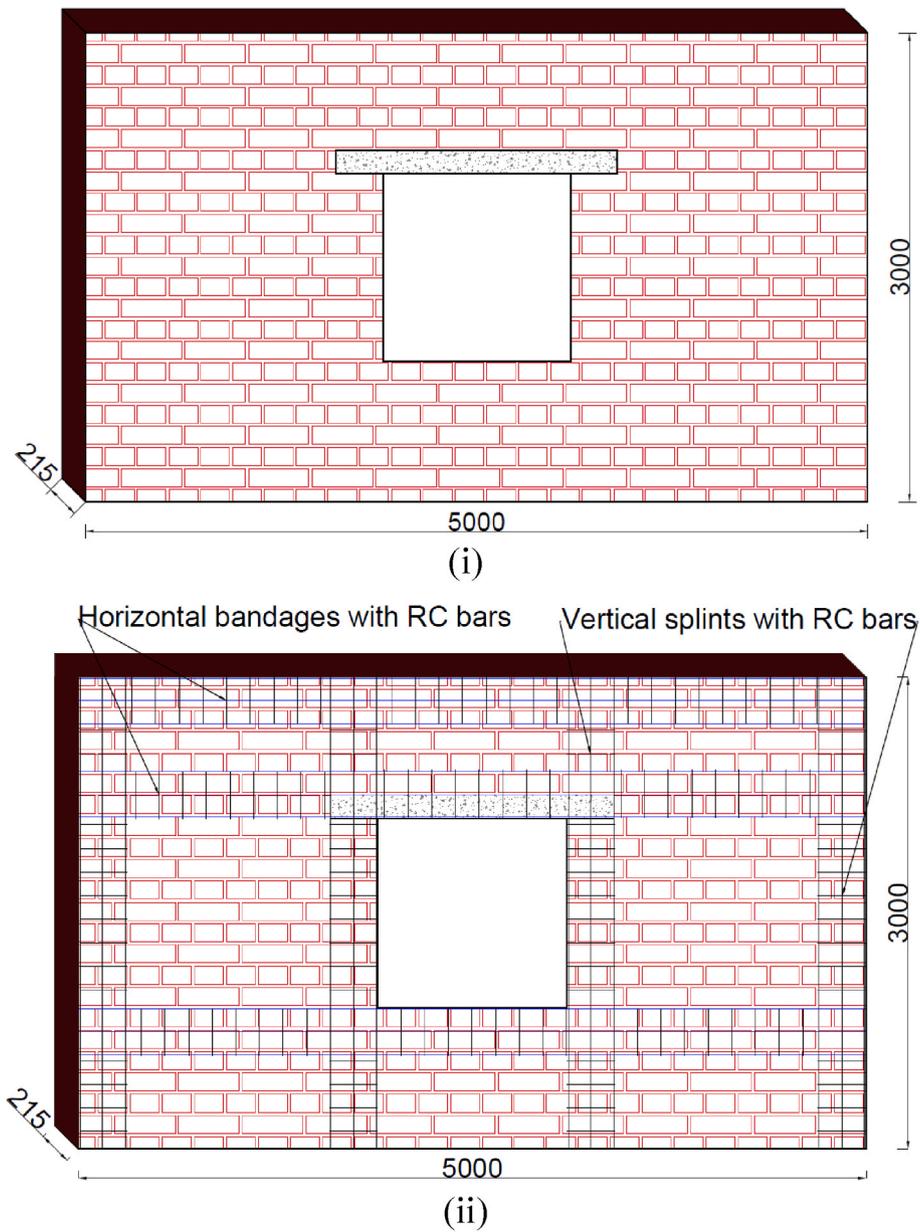
Fig. 2. Schematic diagrams of the masonry wall: (i) unreinforced; (ii) reinforced with splint and bandages (dimensions in mm).

mechanical properties of the materials used to ensure consistency with the local construction practice. The URM wall (Fig. 2(i)) was built following the standard construction practice in Nepal, without any seismic detailing. The retrofitting technique consists of splints and bandages (Fig. 2(ii)). The wall is confined at the base with parallel flange channels (PFC) sections and angle irons fixed at the wall's sides and end to prevent sliding and ensure only in-plane movement of the masonry wall during testing.

The URM wall is subjected to two-way ramp cyclic loading to induce the usual shear cracking pattern and failure associated with URM structures [70–72]. Next, the wall is retrofitted on both sides with splints and bandages (Fig. 2(ii)) made with 8 mm reinforcement bars anchored at the top of the wall and the foundation slab for seismic strengthening.

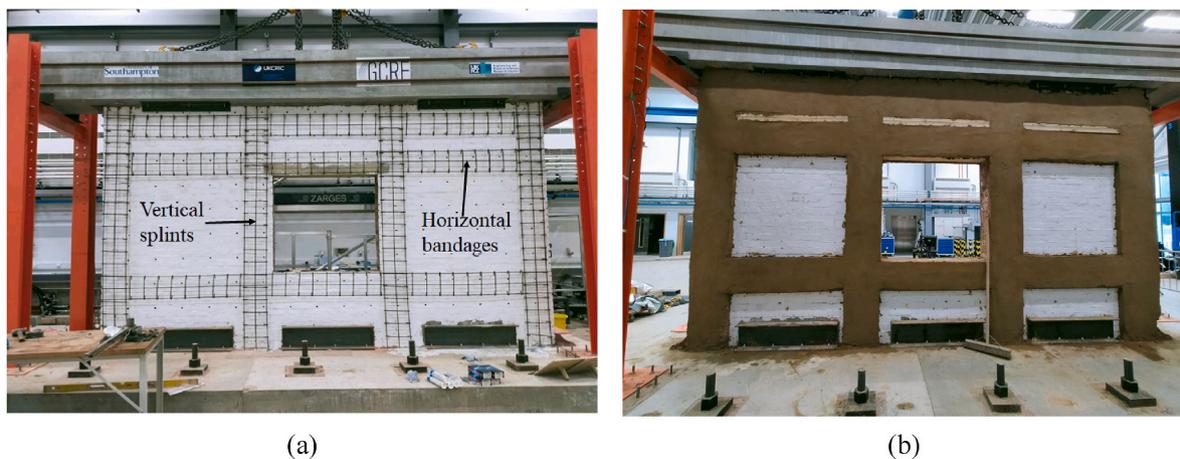
Fig. 3. The retrofitted wall: (a) rebar splint and bandages; (b) overview after covering with layers of mortar screed.

The bent ends of the splints (about 150 mm) are anchored at the top of the URM through 20 mm diameter holes filled with high-strength resins (HIT-HY 170 injection mortar) and fixed in 12 mm diameter 200 mm deep holes at the base with high strength grout (SikaGrout 3200) (Fig. 3(a)). The bandages are wrapped around the wall and tied

together. These are also connected to the splints at the points where they cross each other (top of the wall, sill and lintel). The connected splints and bandages are fixed to the wall with 8 mm anchorage rods set with epoxy resins in 10 mm holes drilled into the bricks, and they are covered with the low-strength 1:6 cement-sand mortar screed to an average thickness of 65 mm in three layers (Fig. 3(b)).

The slightly damaged URM wall was then retrofitted with splints and bandages made with 8 mm high-yield rebars and covered with the 1:6 cement-sand mortar screed. The splints, which are vertical members, are fixed to the wall by anchoring the bent ends (150 mm long) of the bars in 20 mm holes drilled at the top of the wall (just below the RC beam) and filled with Hilti epoxy resins (HIT-HY 170 injection mortar). The lower ends are placed into 12 mm diameter 200 mm deep holes, drilled into the concrete base slab and sealed with high-strength grout (SikaGrout 3200). Finally, the splints, comprising three vertical bars spaced by 350 mm long bars (bent 50 mm at both ends to have a span of 250 mm), are placed at both ends of the wall and edges of the window opening, as shown in Fig. 3(a).

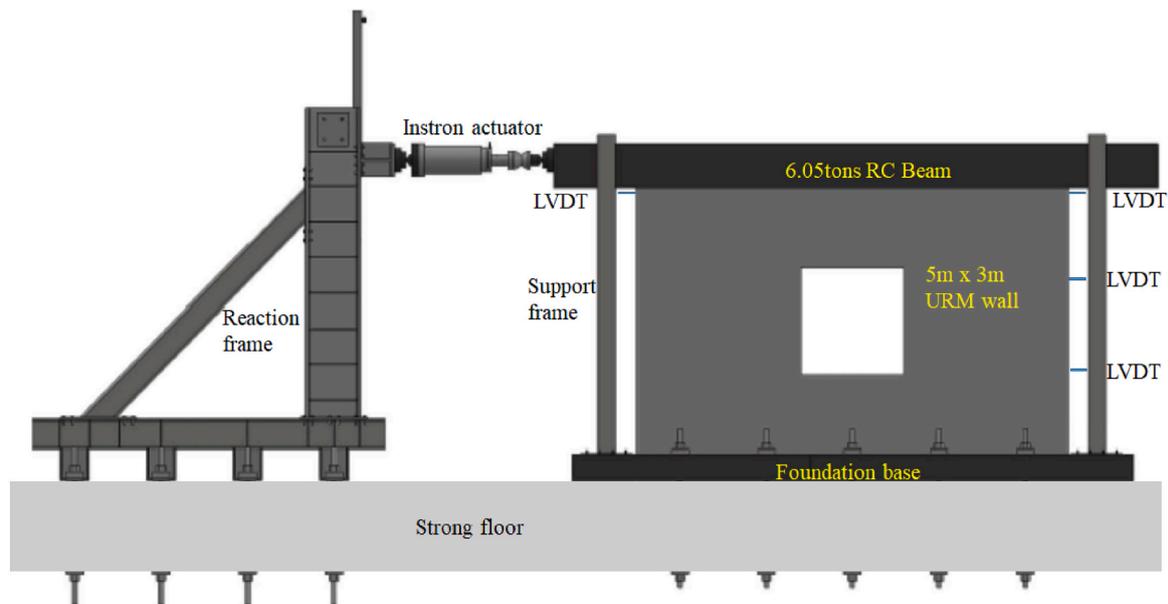
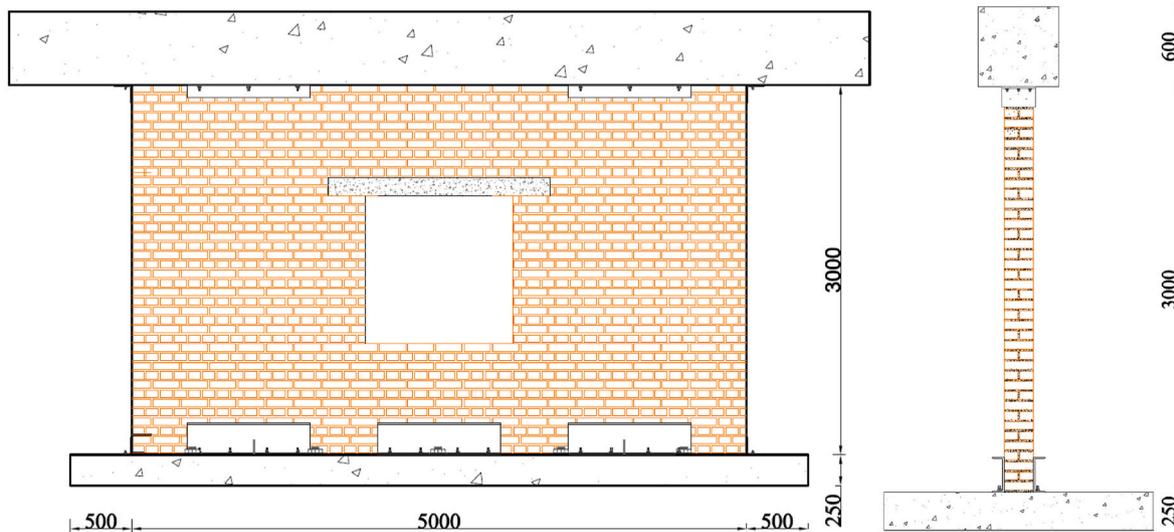
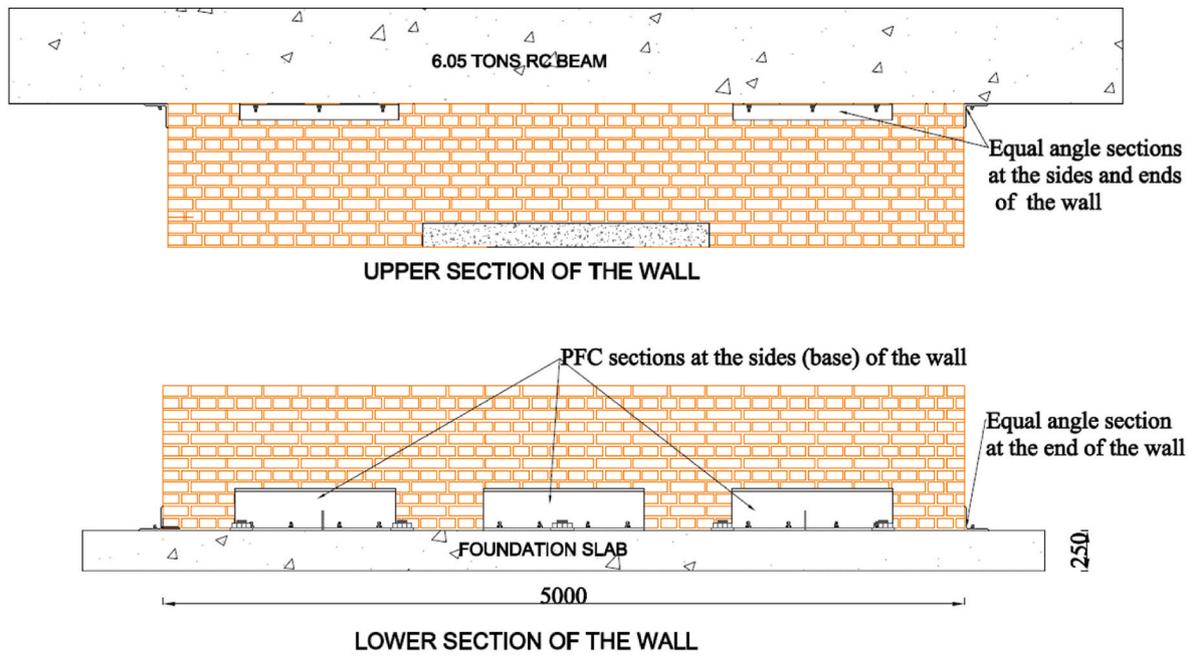
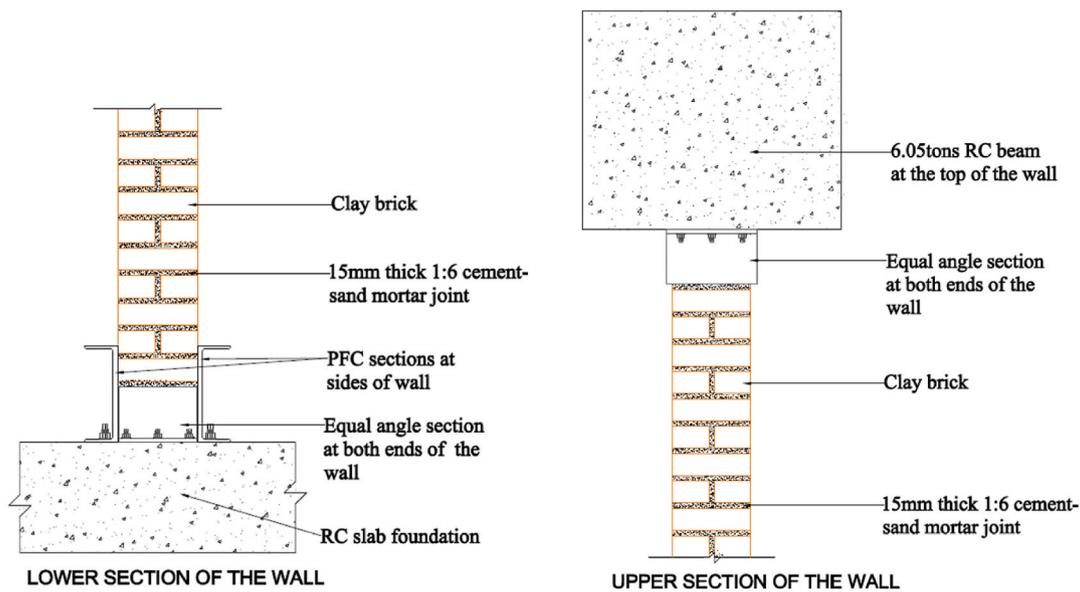
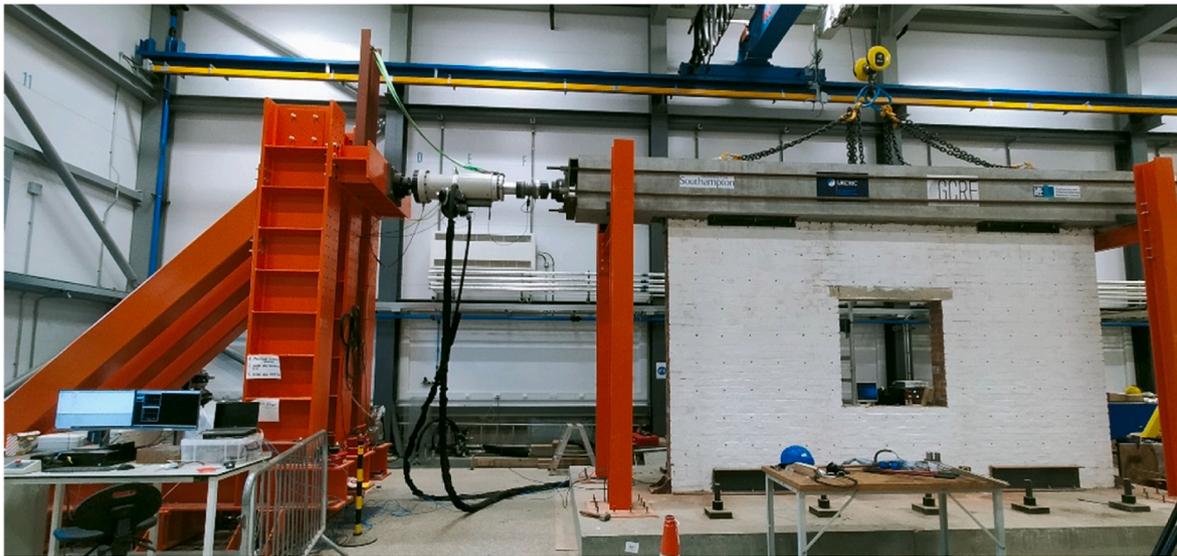
Fig. 4. The experimental test setup.

(a) schematic drawing

(b) Front view of wall

(c) side view

(d) views of equal angles and PFC sections connections to wall (front and back)

(e) Side views of wall with the angles and PFC connections

(f) Laboratory implementation

A hydraulically powered 250 kN Instron hydropuls linear actuator with  $\pm 125$  mm stroke was used to apply a two-way ramp cyclic lateral load [55,72–74] to the end of a 6.05-ton RC beam attached to the top of the masonry wall (Fig. 4). The RC beam weight is equivalent to the estimated load of the roof for a typical floor wall. The actuator is also connected to a data acquisition system (Strainsmart 8000) to record the load and displacement from the actuator during testing. The wall is confined at both the base with parallel flange channels (PFC) sections and the top with equal angle sections to avoid any sliding and ensure the

The wall was painted white with black dots marked at 300 mm centres to measure the displacement field using the Digital Image Correlation (DIC) technique (Fig. 4(b)) using LaVision’s Davis Imaging

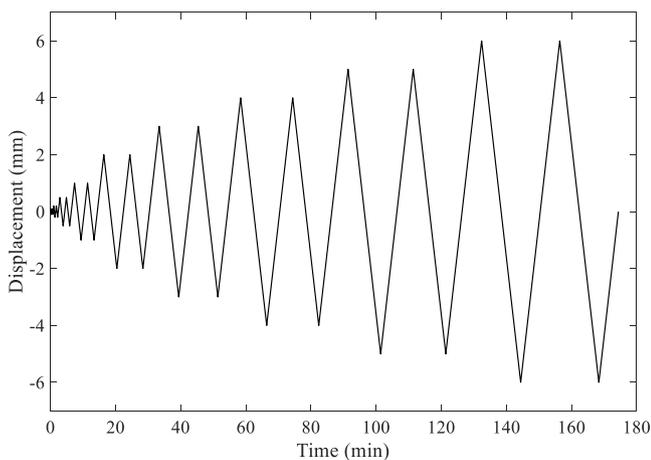
Fig. 5. The experimental loading sequence.

The load was applied using displacement control as a two-way ramp cyclic loading (Fig. 5) by gradually increasing the amplitude of the displacements, utilising a 1 mm/min frequency for each cycle. The loading on the URM specimen continued until the shear and lateral cracks, introduced mainly at the brick-mortar interface, were observed at 3 mm and 4 mm amplitudes. Then, the retrofitted wall was loaded with the same protocol, the difference being that the loading was increased to 6 mm amplitude as no damage was observed at the end of the 4 mm loading sequence.

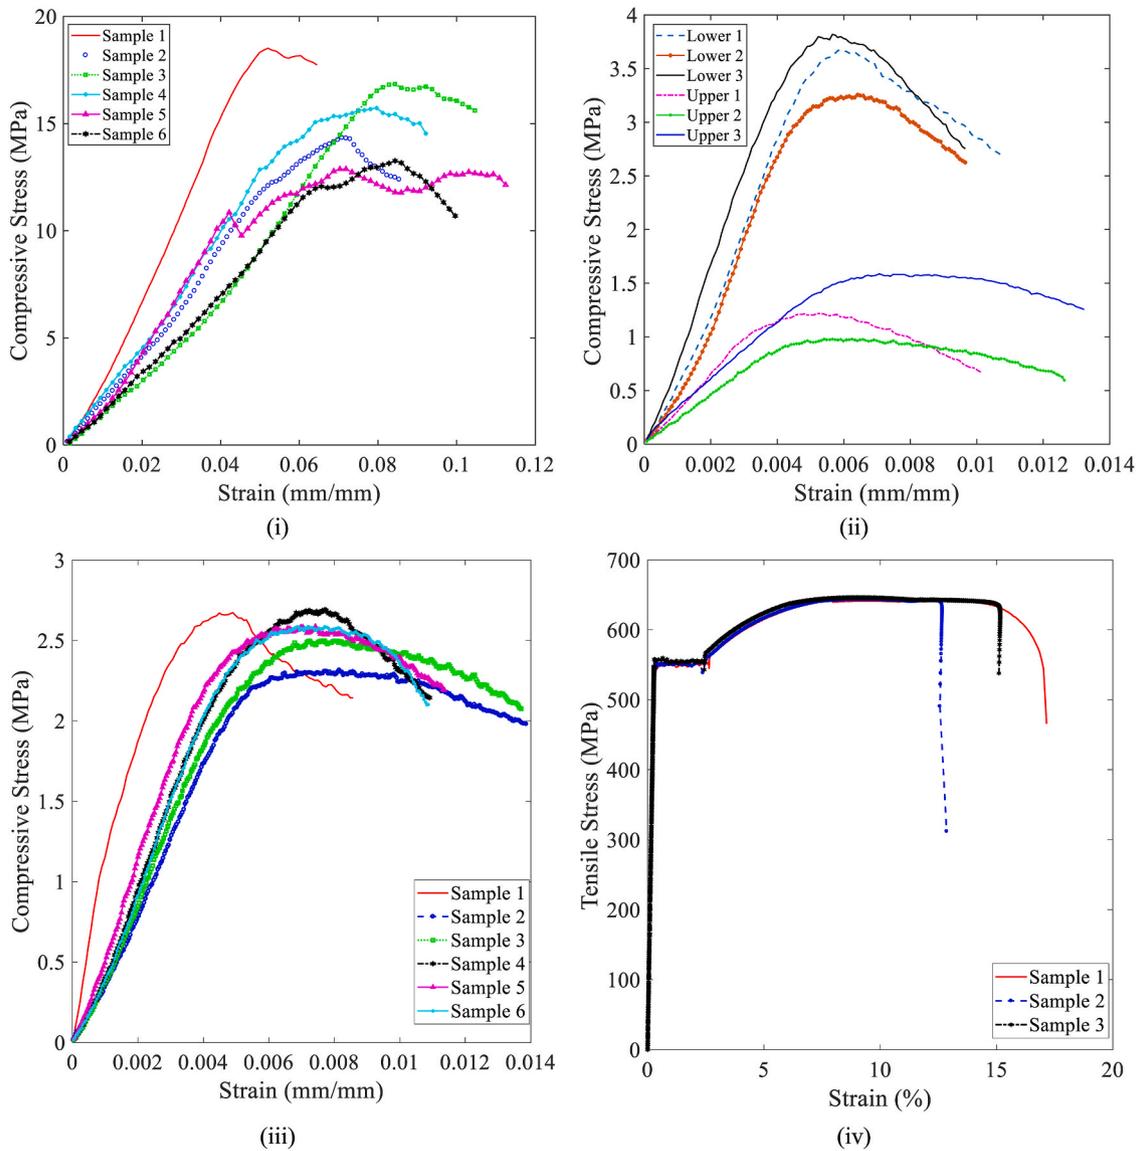
Fig. 6. Typical stress-strain behaviour of the wall component materials; (i) clay brick, (ii) wall mortar, (iii) wall render and (iv) 8 mm reinforcement bars.

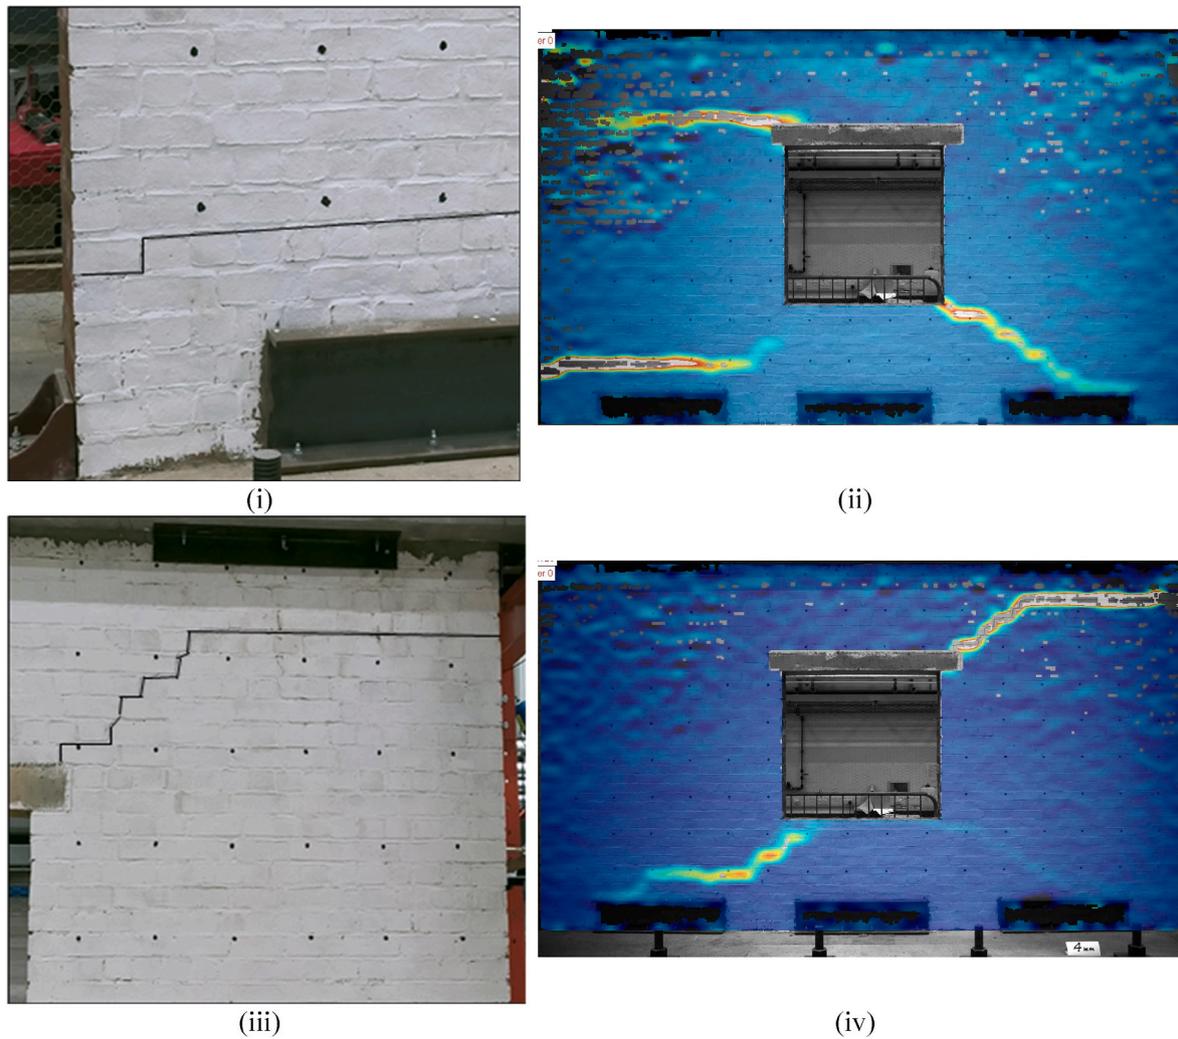
Fig. 7. Failure modes of URM at different levels of displacement loading: (i) Lateral crack at the base at 3 mm; (ii) Digital Image Correlation corresponding to 3 mm amplitude; (iii) diagonal cracks at the edge of window opening towards the top at 4 mm (iii) DIC image corresponding to 4 mm amplitude.

The applied cyclic, in-plane lateral displacement loading resulted in extensive cracking of the URM wall. During the first part of the test, crack initiation and growth were monitored by visual inspection (after each load cycle) and video imaging. No crack was observed at lower levels of amplitude until 3 mm, when lateral crack damage was observed near the base of the wall (Fig. 7(i) and (ii)). At increasing amplitudes, diagonal cracks were observed at 4 mm amplitude at the top of the window opening extending towards the upper part of the URM (Fig. 7 (iii) and (iv)).

all the observed crack damage at the 3 mm loading and the diagonal crack damage at the edges of the window opening resulting from the 4 mm loading cycle (Fig. 8(iv)). The processed DIC images further revealed minor crack mechanisms that could not be observed by visual inspection during testing, such as the diagonal crack at the bottom-left of the window opening (Fig. 7 (iv)) and the crack at the top-left of the opening (Fig. 7(ii)).

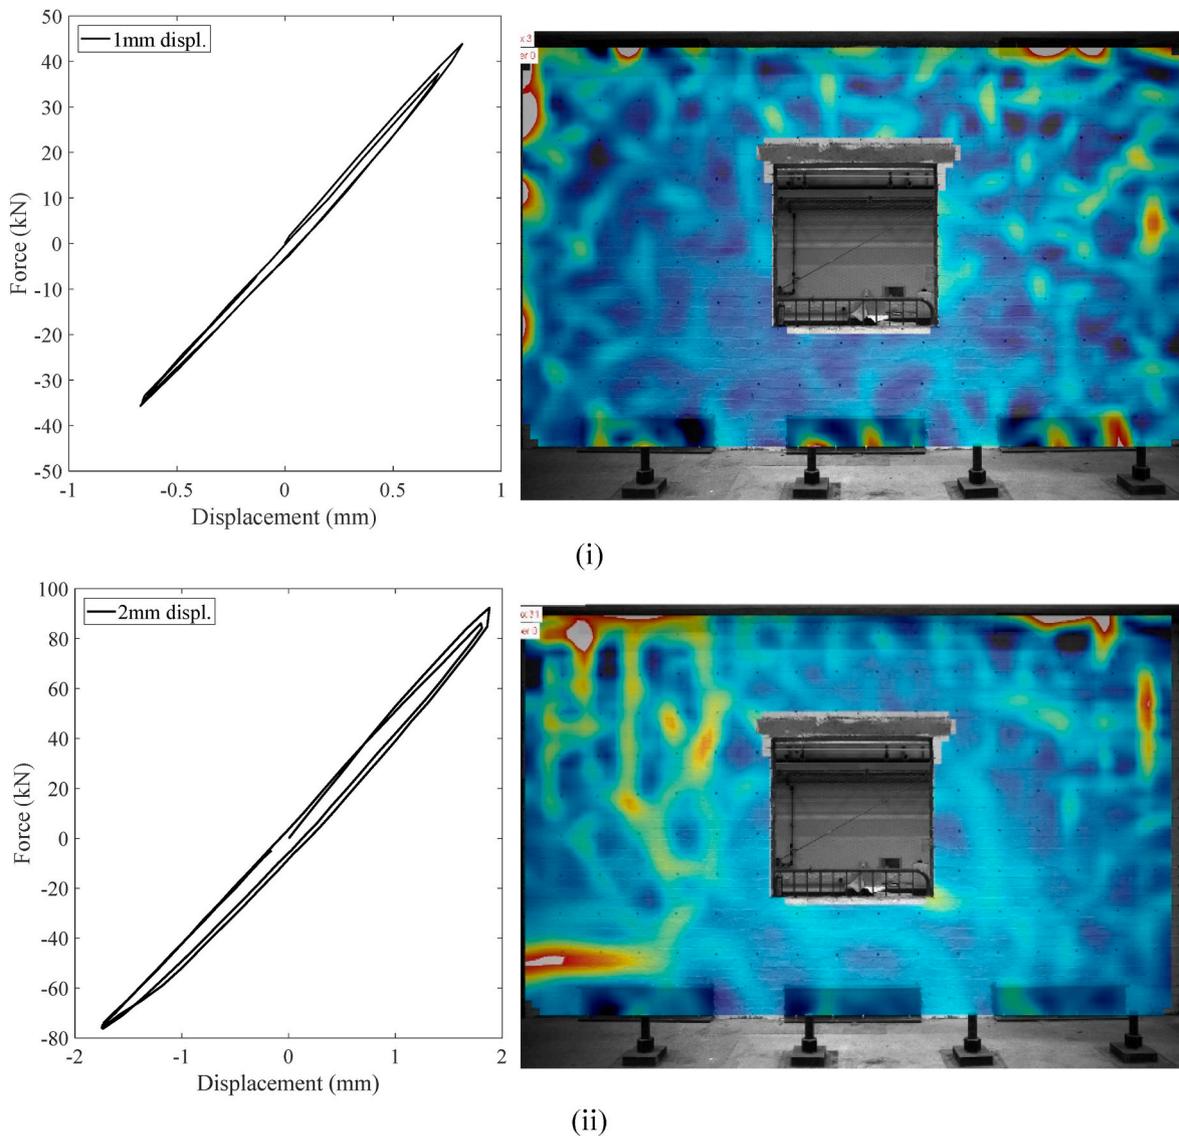
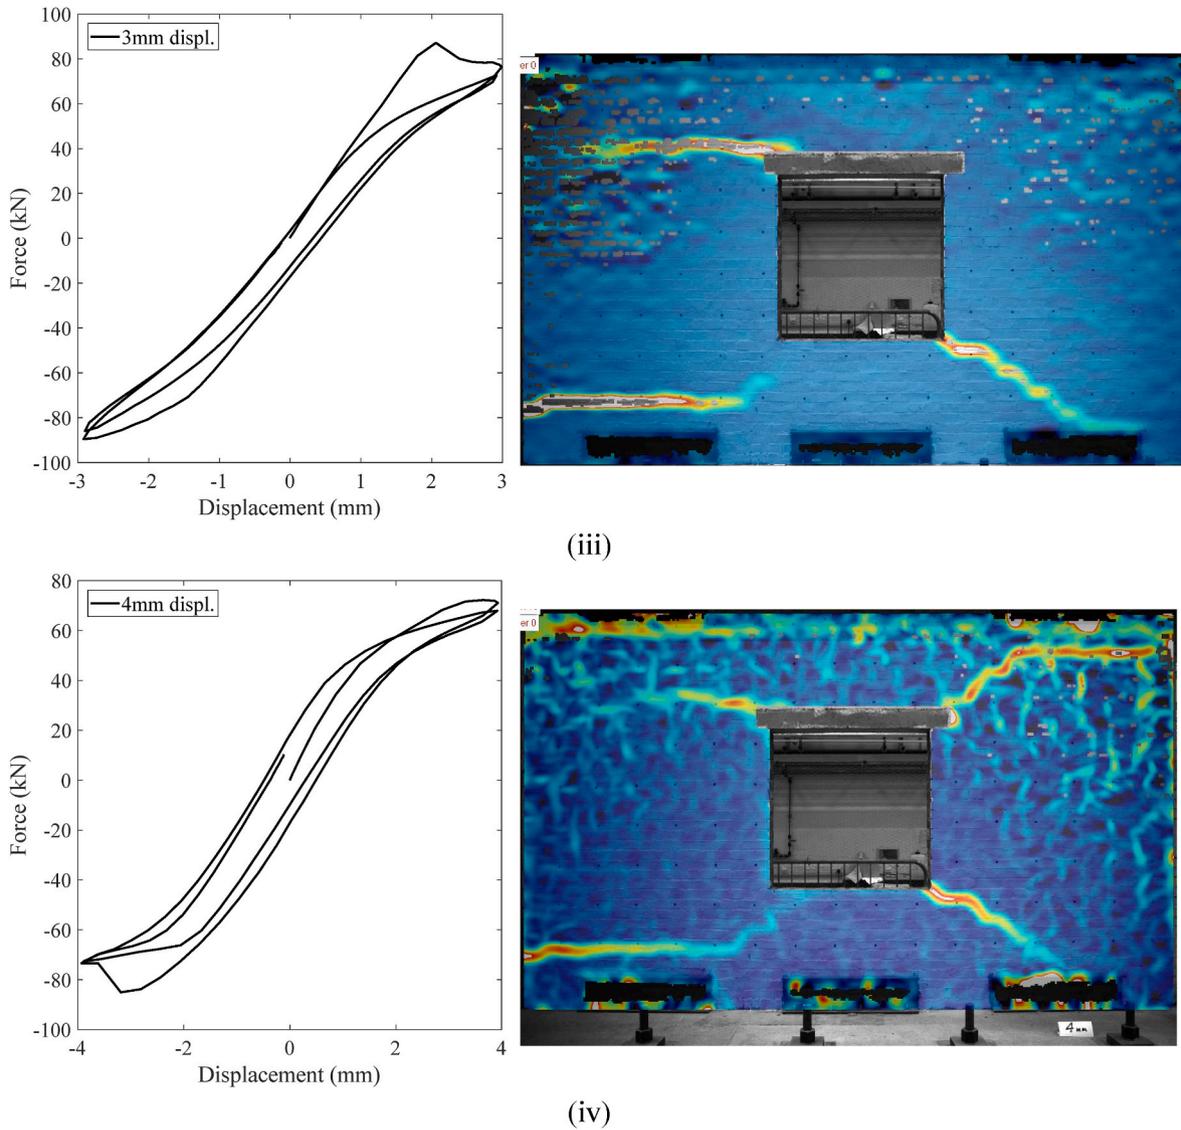
**Fig. 8.** The force-displacement curves and the corresponding DIC images at each loading cycle of the test on the URM wall: (i) 1 mm displacement amplitude (ii) 2 mm displacement amplitude (iii) 3 mm displacement amplitude (iv) 4 mm displacement amplitude.

As shown in Fig. 8(i-iv), there is no noticeable crack damage at the 1 mm loading cycle (Fig. 8(i)), while the 2 mm loading cycle image shows the beginning of the crack at the lower part of the wall (Fig. 8(ii)). The horizontal crack in Fig. 8(ii) becomes more pronounced and visible at the 3 mm loading with other cracks that were not noticeable by visual inspection (Fig. 8(iii)). Further, the 4 mm loading cycle image captures

The force-displacement behaviour and the corresponding DIC of the URM wall at each loading cycle are shown in Fig. 8 (i – iv). The ultimate load-carrying capacity of the URM wall increased with the displacement loading from the 1 mm amplitude (49.9 kN) and 2 mm amplitude (95.80 kN) until about 3 mm displacement loading when the lateral crack at the lower part of the wall occurred, leading to a slight reduction in the loading capacity (95.62 kN). This crack further reduces the wall's stiffness by about 34.7%, hence its load-carrying capacity. Further reduction in the load-carrying capacity was observed at the 4 mm displacement loading (82.96 kN), where more significant diagonal crack

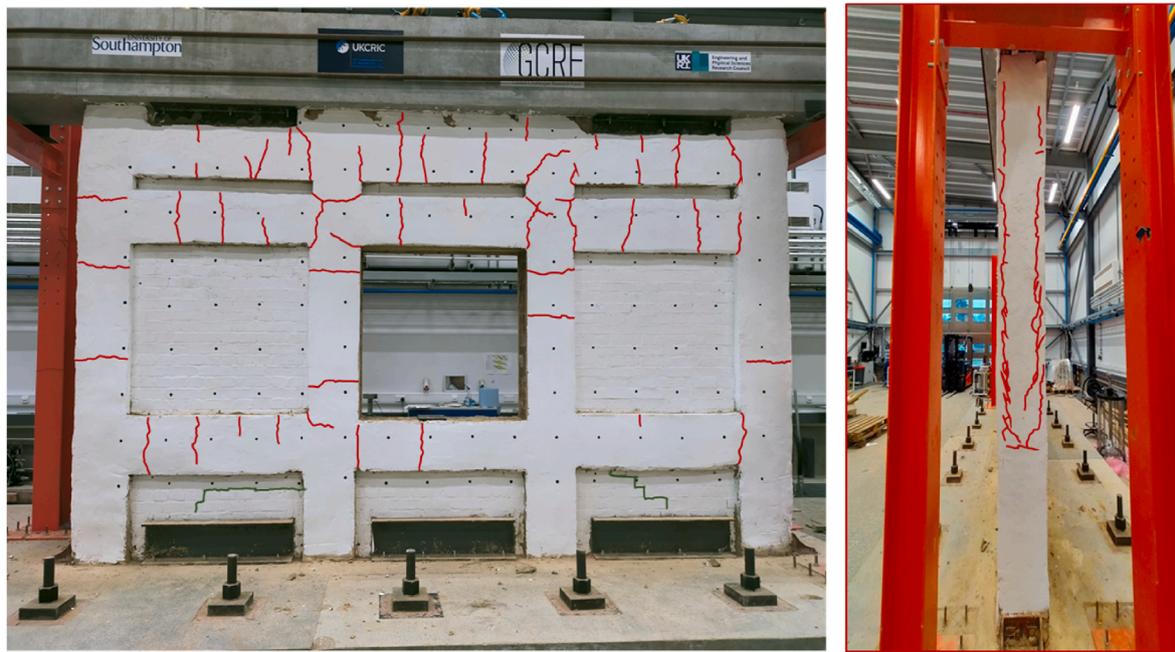
Fig. 9. Observed crack damage to the retrofitted wall at the end of the test.

The retrofitted wall was subjected to the same two-way ramp cyclic displacement loading protocol used on the URM wall. This loading was subsequently incremented to 6 mm amplitude (having observed little or no cracks on the wall) and finally pushed monotonically until a 20% drop in force (the test was stopped at this point for safety reasons). The wall was visually inspected for crack damage after each loading cycle. The retrofitted wall exhibited some little hairline cracks (red lines in Fig. 9) and spalling on the wall's rendered parts (mainly at the upper part below the RC beam), which increased as the test progressed and was more noticeable at the end of the monotonic push. There were also diagonal and horizontal cracks in the mortar joint at the lower part of the wall (green lines in Fig. 9). The observed cracks fall under the negligible to slight damage category (Grade 1) class of failure according to the European Macroseismic Scale (EMS-98) [83]. The Grade 1 failure refers to damages with slight non-structural damage having only hairline cracks and the fall of small pieces of plaster.

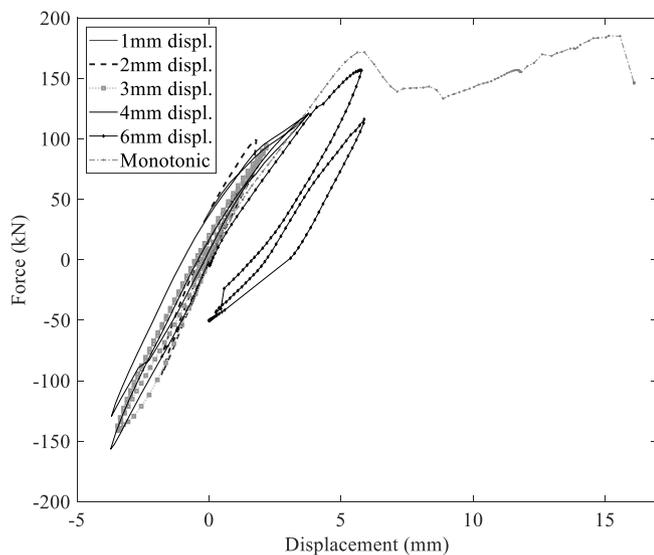
Fig. 10. Force-displacement response of the retrofitted wall.

The force-displacement response of the retrofitted wall to the applied two-way ramp cyclic displacement loading is presented in Fig. 10. The plot includes the monotonic loading applied after the 6 mm cyclic loading and shows an increase in the ultimate load-carrying capacity of the retrofitted wall. The wall was pushed monotonically to about 183 kN, almost double the URM wall's load-carrying capacity (95.62 kN). In addition, the wall stiffness increased with the displacement loading amplitudes until the monotonic loading sequence, when the test was stopped for safety reasons.

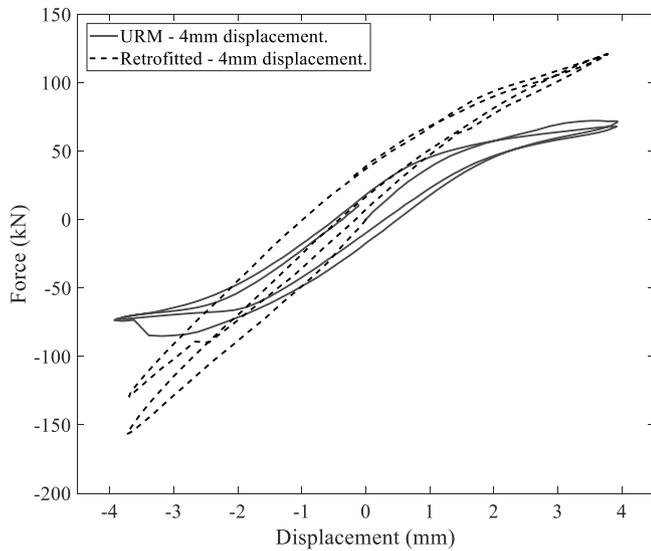
Fig. 11. Force–displacement comparison of both URM and retrofitted walls at 4 mm displacement loading.

The retrofitted wall exhibited a higher load-carrying capacity [42] and had a higher effective stiffness than the URM wall, as seen from the comparison in Table 2 and Fig. 11 below. The ultimate load-carrying capacity of the masonry wall increased from 95.8 kN to 182.97 kN,

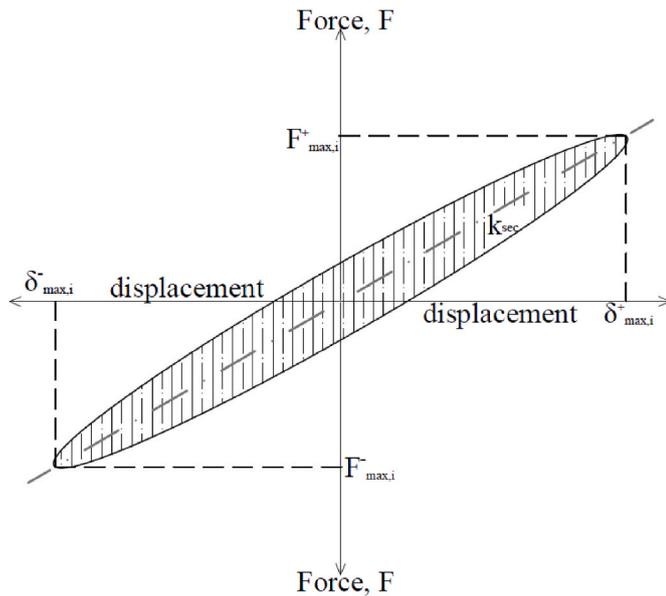
Fig. 12. Typical hysteretic response of masonry structure.

The equivalent viscous damping is a good indicator of the energy dissipation capacity and the stability of the hysteresis behaviour [88]. It is computed as the ratio between the energy dissipation of the completed cycle and its corresponding force-displacement response (elastic energy)

(Fig. 12). It is calculated for each loading cycle (Equation (4)).

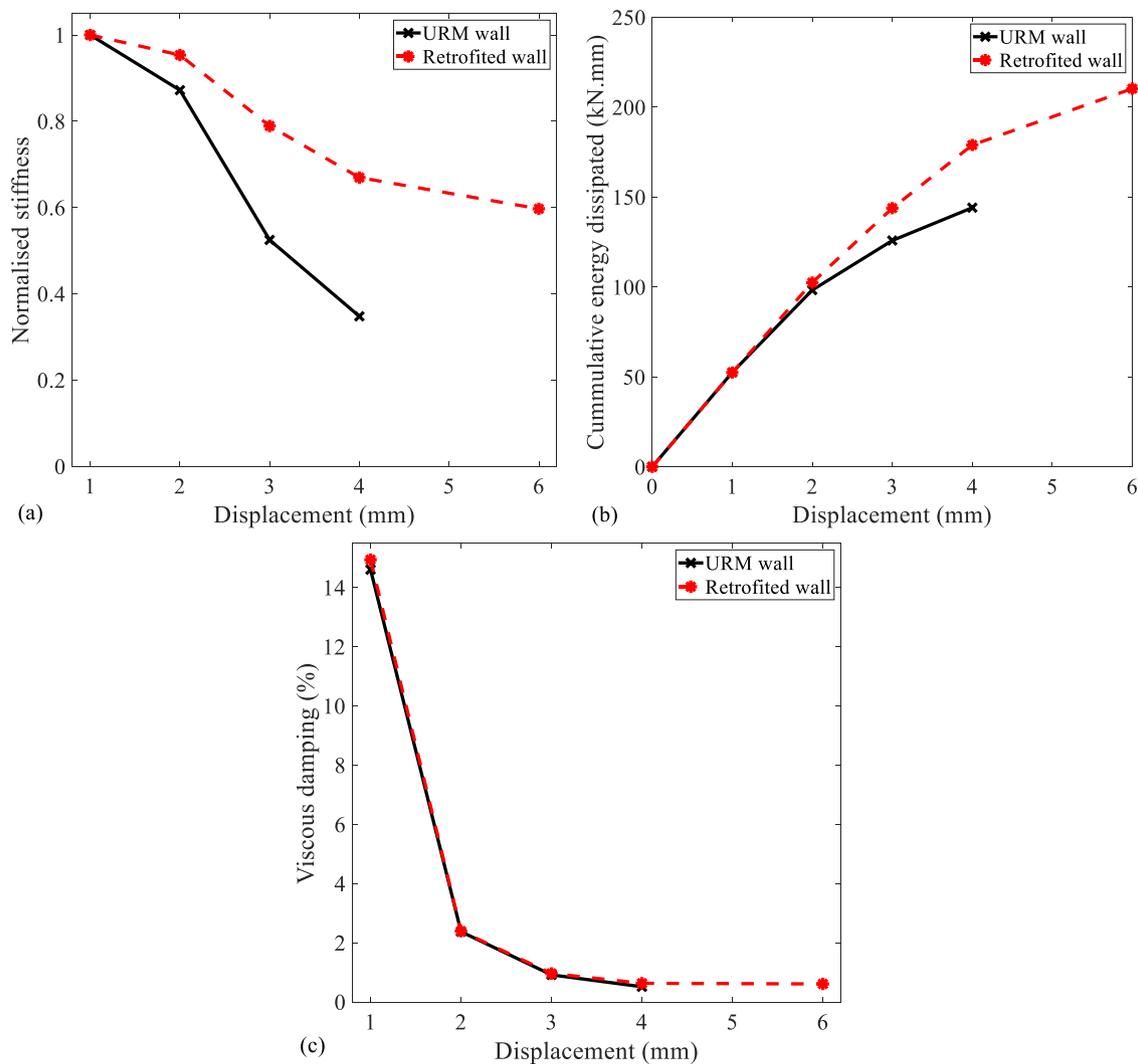
**Fig. 13.** The damage parameters of the URM and retrofitted walls (a) normalised effectiveness stiffness, (b) cumulative energy dissipated and (c) viscous damping.

Fig. 13(a) shows the normalised stiffness of the masonry wall to the

corresponding displacement estimated from equation (1). The secant stiffness of the wall decreases as the displacement load increases with crack formation at each loading cycle. The retrofitted wall exhibited a higher stiffness resistance than the URM at each loading displacement. The percentage increase in the normalised stiffnesses between the retrofitted and URM walls are 8.1%, 26.4% and 32.2% for the 2 mm, 3 mm and 4 mm displacement loadings, respectively.

Fig. 13(c) shows the equivalent viscous damping of the masonry wall at the different loading amplitudes. The viscous damping decreases with increasing loading amplitude in the URM and retrofitted wall. For example, 83.8%, 93.7% and 96.5% decreased for the 2 mm, 3 mm and 4 mm, respectively, from the 1 mm loading amplitude in the URM wall. A similar trend is observed in the retrofitted wall, having reduced viscous damping by 84%, 93.6%, 95.8% and 95.9% for the 2 mm, 3 mm, 4 mm and 6 mm, respectively.

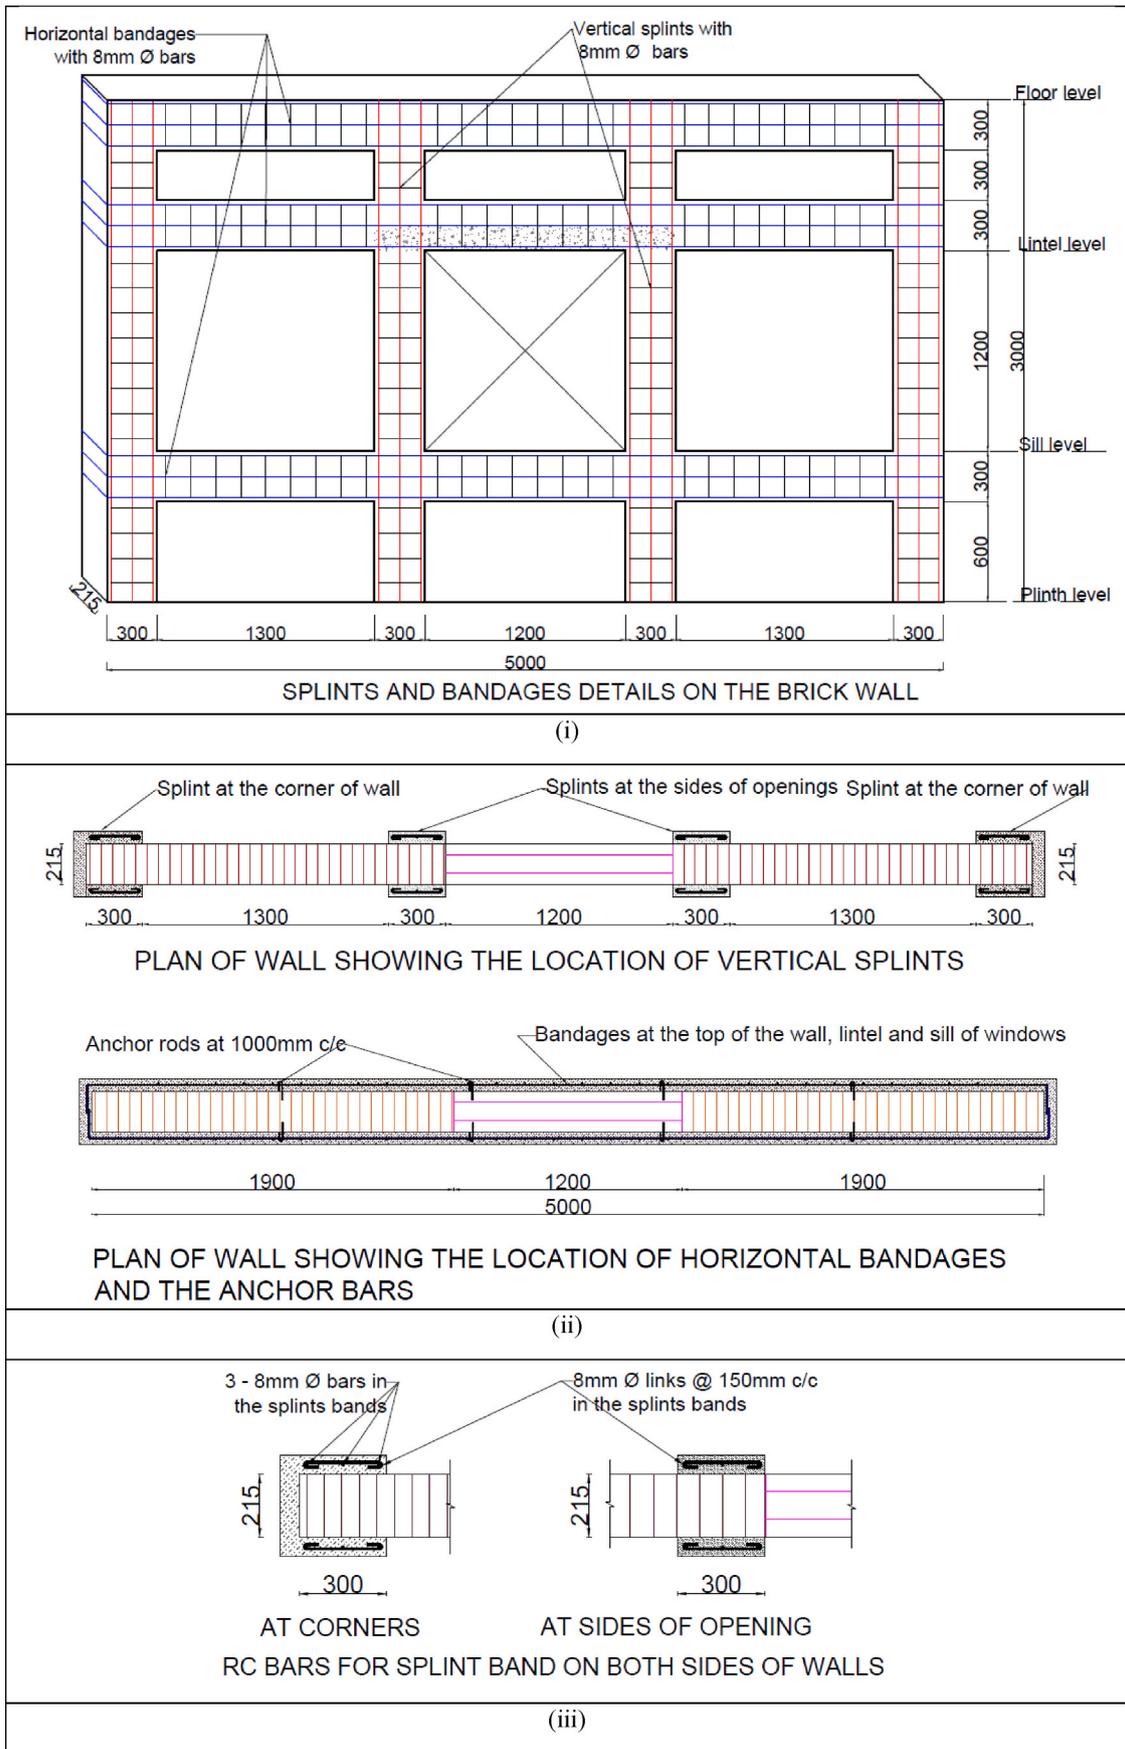
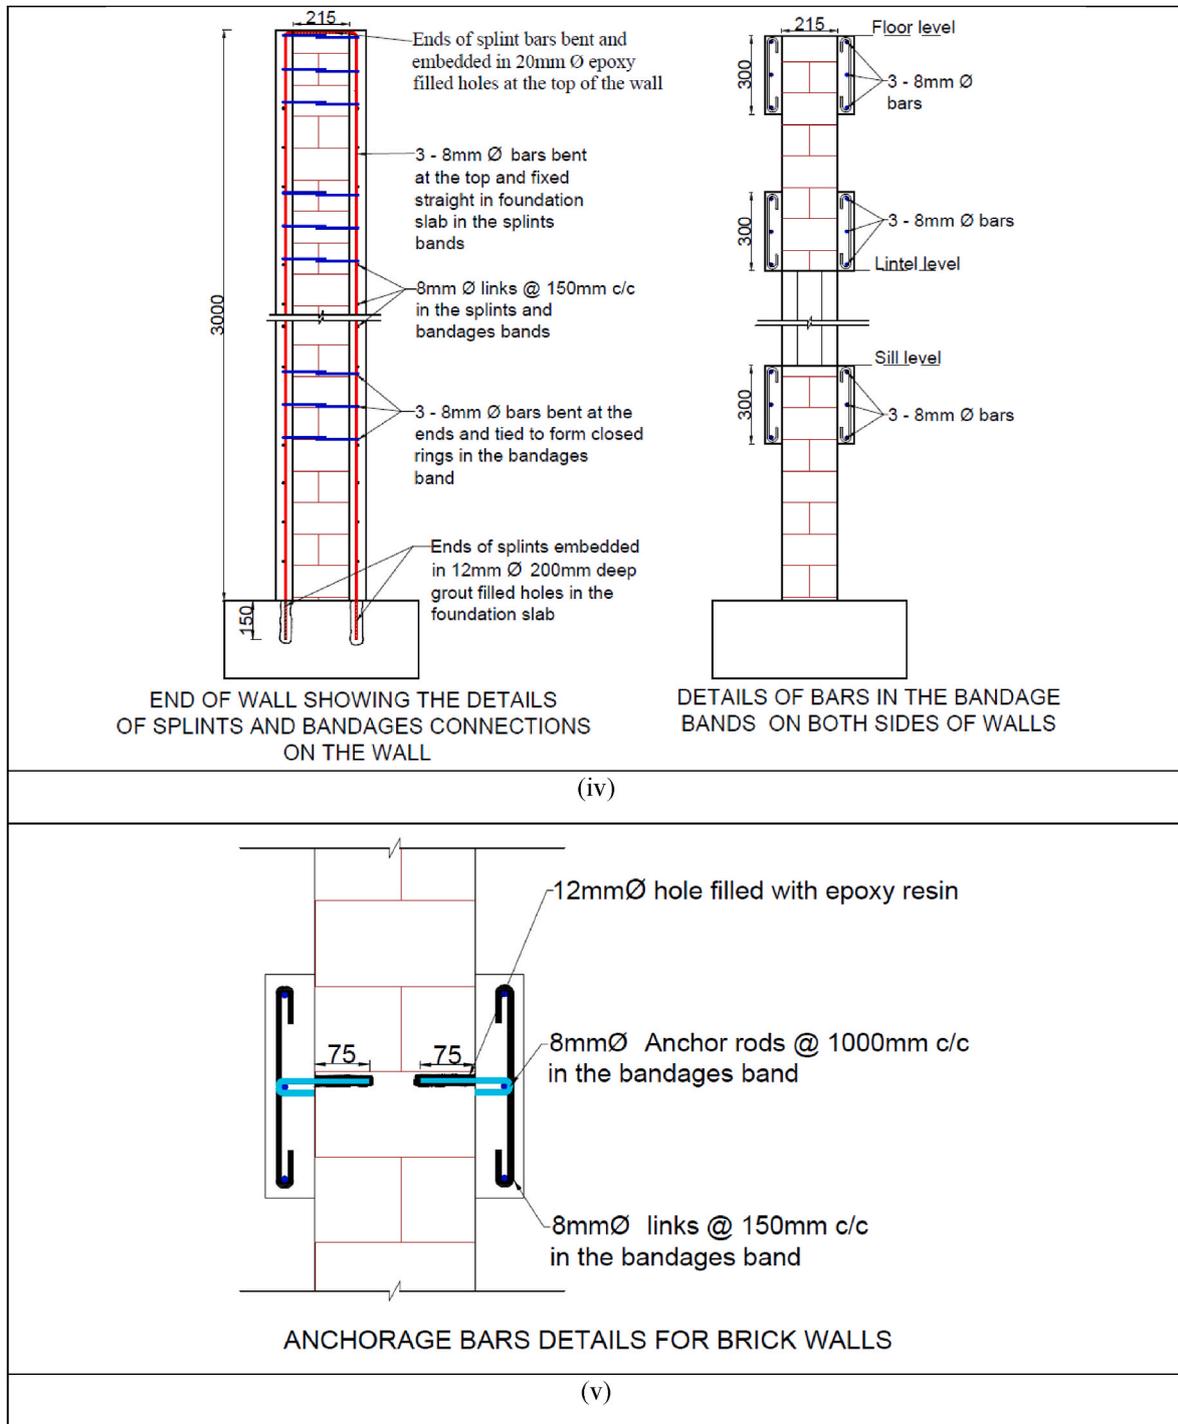
Fig. 14. The procedure for retrofitting Nepalese school buildings.

- The clay bricks should be set in 1:6 cement-sand mortar as recommended by the NBC [69] rather than the mud mortar specified by NSET-Nepal.
- The splints, comprising three vertical bars spaced with 350 mm long bars (bent 50 mm at both ends such that it spans 250 mm) at 150 mm centres, are fixed at the edges of the walls' opening, ends and corners (Fig. 14(i) and (iii)). The spanning and locations of the splints and bandages are as recommended by NSET-Nepal [64].

- The top end of the splints should be bent (about two-thirds the width of the wall) and fixed in holes drilled at the top of the wall. Alternatively, the lower ends are fixed straight into holes in the foundation slab (Fig. 14(ii) and (iv)) instead of bent into the lower part of the wall.

- The splints and bandages are held close to the wall by anchor bars made from reinforcement. The bars are bent at the ends, fixed into holes drilled (about half the width of the wall) into the bricks, and filled with epoxy resins at about 1 m centres (Fig. 14(v)). The anchor bars should be fixed with epoxy resin as it is stronger than the cement slurry recommended by NSET-Nepal.

- The splints and bandages are afterwards covered with a 1:6 sand-cement render/plaster mixture in layers, depending on the thickness. Sand-cement render/plaster should be used on the splint and bandages instead of the concrete recommended by NSET-Nepal, as it was found suitable for the wall and will be cheaper and faster to install.
