**HOUSING CONDITIONS AND WASTE
MANAGEMENT IN KARMO SQUATTER
SETTLEMENT, ABUJA-NIGERIA.**

**DEPARTMENT OF GEOGRAPHY
FEDERAL UNIVERSITY OF TECHNOLOGY
MINNA, NIGERIA**

*Being a dissertation submitted in partial fulfillment
for the award of master of Technology Degree in
Remote Sensing Applications in The Department of
Geography School of Science and Science
Education, Federal University of Technology,
Minna Nigeria*

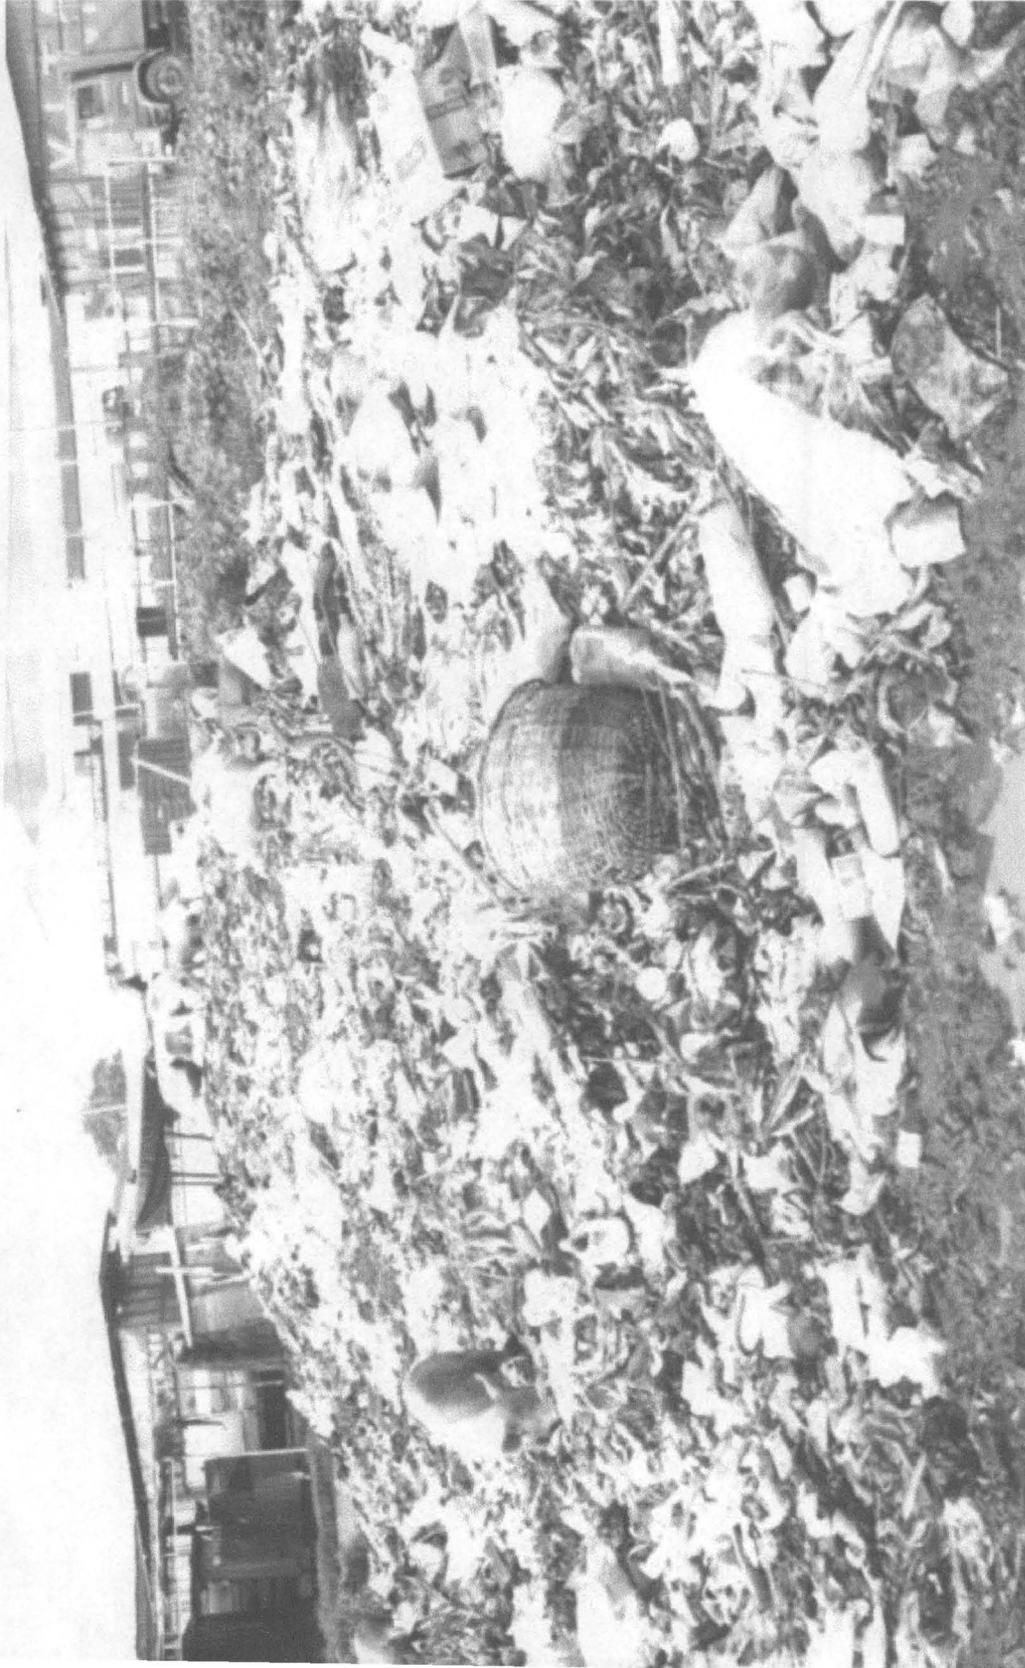
Plate 4.9 Disposal Points

The respondents were asked on the methods and procedure of managing the domestic waste generated from the households. Dustbin of one type or the other, buckets and bags were used to collect wastes while a few use newspaper. The impression generally on the waste management in Karmo is that available open spaces are used to store waste and this gives the impression of the frequency that waste disposal will require in the study area. Respondents were further asked on the method of waste disposal. They claimed that the inhabitants either dispose the waste by piling in an open space or burn them. I.e. plate 4.9 and 4.10.

The respondents were asked on the methods and procedure of managing the domestic waste generated from the households. Dustbin of one type or the other, buckets and bags were used to collect wastes while a few use newspaper. The impression generally on the waste management in Karumo is that available open spaces are used to store waste and this gives the impression of the frequency that waste disposal will require in the study area. Respondents were further asked on the method of waste disposal. They claimed that the inhabitants either dispose the waste by piling in an open space or burn them. I.e. plate 4.9 and 4.10.
