**THE EFFECTS OF RAINSTORM ON BUILDINGS IN CHANGHAGA  
AREA OF NIGER STATE**

**YISA MERCY LAMI  
REG NO. PGD/GEO/2001/2002/212**

**FEDERAL UNIVERSITY OF TECHNOLOGY  
MINNA NIGER STATE**

**PROJECT SUBMITTED IN PARTIAL FULFILMENT OF THE  
REQUIREMENT FOR THE AWARD OF POST GRADUATE DIPLOMA  
[PGD] ENVIRONMENTAL MANAGEMENT**

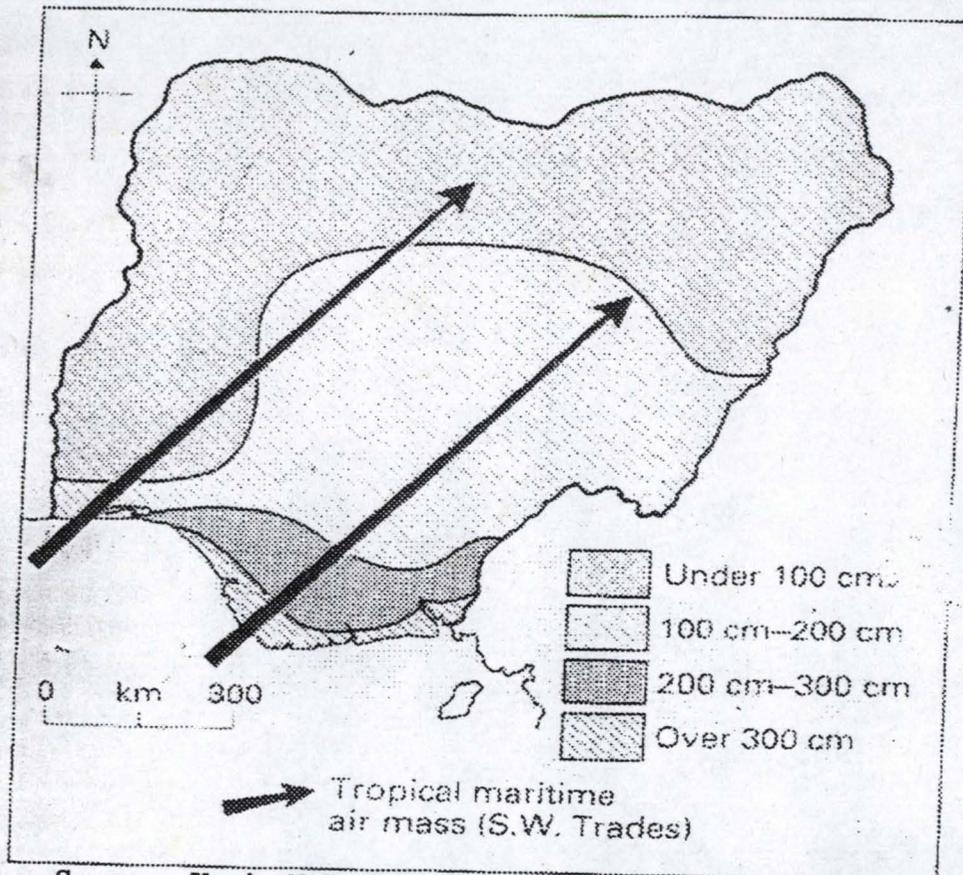
Figure: 2.2

Wet season winds and rainfall (April-October).  
 The full effect of the tropical maritime air mass as the main factor which brings rainfall is felt in this season. Because it comes from the south and drops its moisture progressively northwards, rainfall diminishes from south to north.

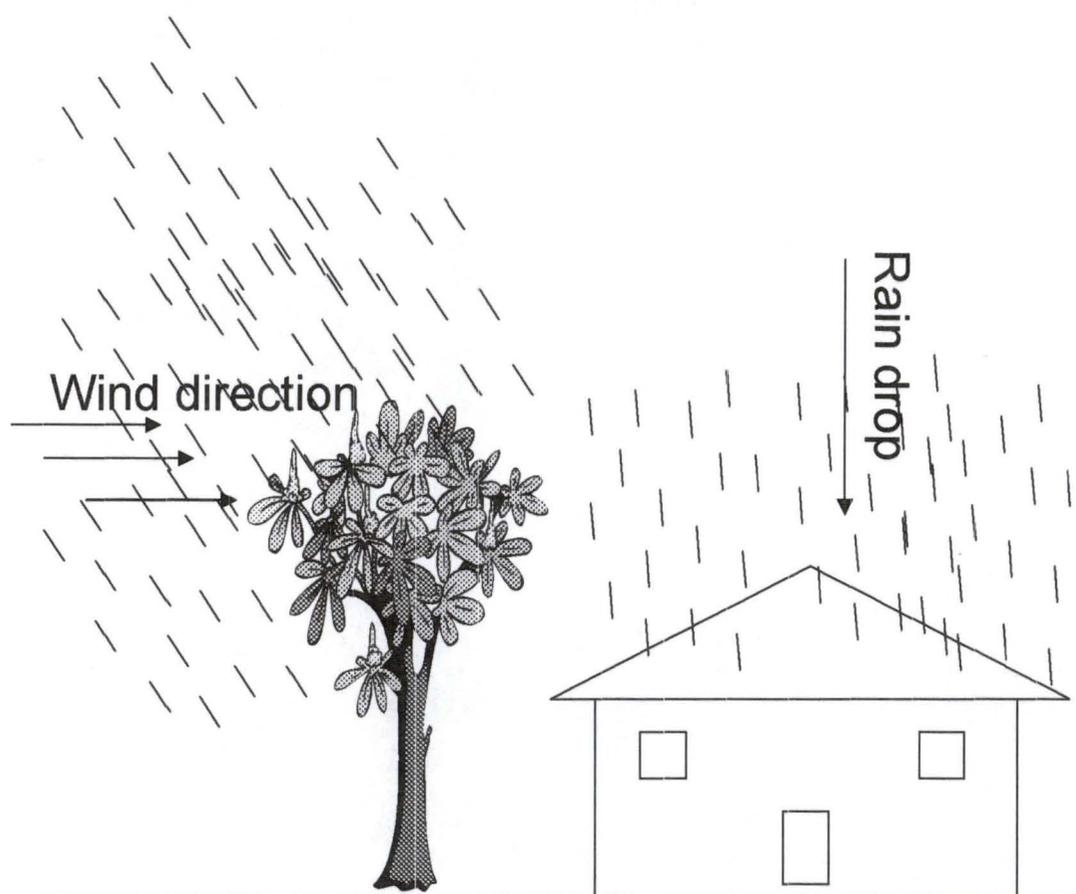
A

Fig. 5.1 shows that the tree act as a wind breaker to the wind direction.

High pitched roofs will be very suitable for Chanchaga buildings. From the illustration below, because of the trees planted at the direction of the wind in house A, the effects of rainstorms will be reduced to some extent on the buildings. Because the trees break the wind flow so that rain droplets do not strike the buildings directly also in house A, the trees reduce the speed and pressure of wind that may try to lift the roofing sheets off the buildings. While on the other hand, house B will be affected seriously by the rainstorm because there are no trees to break or reduce the speed and pressure of wind. So the building surfaces will receive more raindrop strikes that will damage the rendering materials e.g. paint, dampen Fascia boards, ceiling boards and walls. The wind speed can result in the lifting off of the roofing sheets.

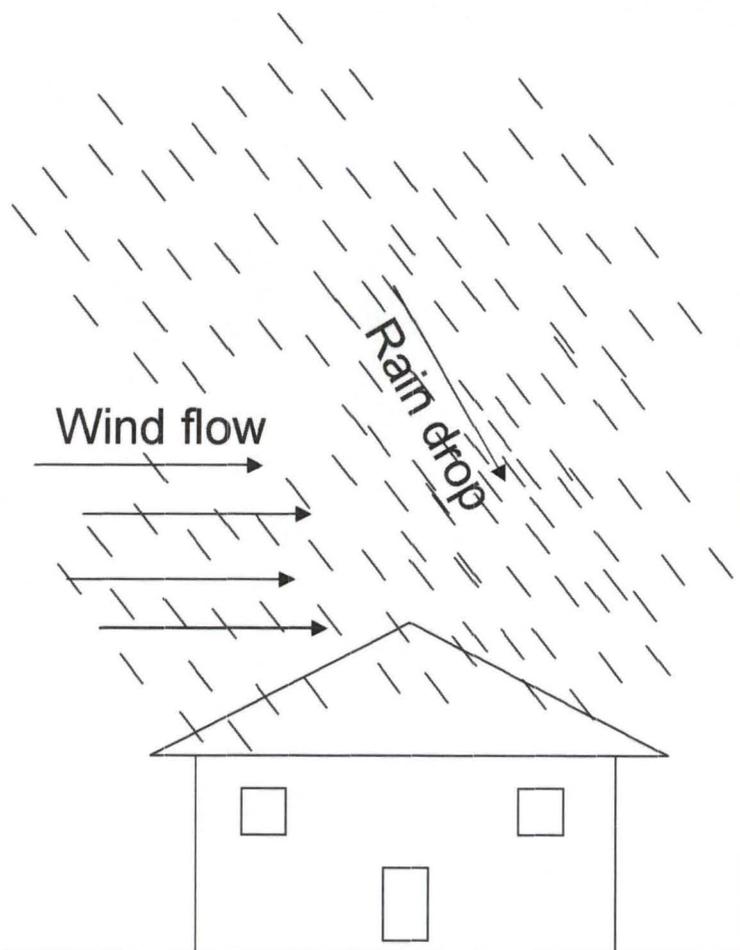
B

Fig.5.2 shows the effect of wind on rain drop

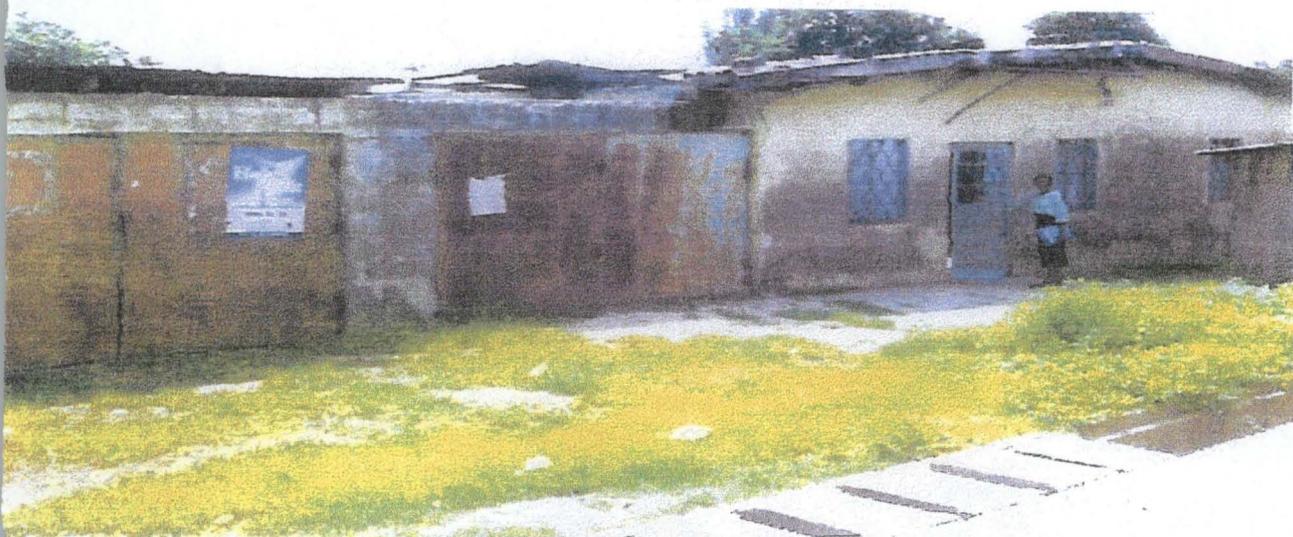
**Plate 1:** The effect of rainstorm on a house; Wind has blown off Part of the roof, discoloured paint surface, corroded metal gate, roofing timber, fascia, board and ceiling board decayed due to moisture.

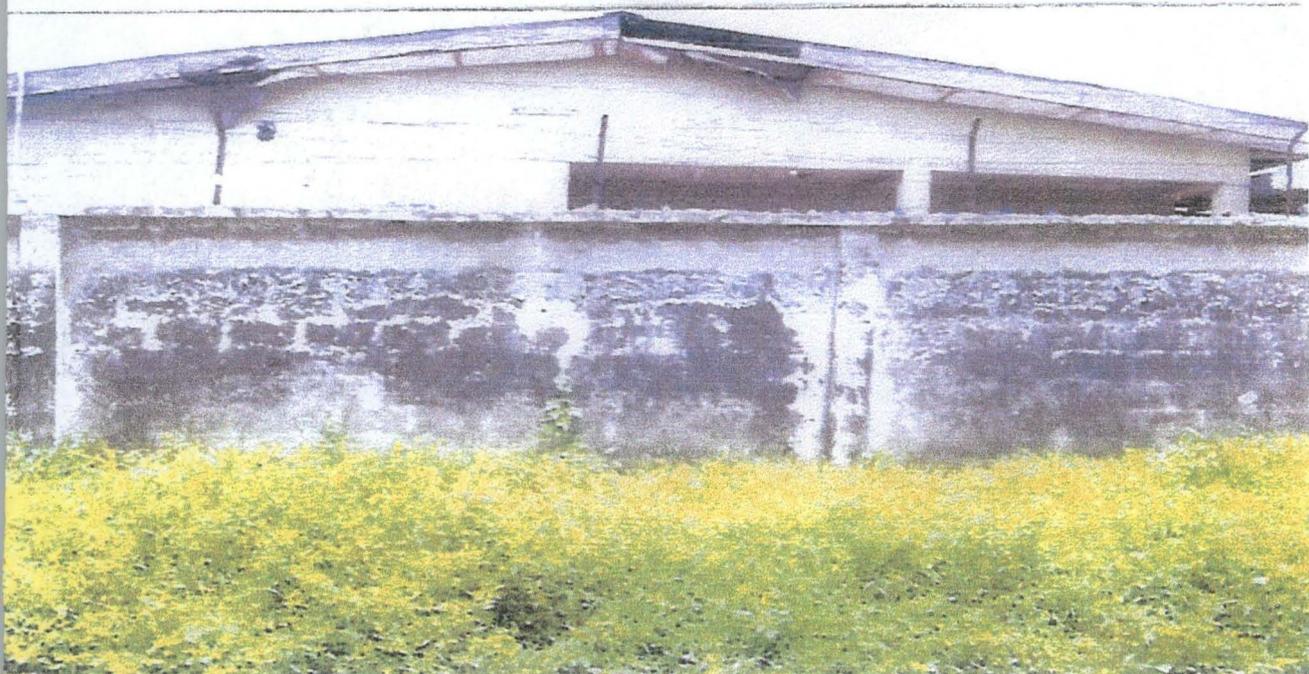
**Plate 2:** Shows the effect of rain on wall surface resulting to discoloured paint wall, rendering flaked exposing the blocks with part of fascia board and ceiling board decayed and falling off.

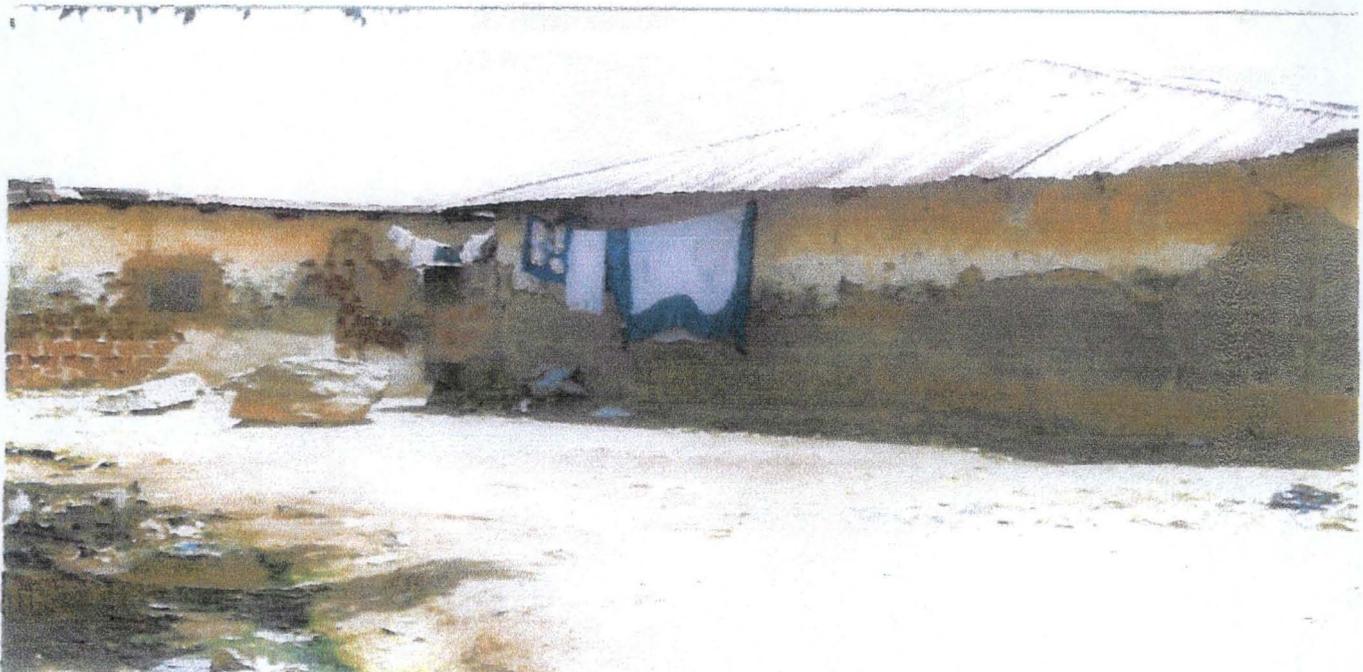
**Plate 4:** Shows the effect of rain which have wash off the paint and peel of the rendering exposing the mud and sandcrete block in Chanchaga town.

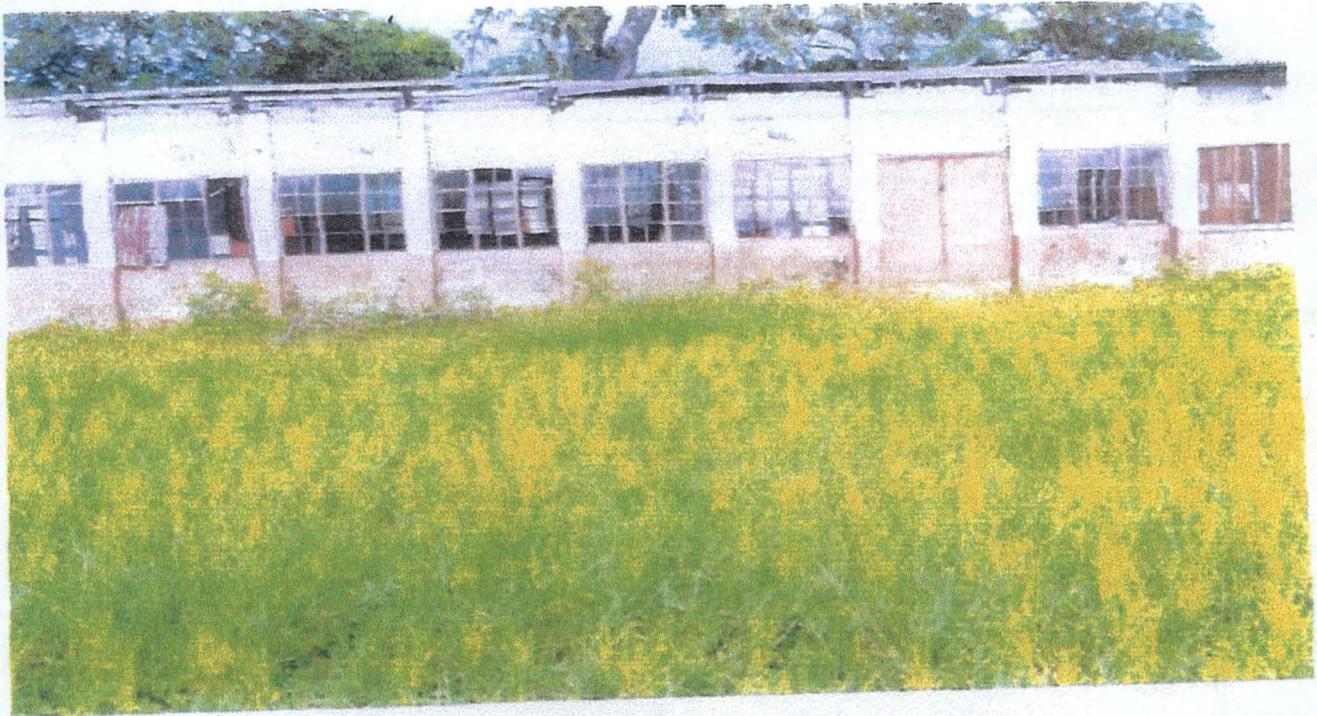
**Plate 5:** Shows the effect of wind blowing off roofing sheet of classroom block in Government Technical College Minna in Chanchaga town.

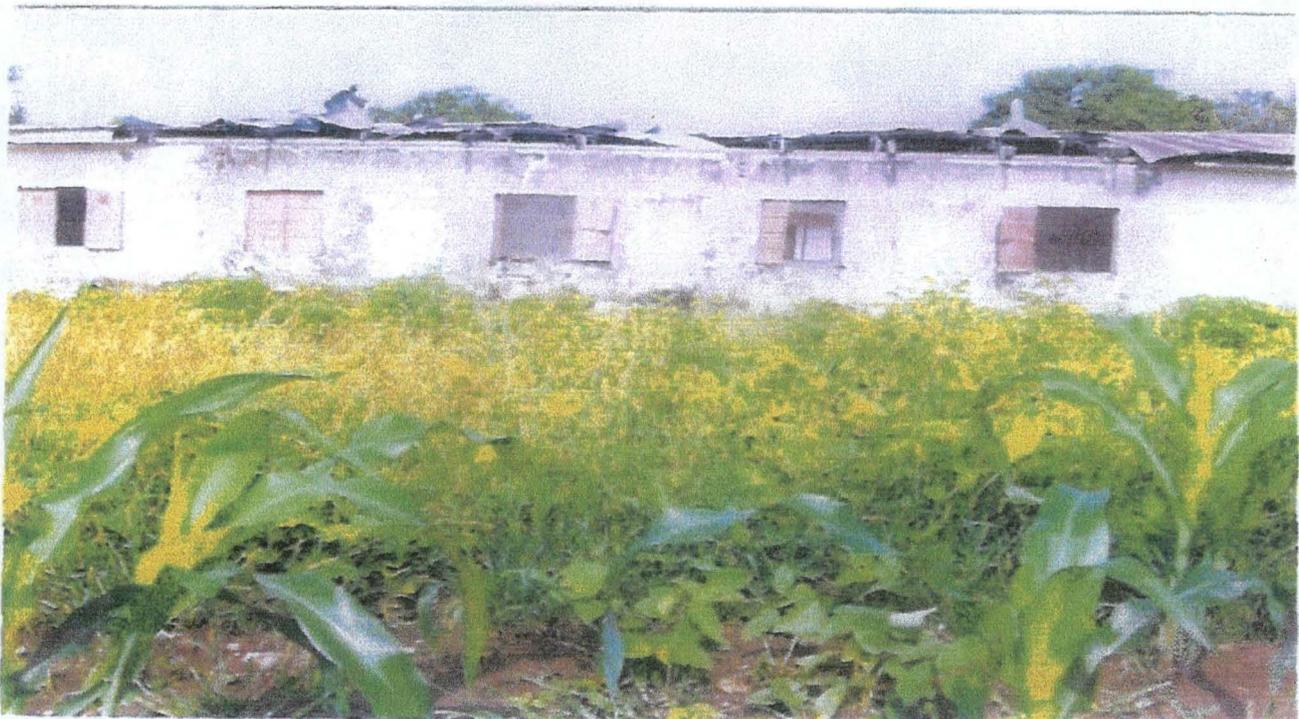
**Plate 6:** The effect of rain washing away the paint on wall and Wind blowing off part of the roofing sheet. Also part of Fascia board and ceiling board completely falling off in G.T.C. Minna.

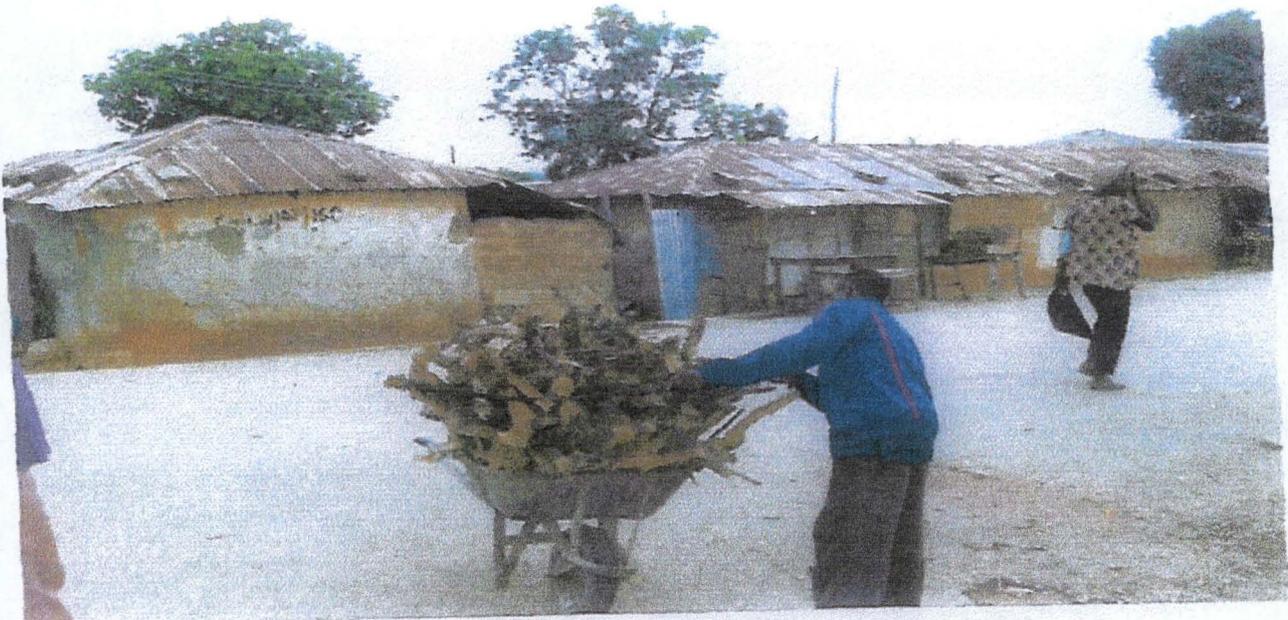
**Plate 7:** Shows large stone and block placed on roof top to prevent roofing sheet from been blown off by wind. Also shown the effect of rain on wall discolouring and flaking the rendered wall

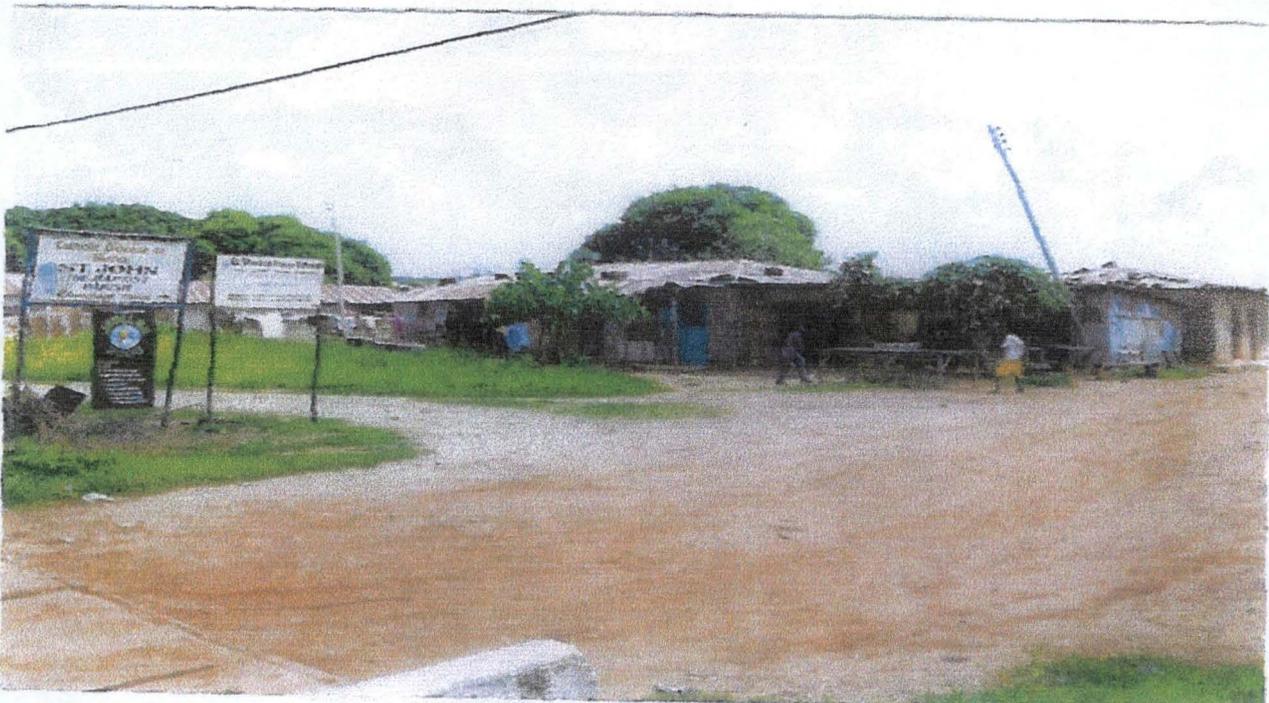
**Plate 8:** Shows buildings with large stone and block laid on the roofing sheets to prevent lifting in the event of rainstorm within Chanchaga town.

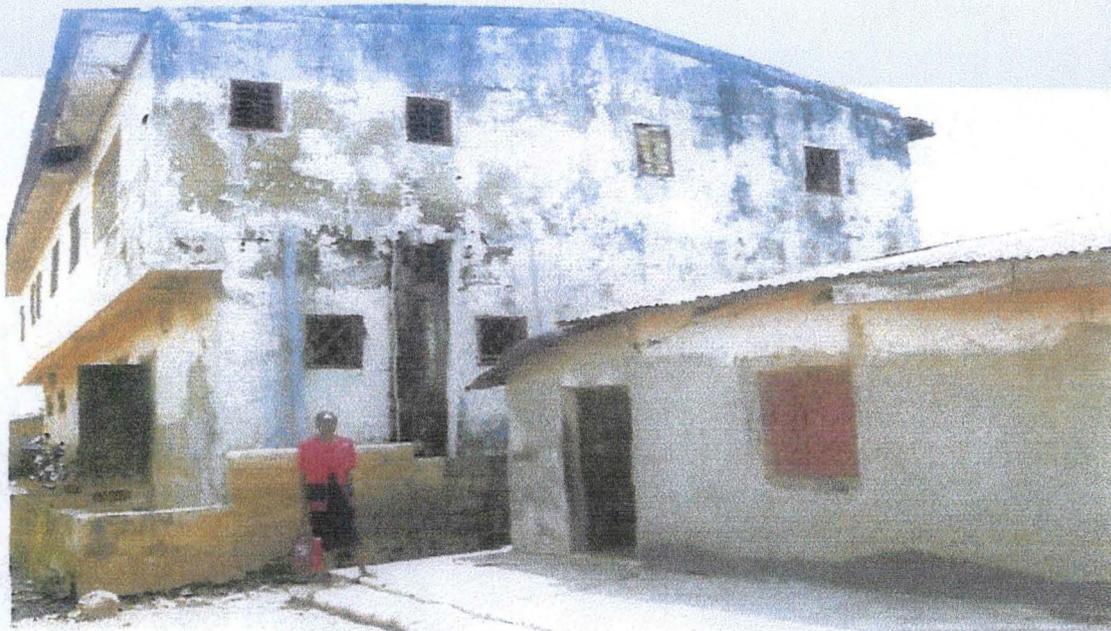
**Plate 9:** Shows the effect of rain on a storey building washing of the paint and damp penetration at the top part of wall surface.

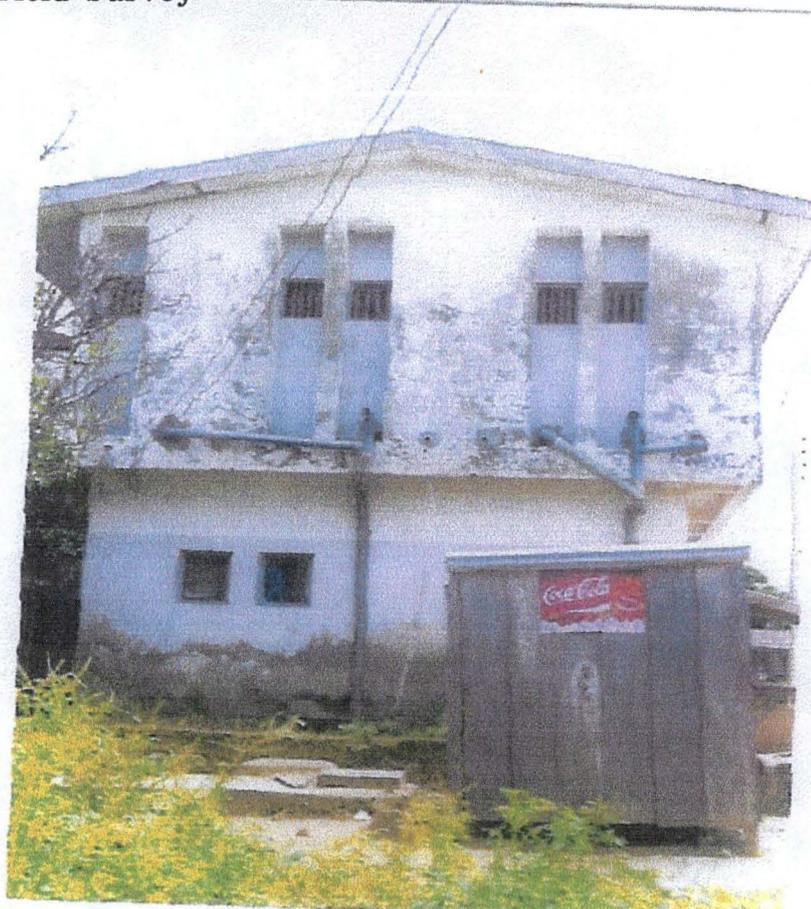
**Plate 10:** Shows a storey building affected by rainstorm causing discolouration of the wall at the first floor of the building and underground moisture at the ground floor in Chanchaga town.

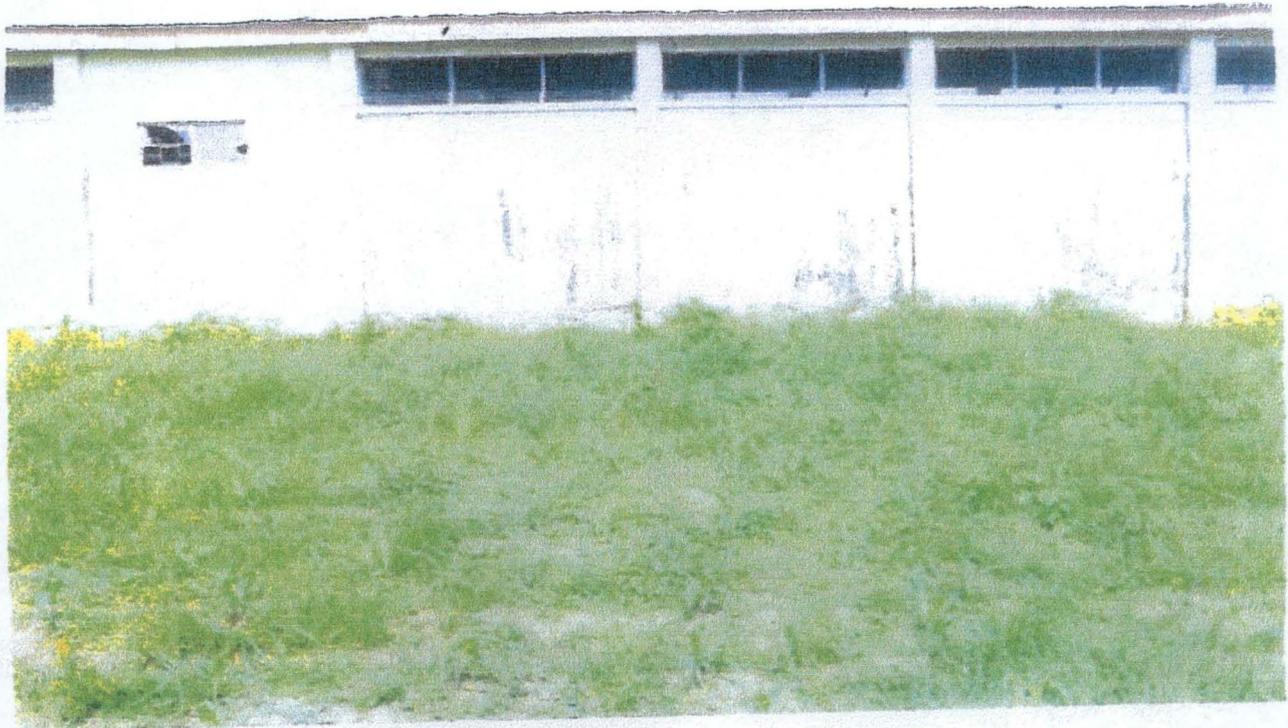
**Plate 11:** Shows the effect of rain on wall surface washing off the paint on a workshop block in G.T.C. Minna in Chanchaga town.

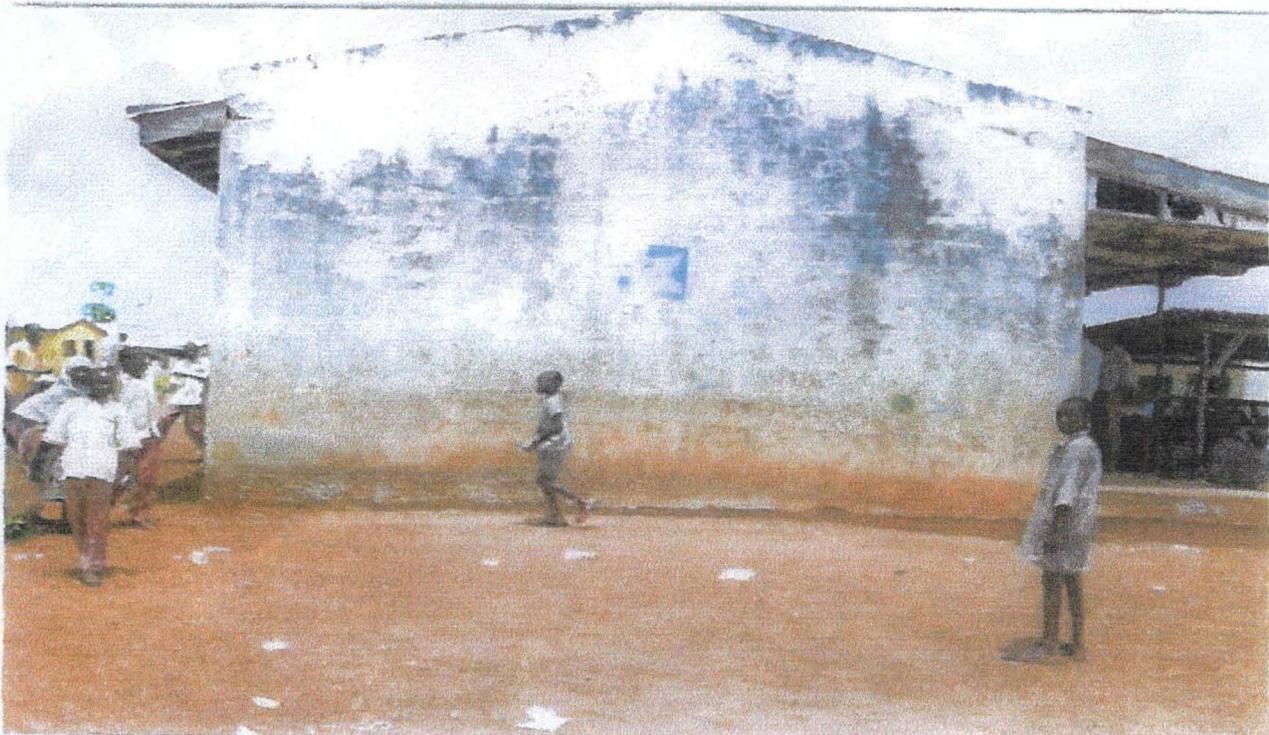
**Plate 12:** Shows the wall of a Primary School in Chanchaga with washed off paint surface, flaked rendered wall and damped fascia board with decayed ceiling board.
