**AN ASSESSMENT OF FLEXIBLE PAVEMENT FAILURE AND  
ENGINEERING PROPERTIES OF SUB-GRADE MATERIALS  
ALONG ZUBA- GWAGWALADA CARRIAGEWAY,  
FEDERAL CAPITAL TERRITORY, NIGERIA.**

**A THESIS SUBMITTED TO THE POSTGRADUATE SCHOOL,  
FEDERAL UNIVERSITY OF TECHNOLOGY, MINNA.**

**IN PARTIAL FULFILLMENT OF THE REQUIREMENTS FOR  
THE AWARD OF THE DEGREE OF MASTER OF  
TECHNOLOGY (M. TECH) GEOGRAPHY WITH  
ENVIRONMENTAL MANAGEMENT  
(ENVIRONMENTAL DEVELOPMENT PLANNING).**

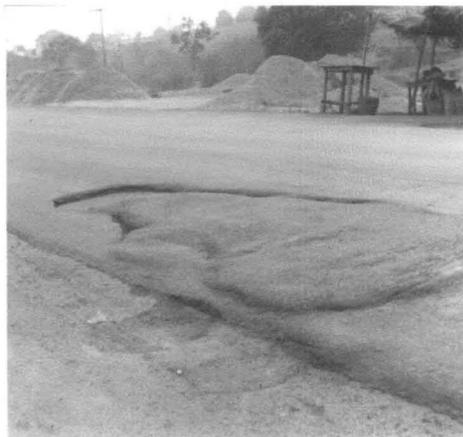
**Plate iii Surface Raveling**

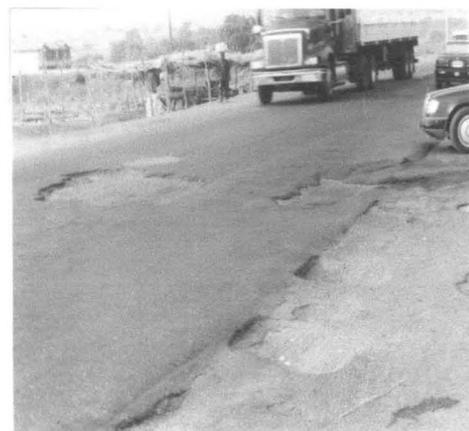
**Plate iv Pothole Manifestations**

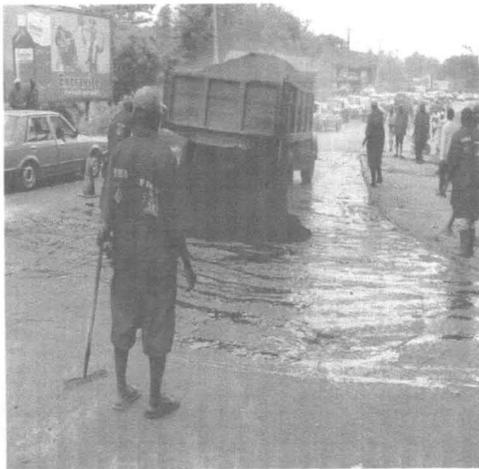
**Plate v Major Maintenance Works**

Besides the massive rehabilitation works implementation by these agencies, other remedial approaches such as vegetal control, desilting catch basins and repairs, base seals and ISS 2500 liquid stabilizer application were also adopted. These direct-process controls were also complimented by inputs from individuals, communities and Non-Governmental Organization (NGOs), in emergency circumstances as reflected in Plate v –vi.

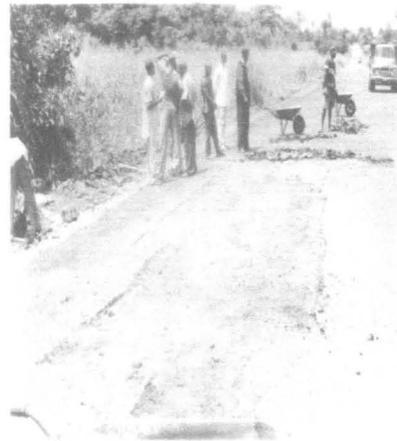
**Plate vi NGO Road Fill Support**

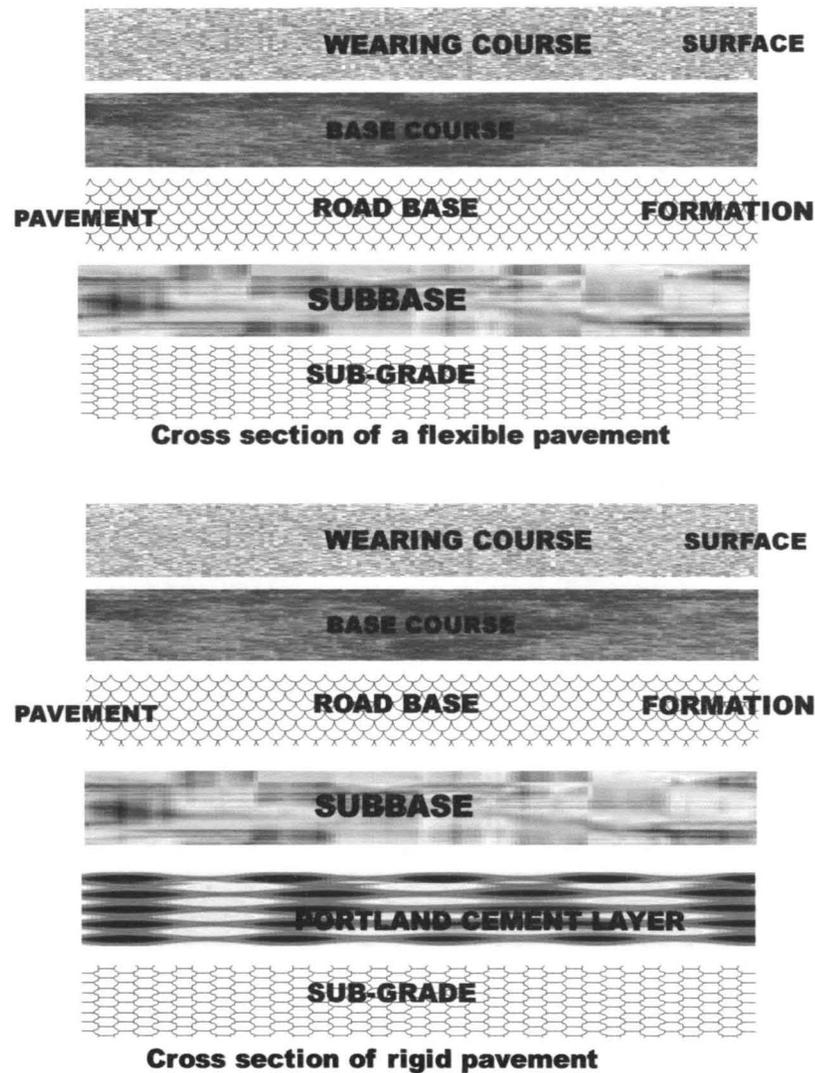
**Fig. 1.3 Typical Flexible and Rigid Pavements**

A flexible pavement may include the following five layers (from base to top)

An asphalt pavement that is placed directly on the sub-grade is known as a full-depth asphalt pavement. In this case, the thickness of the base and sub-base is simply replaced by appropriate “layers” of asphalt concrete to form a thicker layer than would otherwise be required. In the case of asphalt pavements and this reduces the strength of the base and sub-base. Fig 1.3 illustrates typical flexible and rigid pavements.

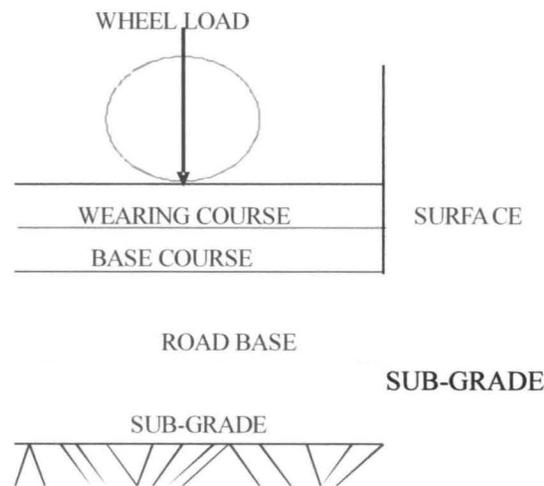
A pavement structure as illustrated in Fig 1.2 consists of a series of layers, beginning with the native soil that constitutes the prepared roadbed (or sub-grade), overlaid by the sub-base and base layers. The strength of these layers increases vertically from the sub-grade to conform to the increasing requirements of stress and load distribution by the base course as depicted in Fig.1.3. This practice contributes to lower economical and efficient use of materials by avoiding “over designing” the lower layers. Some of these layers may be omitted, depending on the strength of native soil and material availability.

Fig. 1.2 **Typical Pavement Structure**

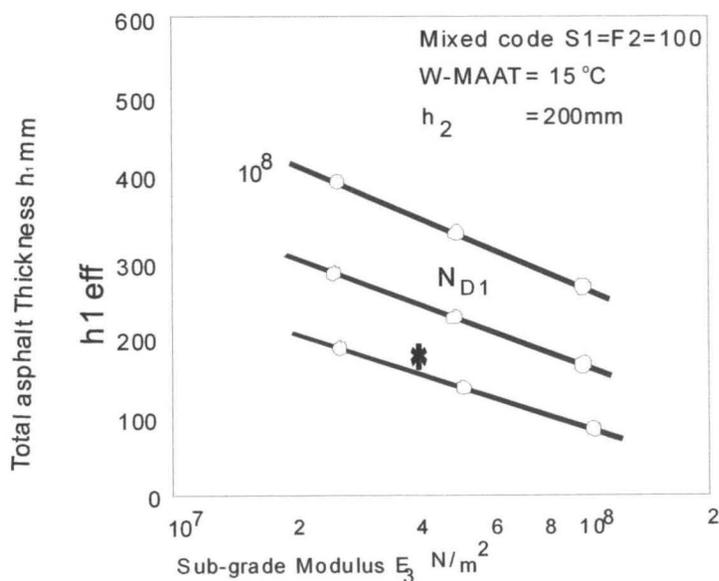
Fig 2.1 Determination of Original Design Life

Subsequently, a chart of the type HN in Fig. 2.1 was also prepared for the given parameters of mix code, w-MAAT and sub-grade modulus. For the experimental cross section, this was achieved by tracing curves for  $N = 10^6$ ,  $10^7$  and  $10^8$  and w-MAAT =  $15^0C$  from Charts HT 6, 14 and 22 ( $E_3 = 2.5 \times 10^7 \text{ N/m}^2$ ) and HT 30.38 and 46 ( $E_3 = 5 \times 10^7 \text{ N/m}^2$ ) on a transparency and drawing in the curves for  $E_3 = 4 \times 10^7$  as shown in Figure. 2.2. The position of the latter curves for  $h_2 = 200 \text{ mm}$  was checked for accuracy and the asphalt thickness for  $h_2$  was 200mm as reflected by the envelopes in Figure 2.2 while the thickness of the unbound layer was found to be about 200mm and the asphalt mix type assumed to be represented by the mix code S1-F2-100. The value of w-M.AAT, derived from the values of MAAT using appropriate chart, was found to be  $15^0c$ . The traffic historical value was estimated at  $N_{A1} = 3 \times 10^6$  and  $7 \times 10^6$  respectively. These data were recorded in worksheet format, as vended in Table 2.1. While values of  $H_1$  and  $E_3$ ; ( $\text{N/M}^2$ ) at  $4 \times 10^7 \text{ N/m}^2$  envelopes were derived as reflected in Figure 2.1-2.

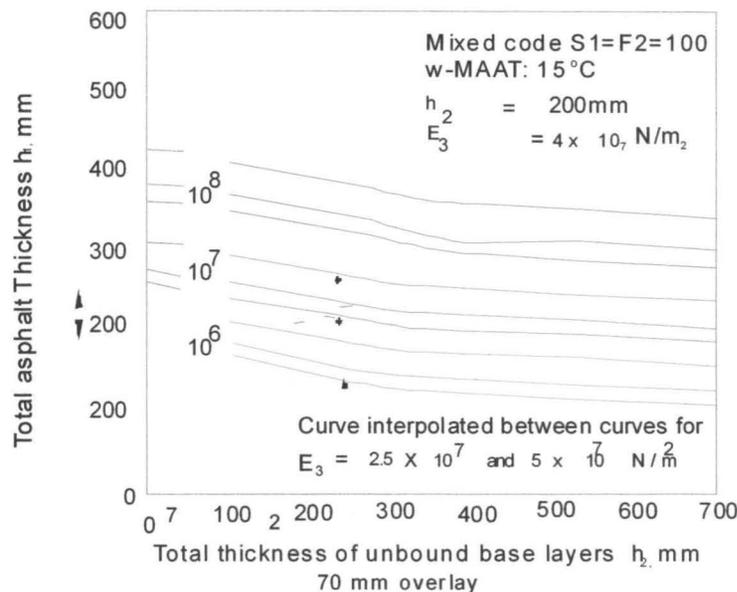
Fig. 2.2 Determination of Overlay Thickness

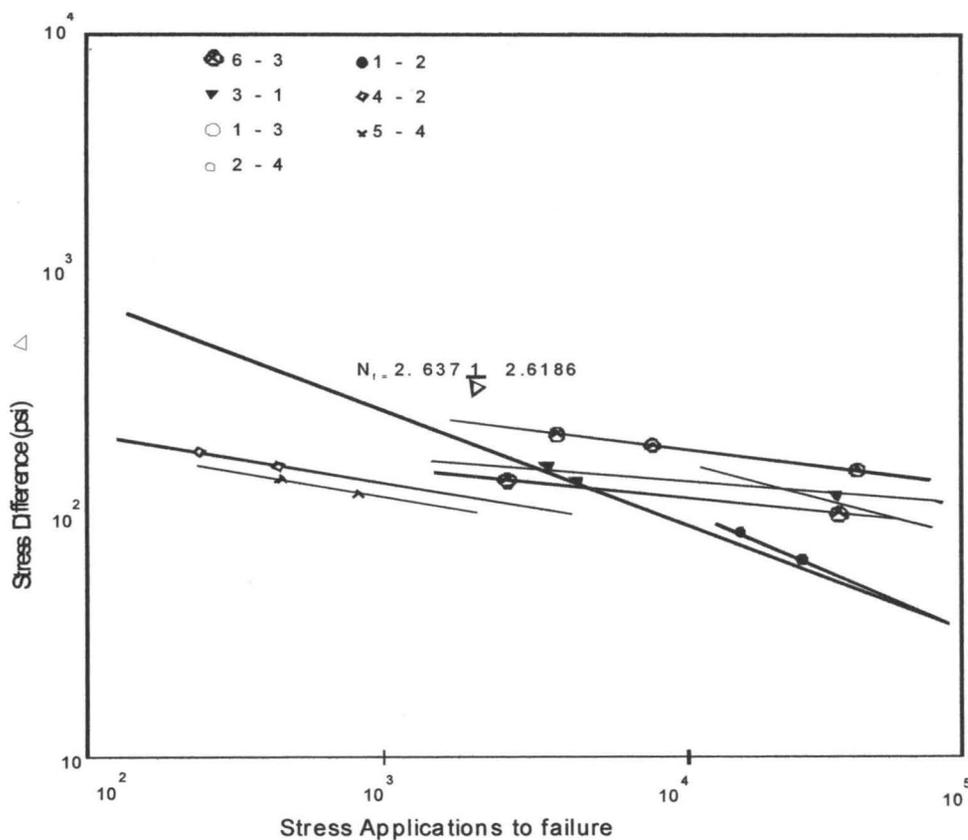
Fig 2.3 Stress Applications to failure for Cores From Master Test Sections

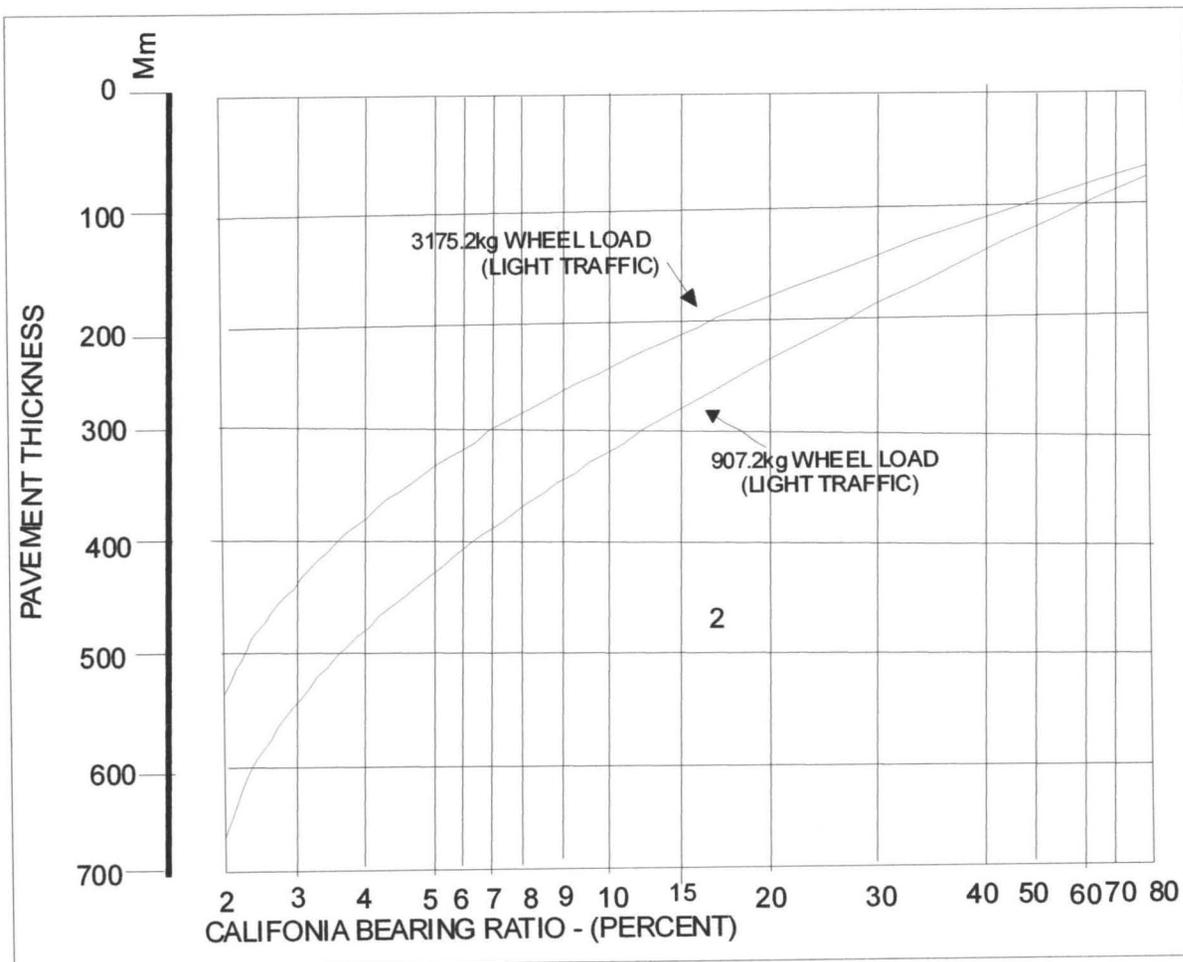
**Fig2.4: SPECIFIC CBR VALUES PER PAVEMENT THICKNESS.**

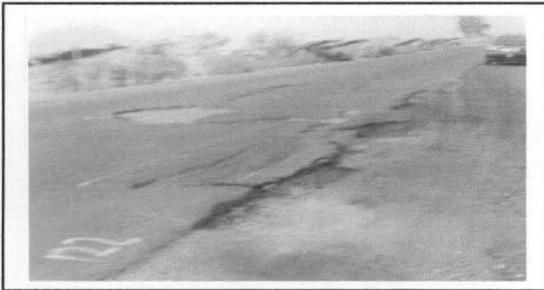
Plate xi. **Failed Cross Section**

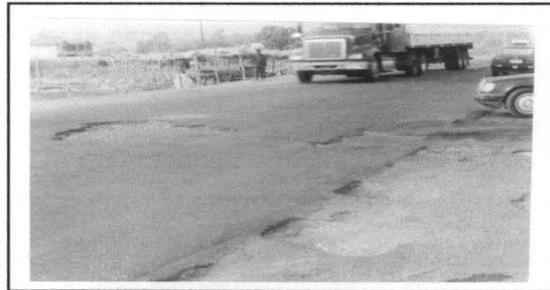
Plate xii. **Failed Cross Section**

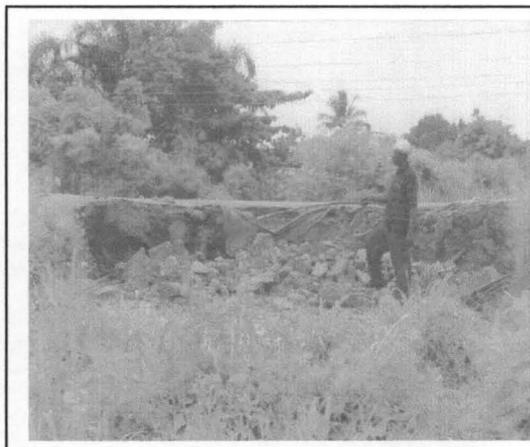
Plate xiii **Shoulder failure**

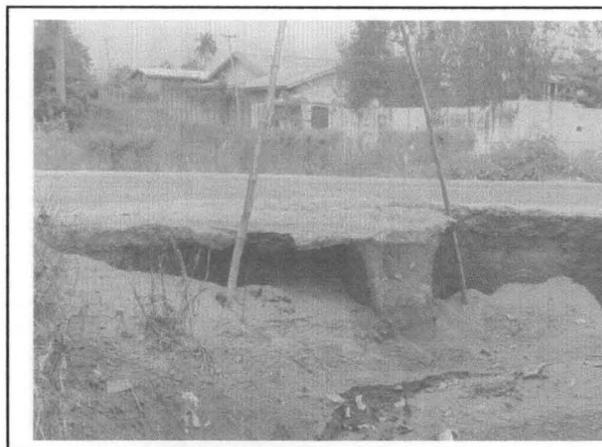
Plate ix **Base Shears within Sub - Grade**

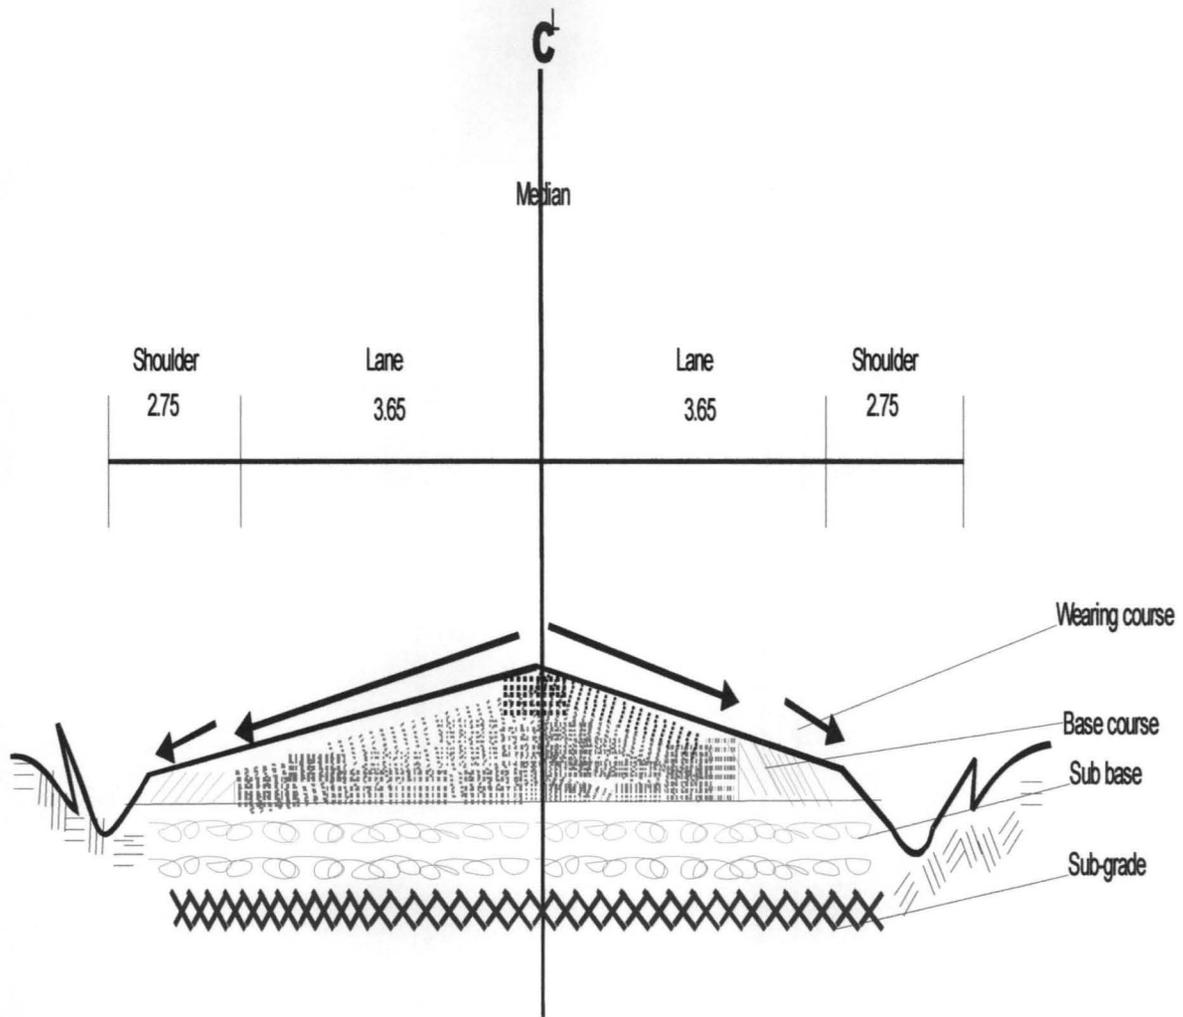
Width of each lane or carriage = 3.65m

Fig. 4.2 Geometry of Zuba – Gwagwalada carriageway

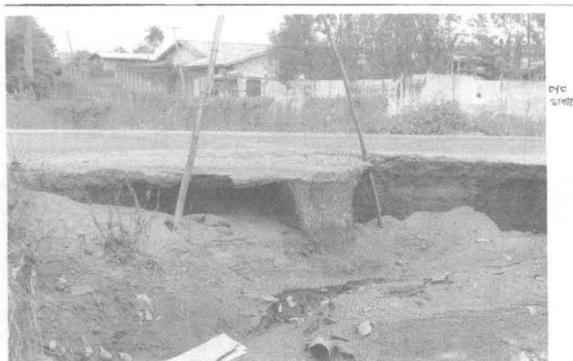
**Plate xv. Base Shears**

Until the planned dual carriage system with integral relief structures are implemented, the problem of premature failure under this circumstance will persist, particularly, within weak depositional and pallid quadrants investigated.

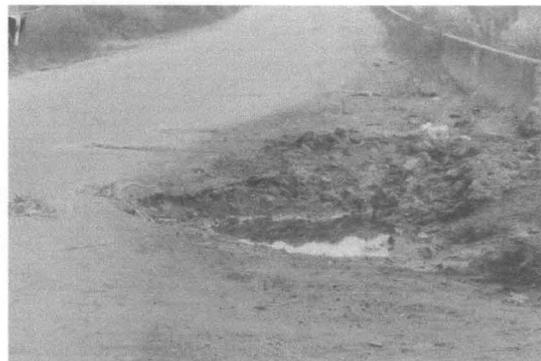
**Plate xvi. Deep Pot Hole**

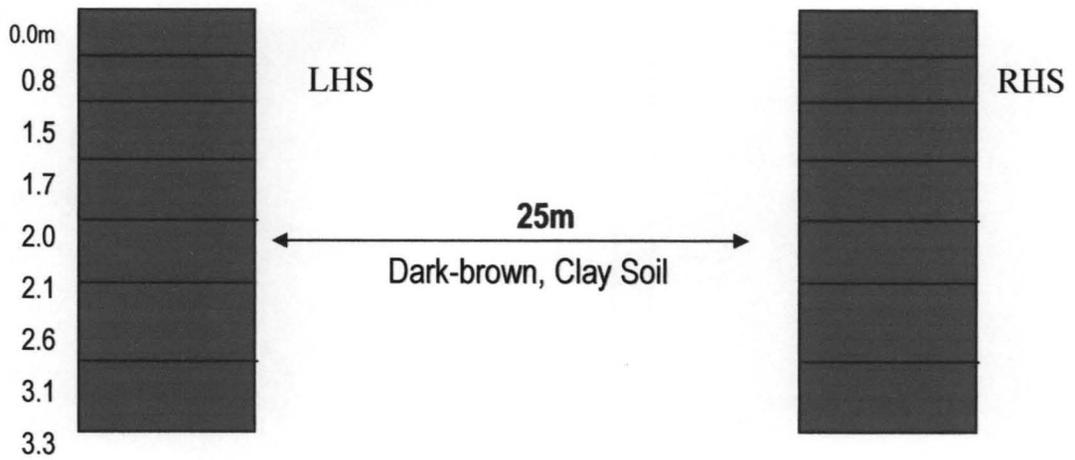
**Fig 4.i: TP1**  
Location: km1 + 200 FCE – Zuba – Tunga Maje

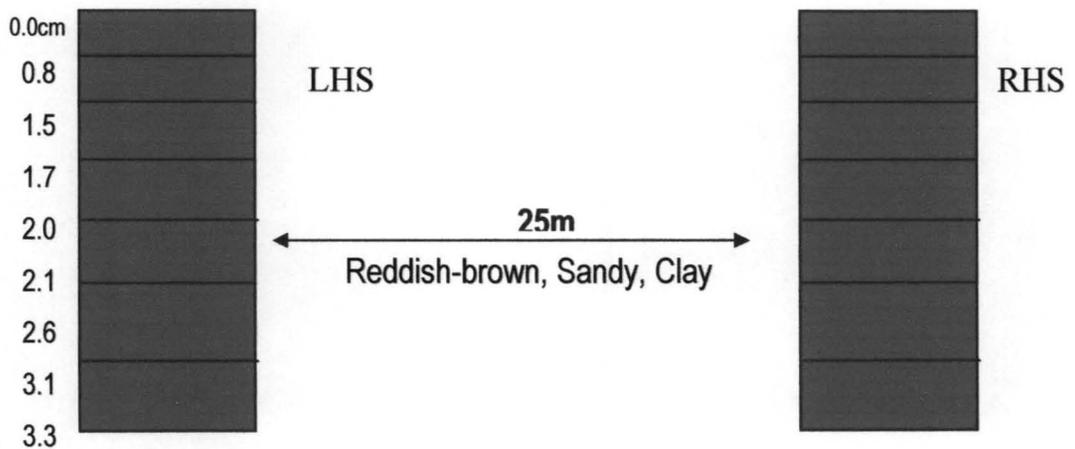
**Fig 4.4ii: TP2**  
Location: km1 + 500 AIRPORT JUNCTIONS – GIRI TUKUNYA

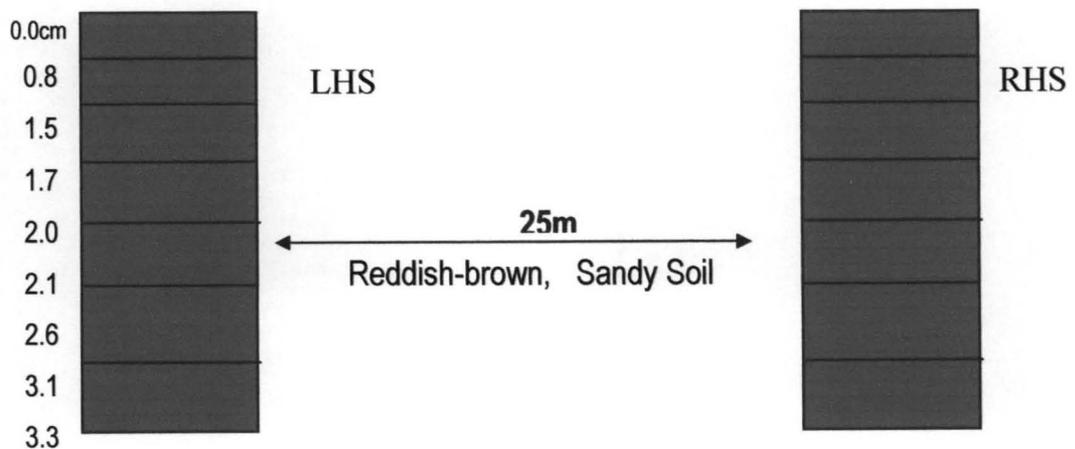
**Fig 4.4iii: TP3**

Location: km 6 + 350

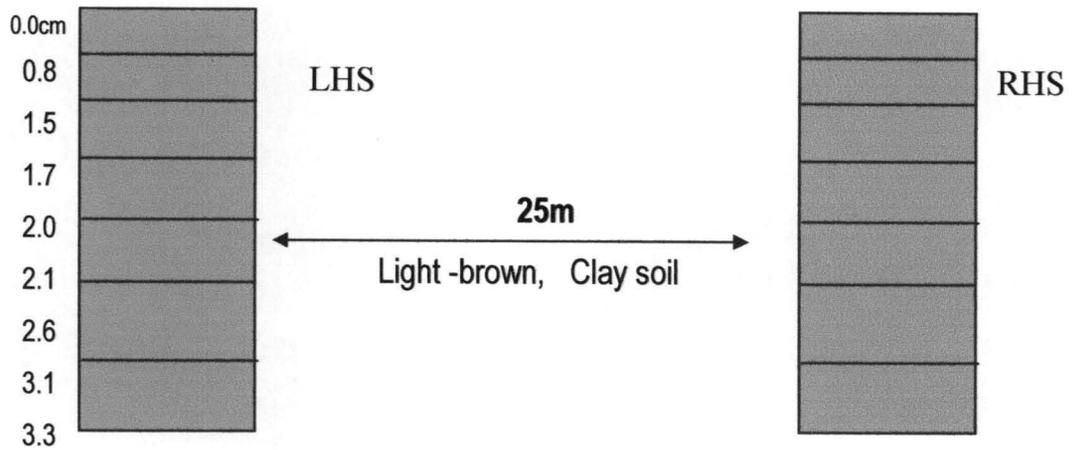
**Fig 4.4iv: TP4**

Location: km 8 +400

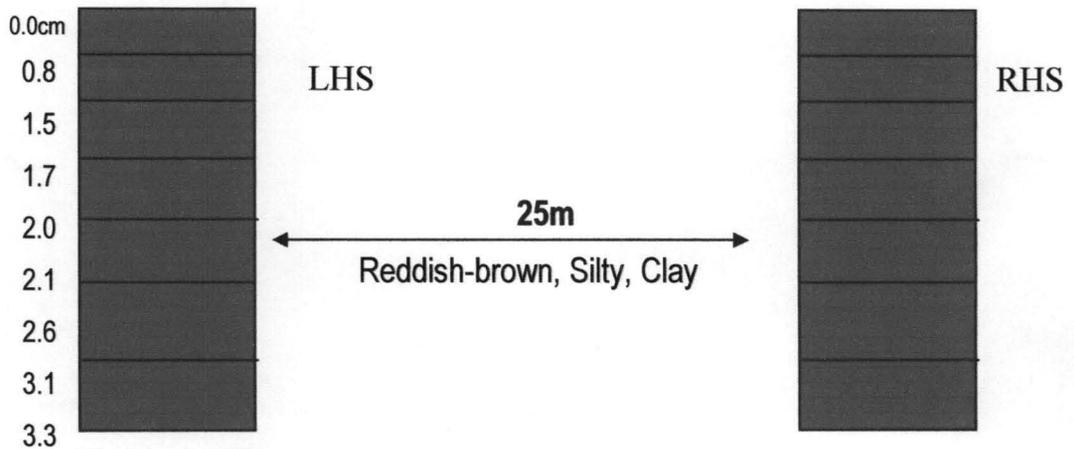
**Fig 4.4v: TP5**

Location: km 10+250

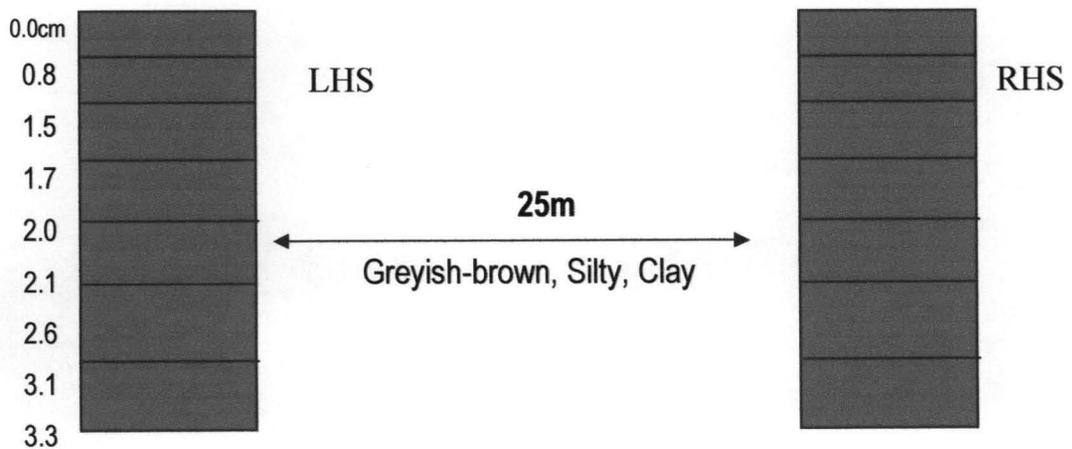
Fig 4.4vi: TP6

Location: km 11+190

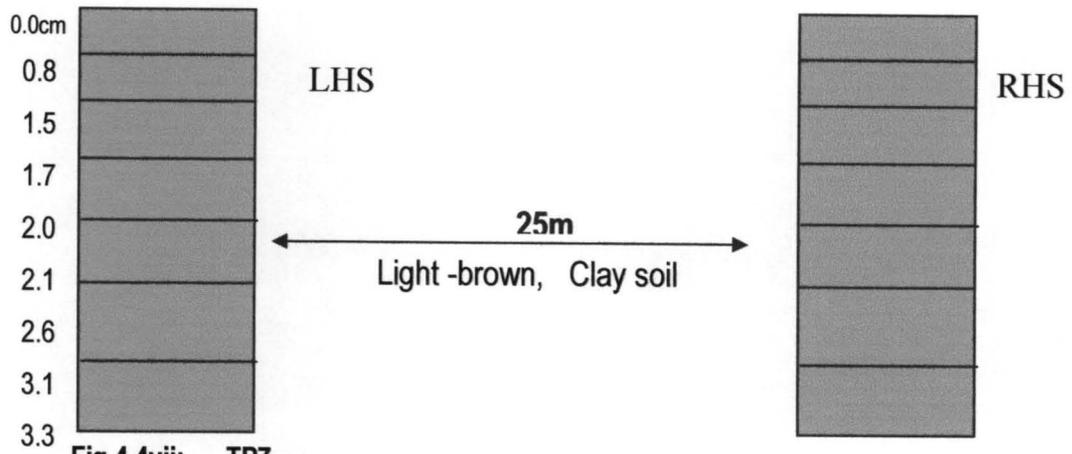
Fig 4.4vii: TP7

Location: km 12+ 150

It is not sure though, if the recorded high water table at 4.2m depth within km 12+150 was as a result of low permeability attribute of clays in water retention but further investigation from the Geological Survey Agency's local mapping report (2005) point to a likely fault effect within the Zuba – Gwagwalada ridge zone. The dominance in either of these candidate factors in engineering infrastructures, such as houses, carriageway, bridges and rail lines portend structural instability.

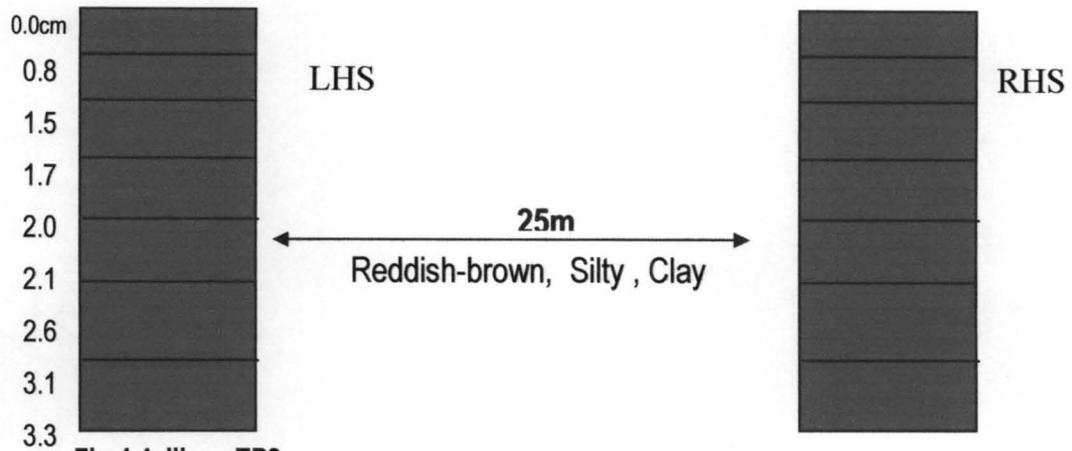
Fig 4.4viii: TP8

Location: km 17+500

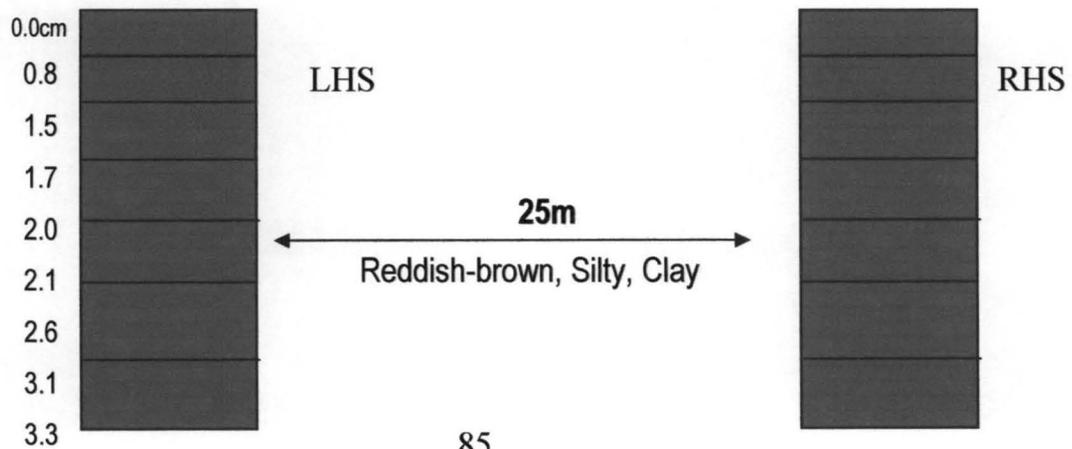
**Fig 4.4ix TP9 - CONTROL PROFILE**

Location: km 19 + 300

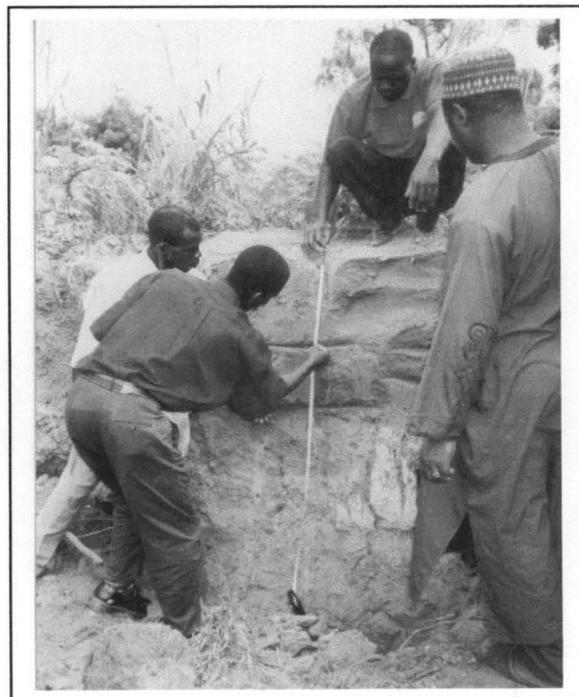
Plate xvii **Insitu Borelog within Failed Carriageway Section**  
Source: Author's field work Zuba -Gwagwalada 2007

The veritable poor drainage texture and weak sub-grade indices derived from field verifications acting in concert with other candidate factors, particularly, doubling traffic pressure in Table 4.4 suggest that their possible roles actually led to overbearing stress that posed barriers to serviceability competence of the Zuba – Gwagwalada Carriageway system.

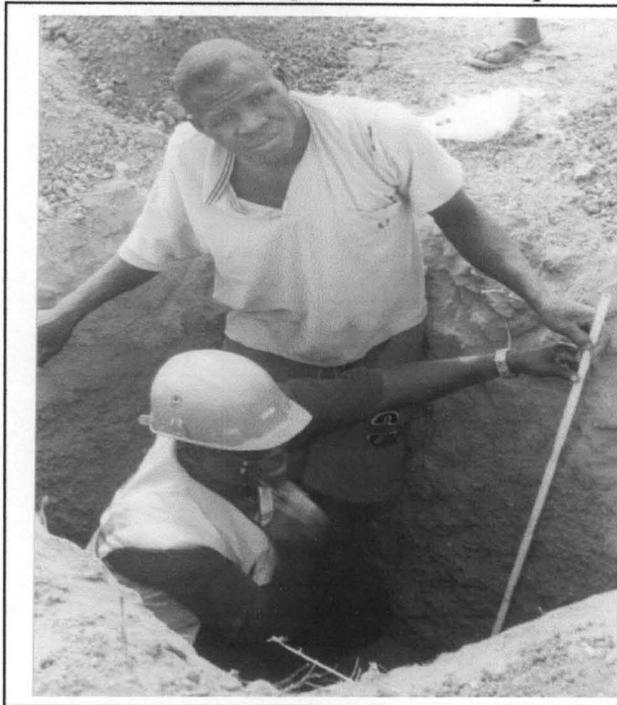
Plate xviii. Stable Section insitu of the Carriageway  
Source: Author's field work, Zuba -Gwagwalada, 2007

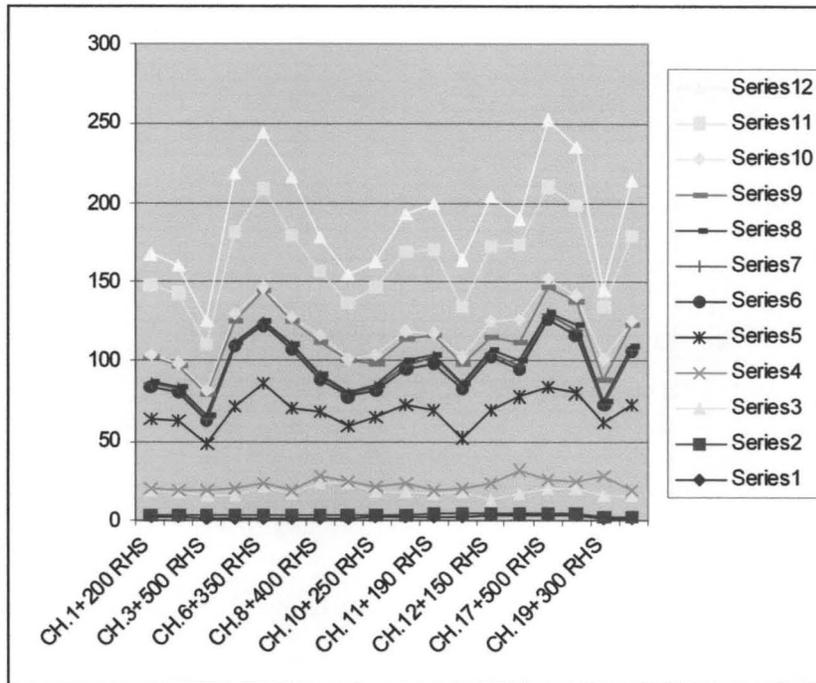
Fig 4.5 Area Chart: Engineering Indices of Soil Test Results

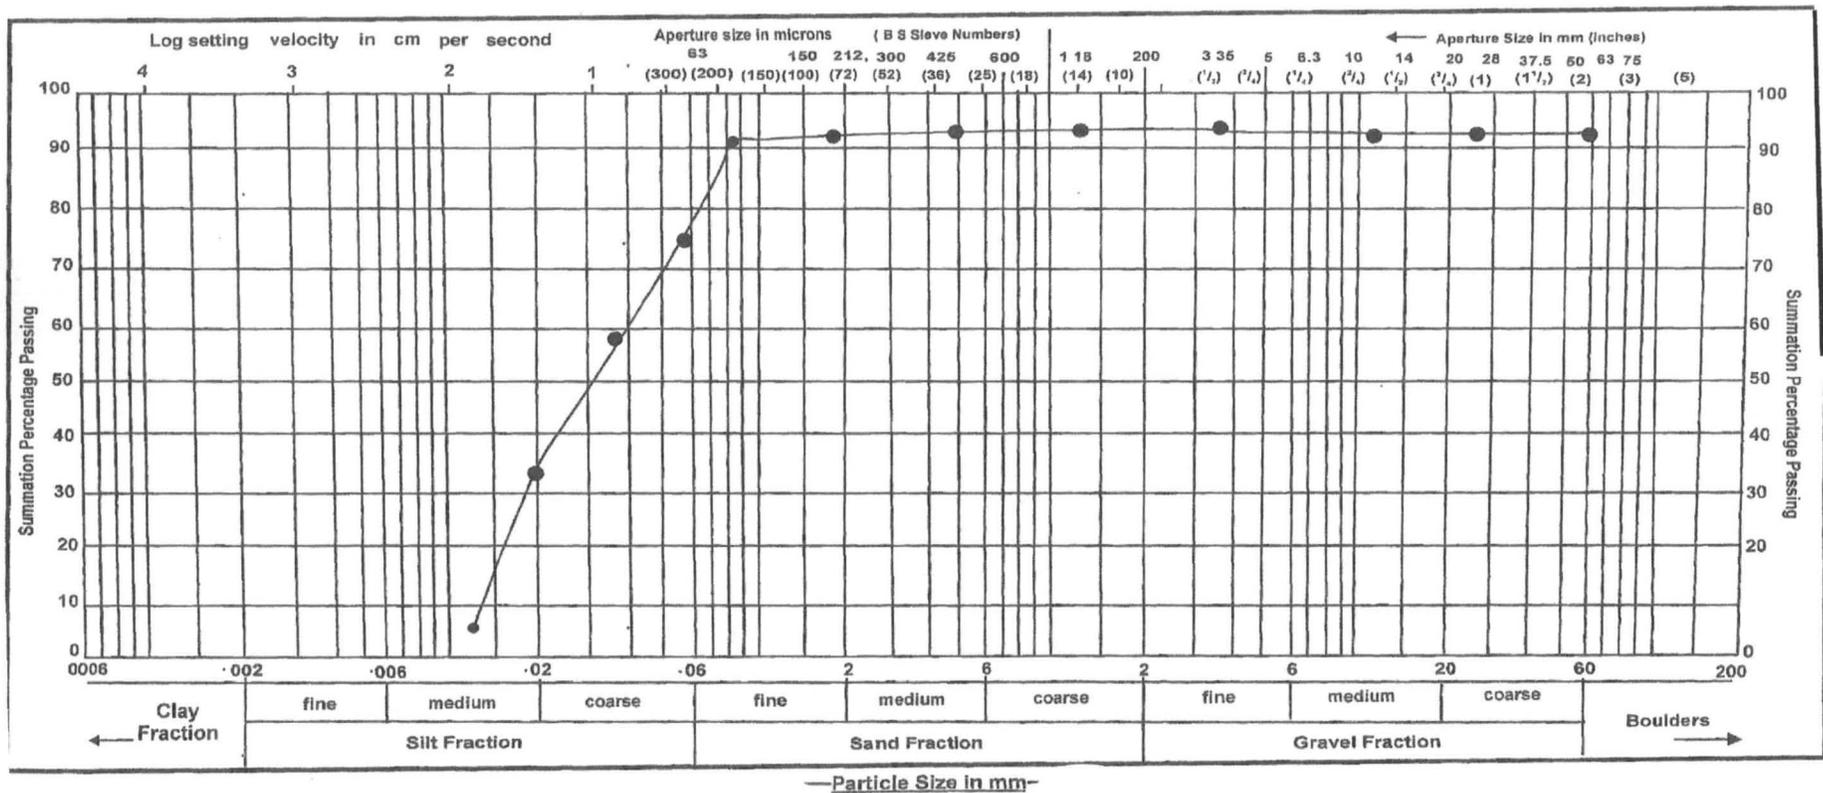
Location ZUBA-GWAGWALDA FCT Boring No. 1 Failed cross section Sample No. KM 1 + 200 Date of Test OCT. 2007  
Description SUB-GRADE SAMPLE FROM FAILED SECTION

Fig. 4.6: Particle Size Distribution of Failed cross section  
Source: Author's fieldwork, 2007

Results of sieve analyses in Table 4.5, as supported by graphical envelopes of Figs. 4.6 – 4.9 revealed two types of distribution curves. While Fig. 4.6 indicates a fairly graded distribution, Figs. 4.7 – 4.8 are marked by coarse voids which reflect very poor gradations. Most samples within the failed sections of Km1+120 – km16+900 tended towards this characteristics; an appreciable degree of normative engineering efforts would have to be effected in order to enhance their suitability competence for a sustainable carriageway structure. However, the ‘control sections’ of km16 + 900 – km19 + 300 in Fig 4.9 on the other hand, demonstrated appreciable degree of operative competence, which would require minimal routine maintenance in event of failure.

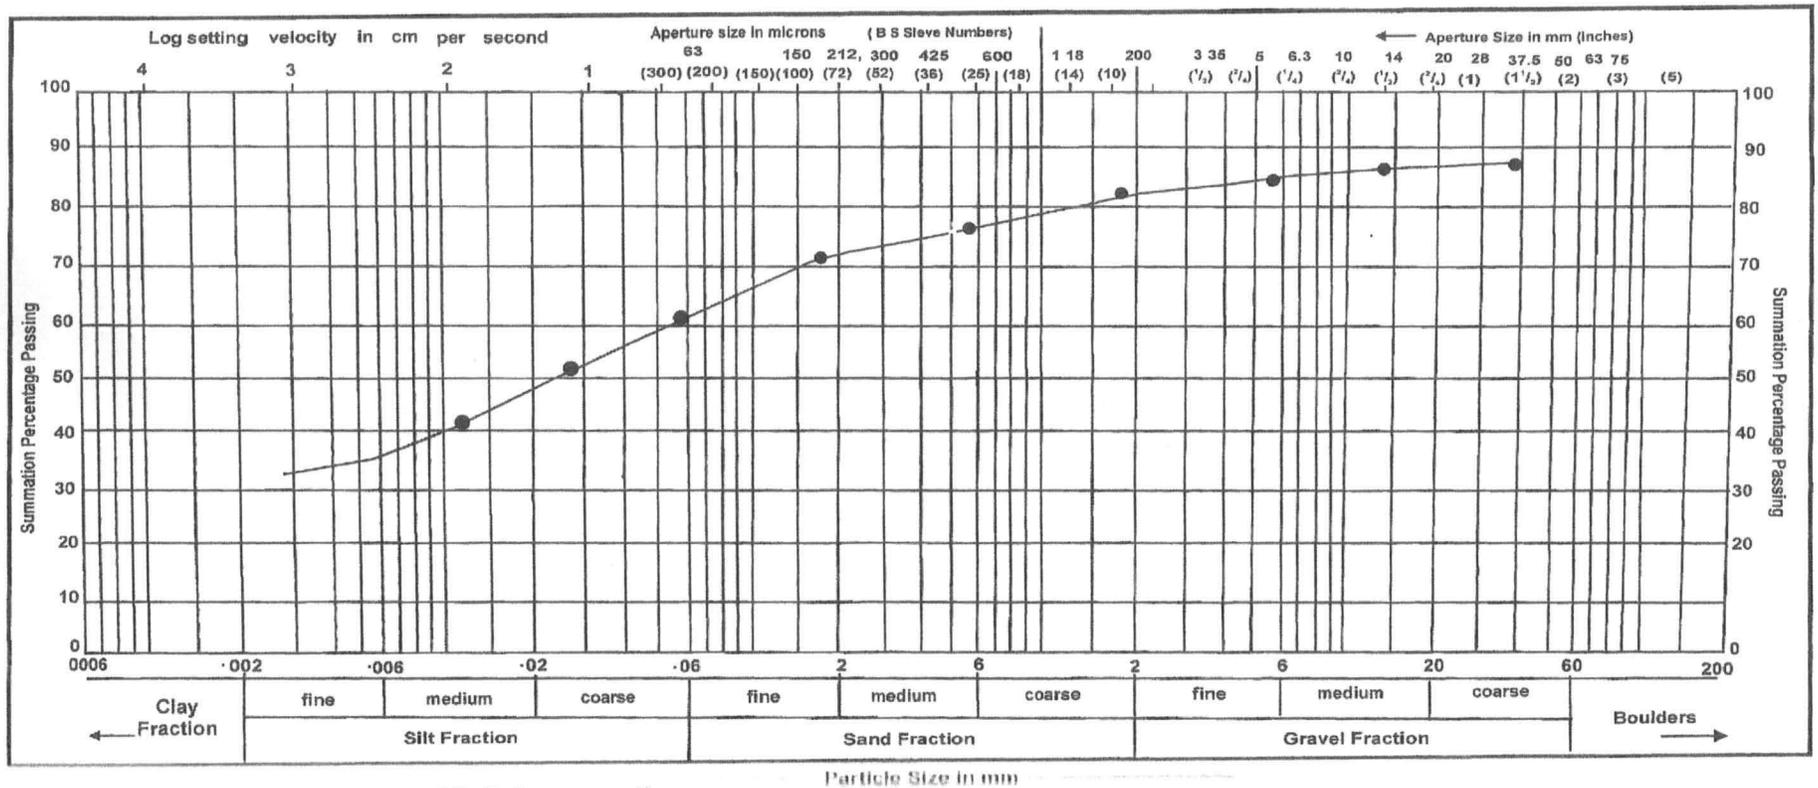
Location ZUBA-GWAGWALDA FCT Boring No. 3 Failed cross section Sample No. KM 6 + 350 Date of Test OCT. 2007  
Description SUB-GRADE SAMPLE FROM FAILED SECTION

Fig. 4.7: Particle Size Distribution of Failed cross section  
Source: Author's fieldwork, 2007

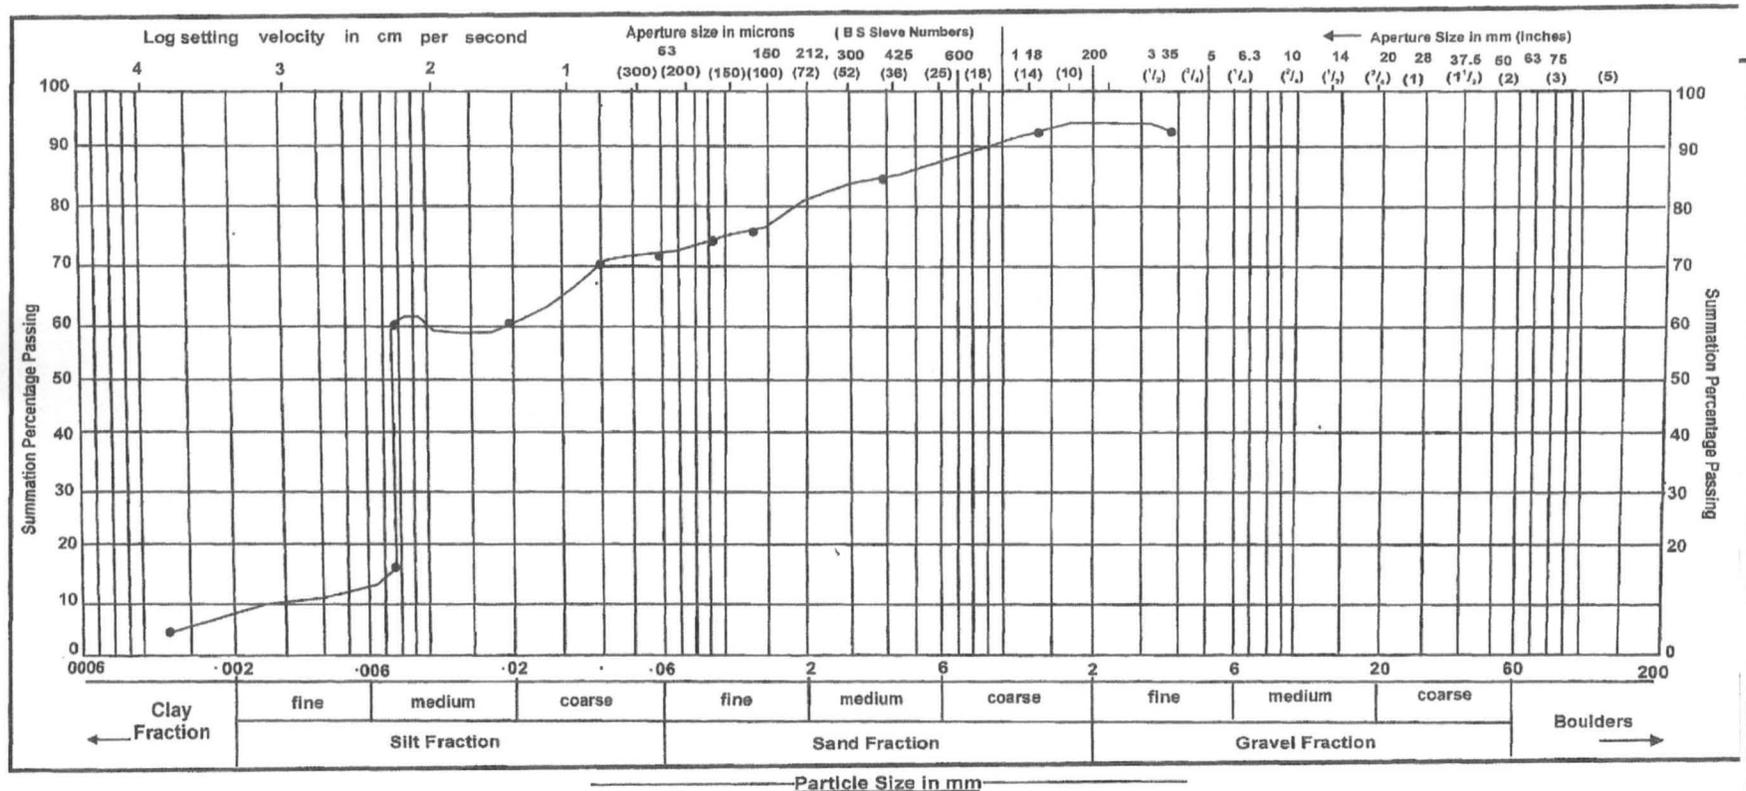
Fig. 4.8: Particle Size Distribution of Failed cross section

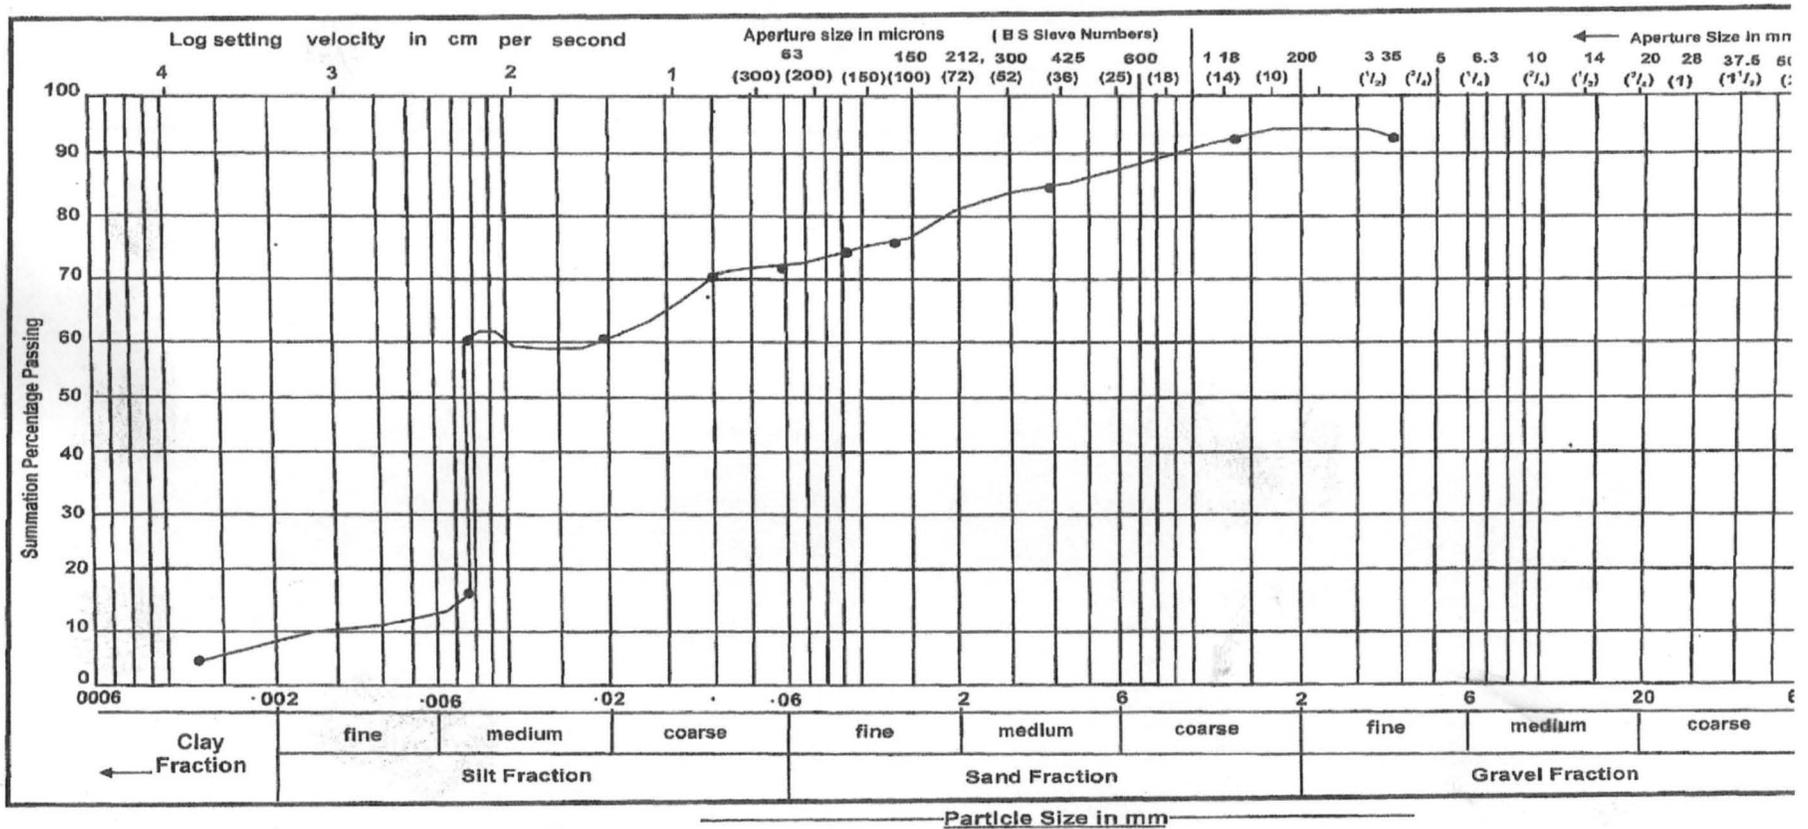
Location ZUBA-GWAGWALDA FCT Boring No. 9 stable cross section Sample No. KM 17 + 500 Date of Test C  
Description SUB-GRADE SAMPLE FROM FAILED SECTION

Fig. 4.9: Particle Size Distribution of 'control' cross section

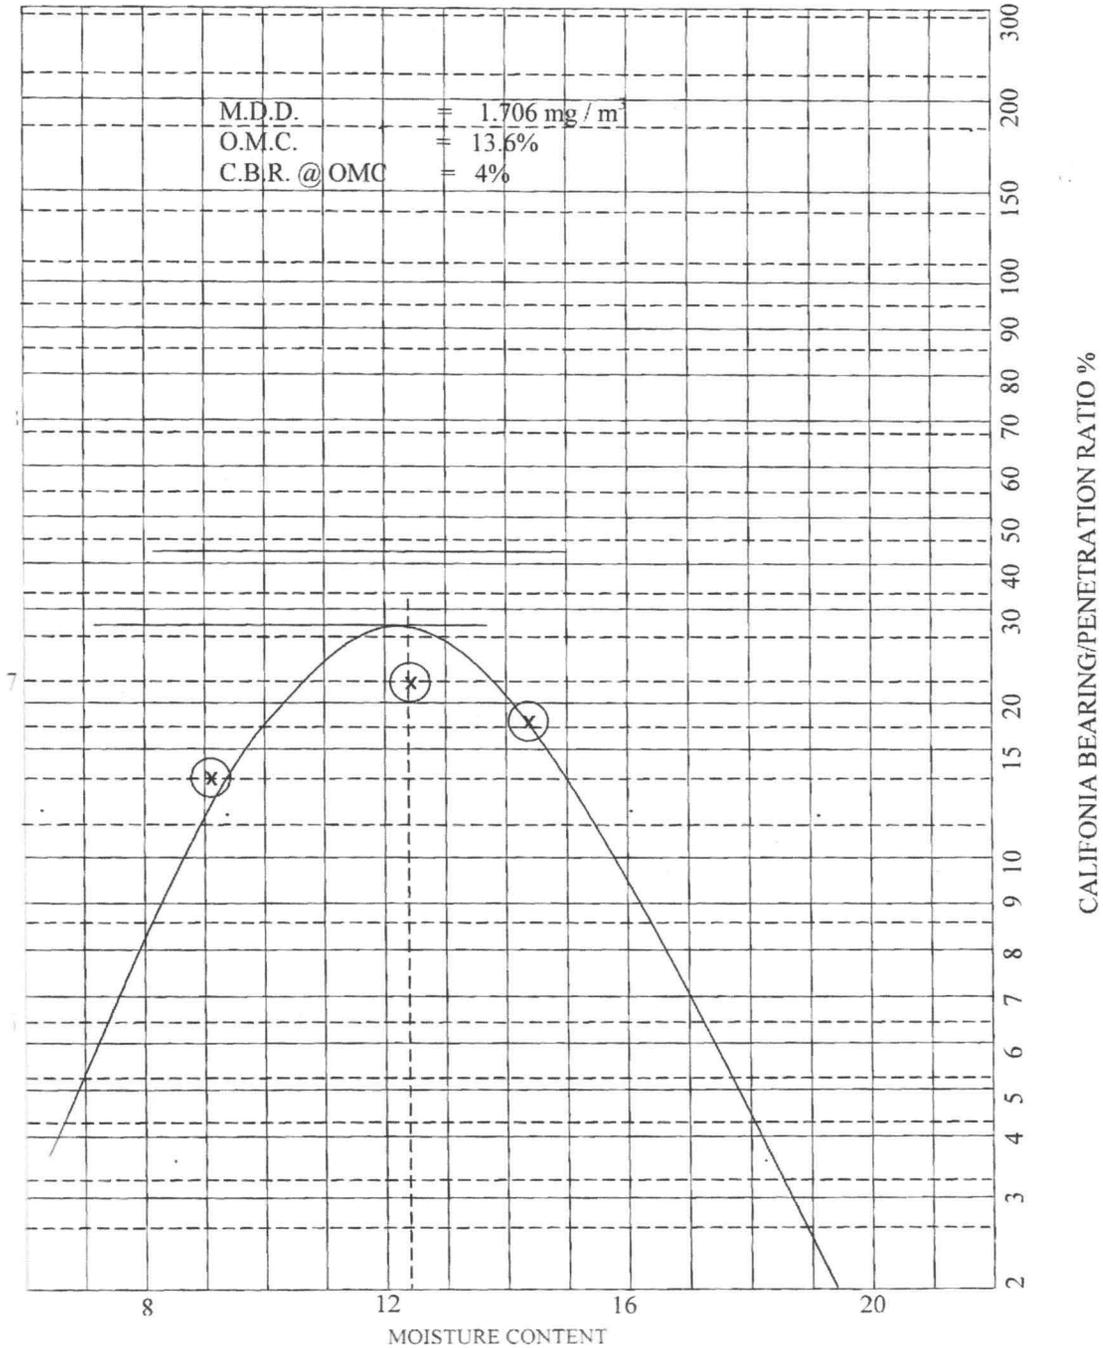
**Fig. 4.10: Atterberg Limits of Failed cross section**  
Source: Author's fieldwork, 2007
