**AN ASSESSMENT OF FLEXIBLE PAVEMENT FAILURE AND  
ENGINEERING PROPERTIES OF SUB-GRADE MATERIALS  
ALONG ZUBA- GWAGWALADA CARRIAGEWAY,  
FEDERAL CAPITAL TERRITORY, NIGERIA.**

**A THESIS SUBMITTED TO THE POSTGRADUATE SCHOOL,  
FEDERAL UNIVERSITY OF TECHNOLOGY, MINNA.**

**IN PARTIAL FULFILLMENT OF THE REQUIREMENTS FOR  
THE AWARD OF THE DEGREE OF MASTER OF  
TECHNOLOGY (M. TECH) GEOGRAPHY WITH  
ENVIRONMENTAL MANAGEMENT  
(ENVIRONMENTAL DEVELOPMENT PLANNING).**

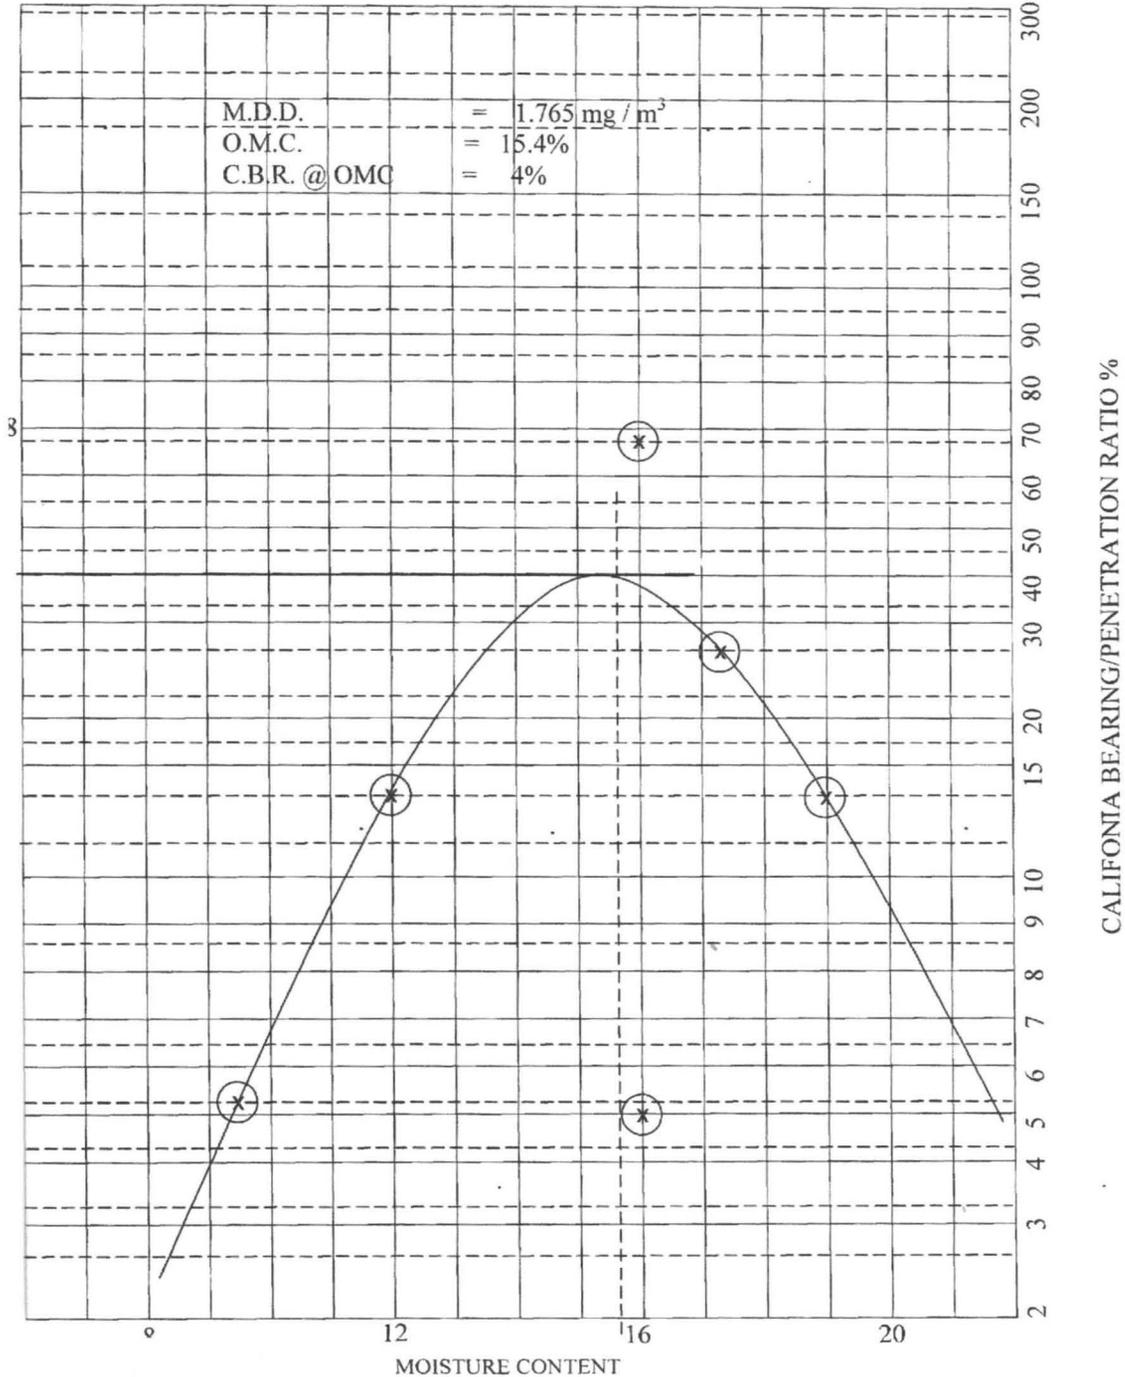
Fig. 4.11: Compaction Test of 'Control' cross section  
 Source: Author's Fieldwork, 2007

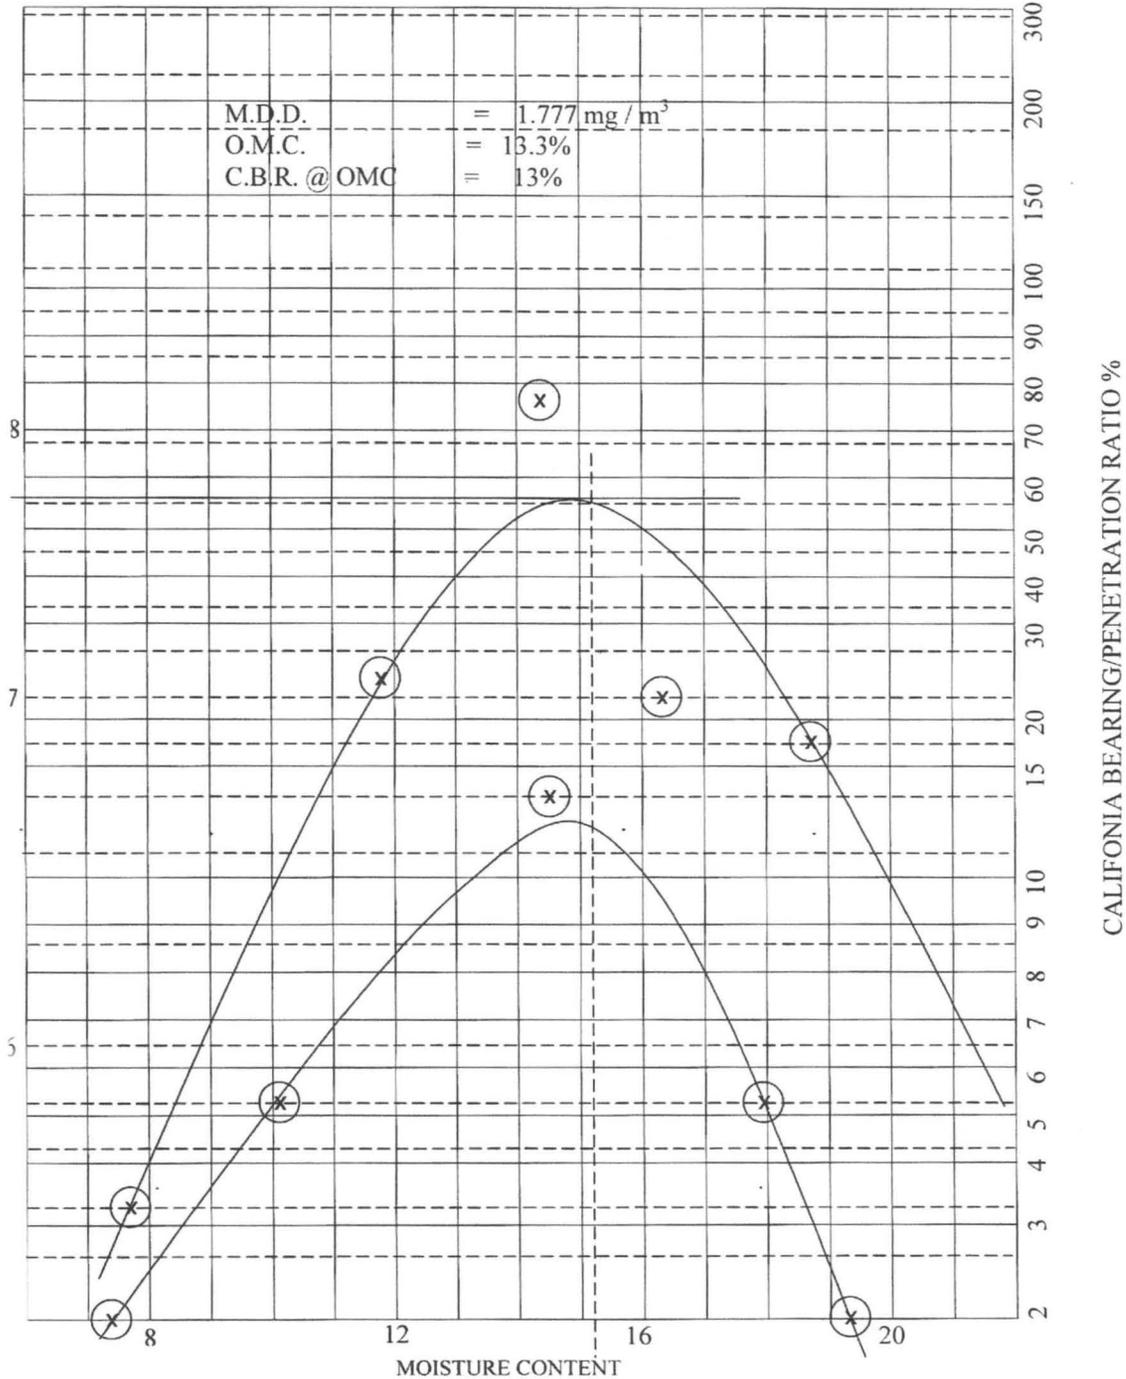
Fig. 4.12: California Bearing Ratio of 'Control cross section  
 Source; Author's fieldwork, 2007

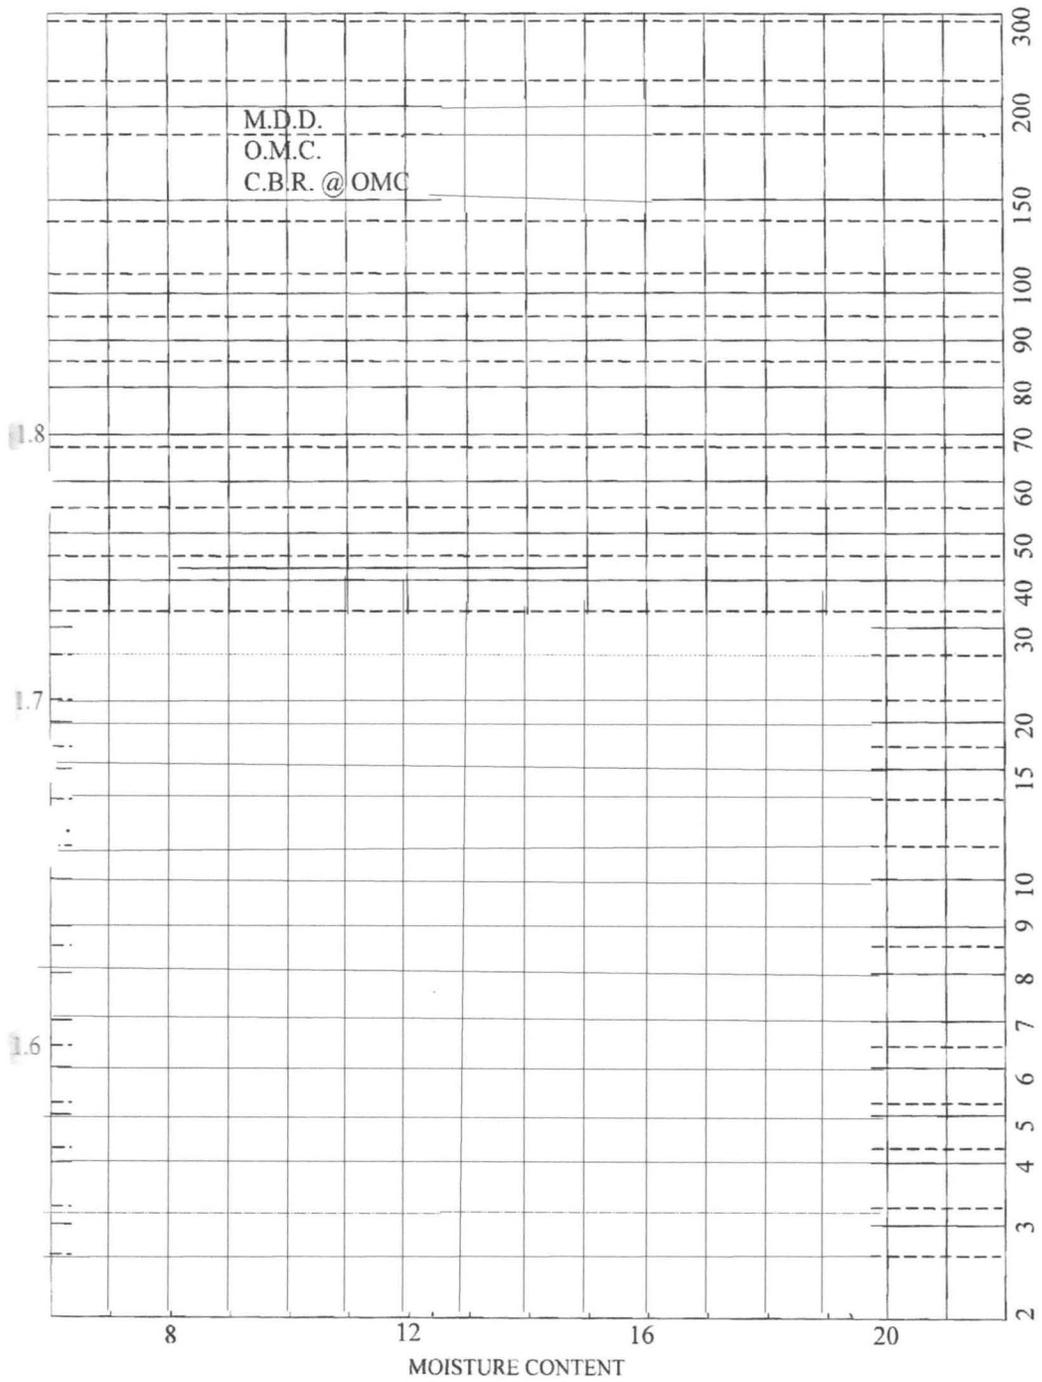
**Appendix 4.1 Atterberg Limits of Failed Cross section**
