1st INTERNATIONAL ENGINEERING CONFERENCE (IEC 2015)

QUALITY ASSURANCE OF HOLLOW SANDCRETE BLOCKS: A CASE STUDY OF HOLLOW SANDCRETE BLOCK INDUSTRIES IN MINNA, NIGER STATE, NIGERIA

¹Tsado T.Y., ²Auta S.M., ³James O. and ⁴Ahmed S. B.

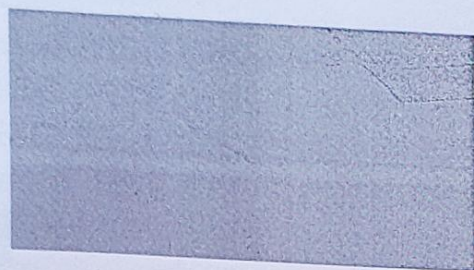
The collapse of several buildings in Minna, the Talba Estate along Minna – Bida road in particular is partly attributed to the use of poor quality blocks in the construction (Tsado and Yewa, 2013). Figure I show hollow block wall failure (Tsado and Yewa, 2013). The authors did not carry-out quality assurance of the hollow blocks used for the construction to ascertain the quality standard of the blocks used for the construction. Frequent collapse of buildings globally calls for proper quality control measures into production of sandcrete blocks especially hollow blocks as walling materials.

Fig. I. Hollow Block Wall Failure
