Gully Erosion Study in Bida Town, North-Central Nigeria Using Integrated Geoscience Techniques

Article in *Water Resources* · November 2020

¹*Okolo, S.I. and Amadi, A.N.

Department of Geology, Federal University of Technology, Minna, Niger State.

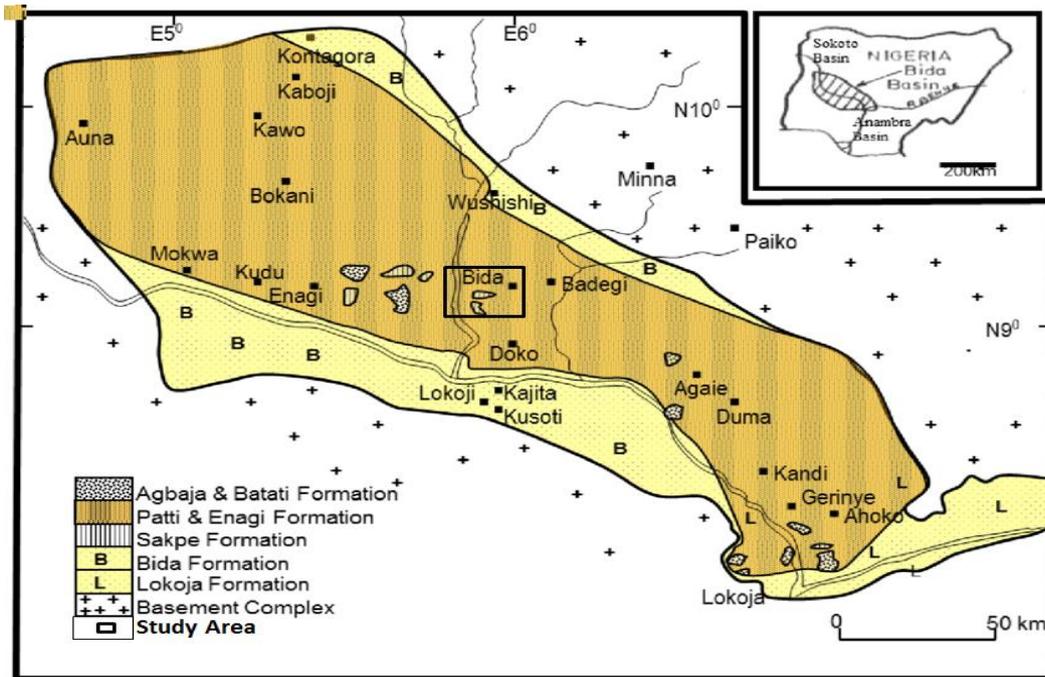
Figure 2: Geological map of Bida Basin showing the study area
(Modified from Adeleye, 1976; Obaje *et al.* 2011)

sedimentary cycle of southern Nigeria in the Upper Cretaceous era (Obaje, 2009). The Bida basin is the area occupied by the Bida sandstone. The Bida Sandstone is divisible into two members: the Doko and Jima members. The Doko Member is the basal unit and consists mainly of very poorly sorted pebbly arkoses, sub-arkoses and quartzose sandstones. These are thought to have been deposited in a braided alluvial fan setting. The Jima Member is dominated by cross-stratified quartzose sandstones, siltstones and claystones.

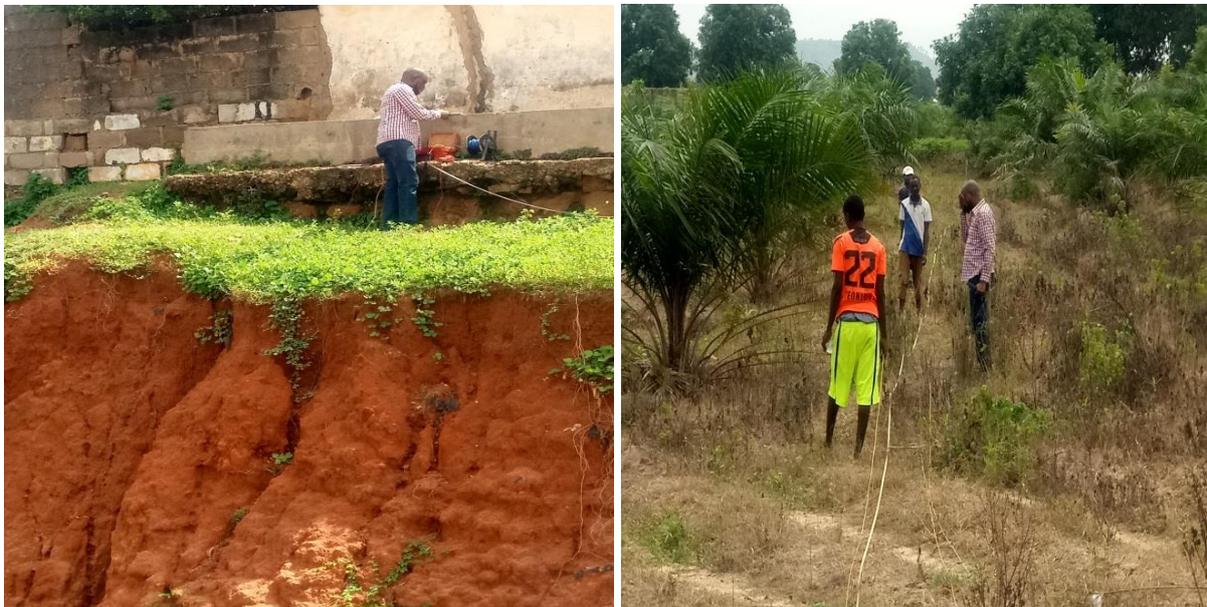
Plate 1: Geophysical Investigation at Dokoza gully erosion site in Bida town

motorized hand pumps in the area. This was achieved with the aid of the GPS and water level metre. Geophysical investigation was carried out using the 1D Vertical Electrical Sounding (VES), and the 2D Subsurface Electrical Imaging (SEI). The Wenner-Alpha array appropriate to image horizontally and vertical running layers of the subsurface was employed for this study. The 2D resistivity imaging was used in measuring and interpreting subsurface characteristics with respect to erosion imaging. The characteristics include depth and tomology of the subsurface lithology, stratigraphy and groundwater table. The 1D Vertical Electrical Sounding (VES) using the Schlumberger array was carried out at Gbongbofu area because of limited space while 2D Wenner Alpha array was carried out in Dokoza, Wonigi, Low-Cost areas (Plate1). The data for this research work was acquired by a multi-electrode resistivity data acquisition system with the activation of 4-point-electrodes. A multi-electrode system developed by ABEM instrument AB, was used for data acquisition in this study. The system consists of a standard earth resistivity meter (ABEM Terrameter SAS4000), four alternate electrode cables, each wheeled on a ream, four coated steel electrodes with various connectors and four metal hammers (Plate 1). The change in voltage is measured at the receiver electrodes.

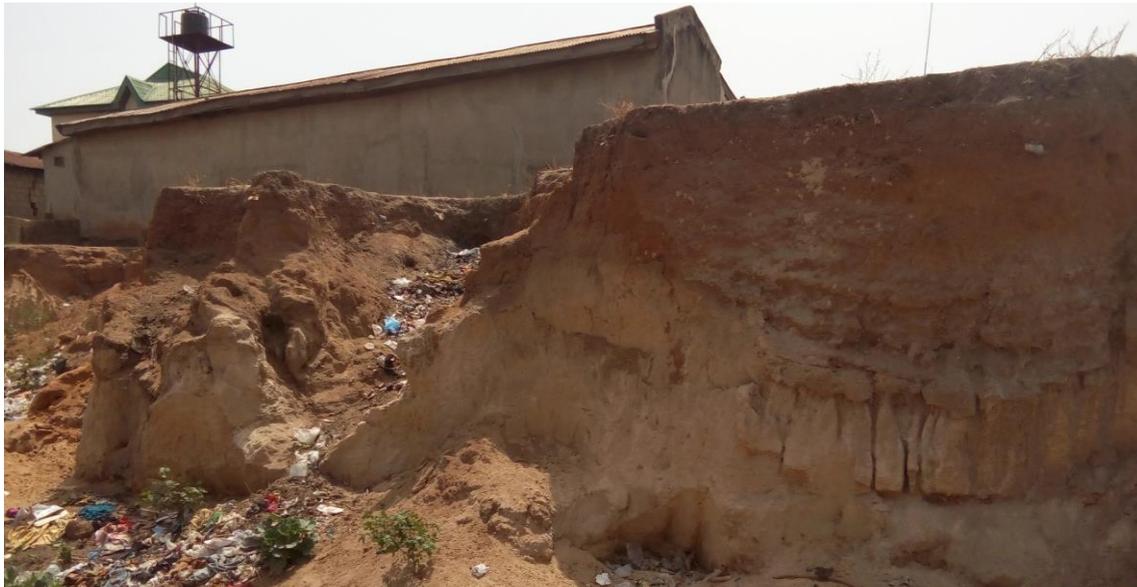
Plate 2: Gully erosion site at Gbongbofu area of Bida Town, Niger State

sandstone that was observed. The topmost layer is greyish in colour and the texture is fine grained. The second layer is light-brown and it is medium grained in texture. The gully erosion site at Gbongbofu is already threatening the buildings in the vicinity and is currently used to dump refuse (Plate 2). The situation is the same at Dokoza gully erosion site as some nearby buildings has been abandoned by their owners due to ravaging gullies leading to the development of cracks on the walls of the building, which are widening day by day (Plate 3).

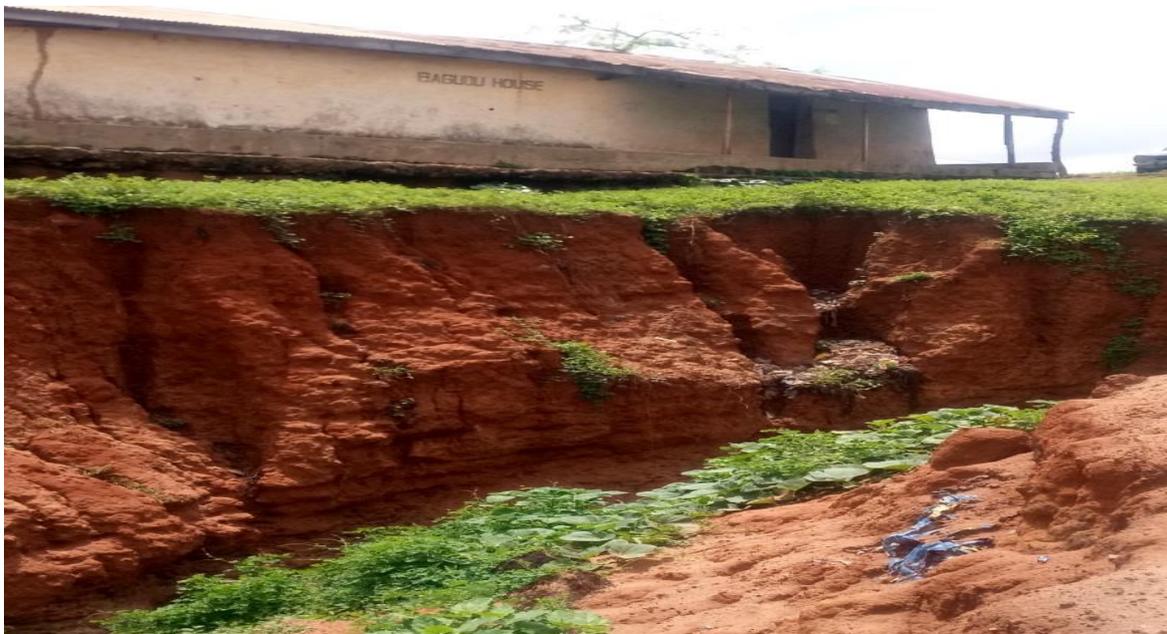
Plate 3: Gully erosion site at Dokoza area of Bida Town, Niger State

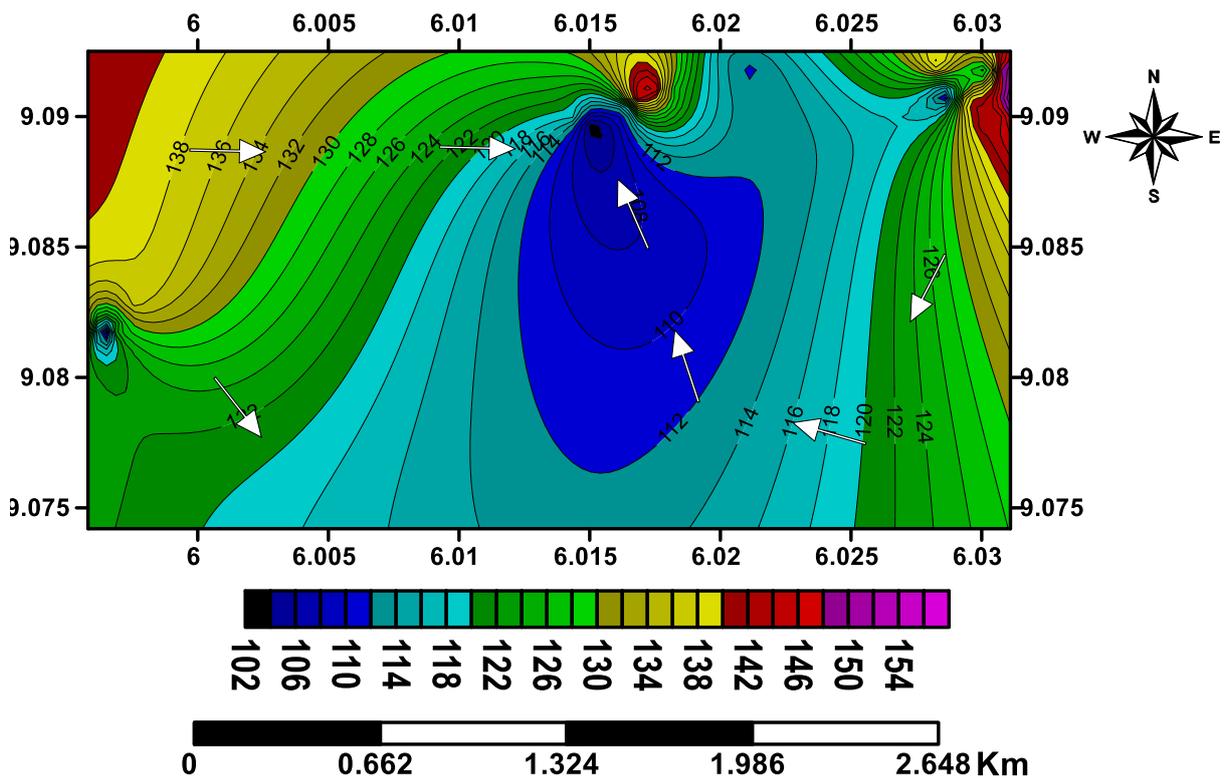
Figure 3: Groundwater flow direction

The depth to water in the study area ranged from 1.4 m to 6.9 m. The groundwater system in area flow towards the central portion of the study area (Figure 3). When water table intercepts the ground surface, a wetland, spring, pond or fadama is formed (Amadi *et al.*, 2013). Bida Town has experienced increased rainfall in the last decade due to climate change and the propensity of the water to begins to erode the loose and friable sandy formation in the study area cannot be overemphasised. The shallow groundwater table, the intensity of the groundwater flow and the saturation of the soil media enhances the erodibility of the formations in the study area. Groundwater flows from areas of high hydraulic head to areas of low hydraulic head in accordance with Darcy’s law of groundwater movement. The intensity of flow coupled with the saturation concept of the subsurface lithologies can result to the formation gully erosion in non-plastic and friable soils (Alao and Amadi, 2012).

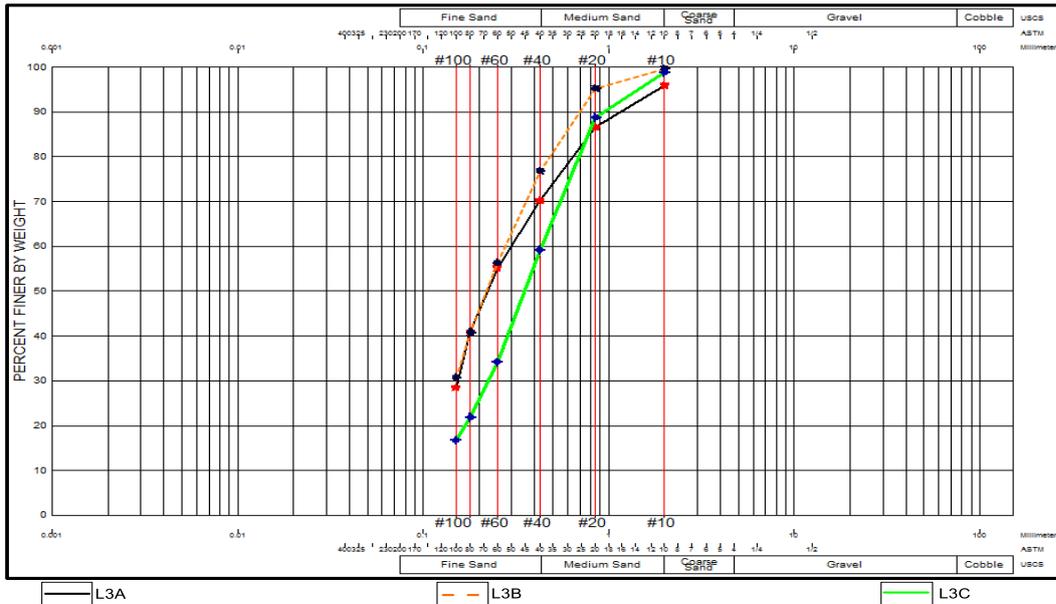
Figure 4: The Particle Size Distribution Curve for soil samples (L3A, L3B and L3C) at Gbongbofu area

The result of the sieve analysis (Figure 4) indicates that the study area is dominated by fine grained to medium grained sandy soil. The hydraulic properties of sandy formation (high porosity and permeability and non-plastic) differentiate it from other soils. The absence of clay within the sandstone formation is the reason for the lack of plasticity of the soils in most locations. This is also the reason why there are more active erosion sites in Bida than in Minna. Geology of the area is a major contributing factor to geohazards such as gully erosion.

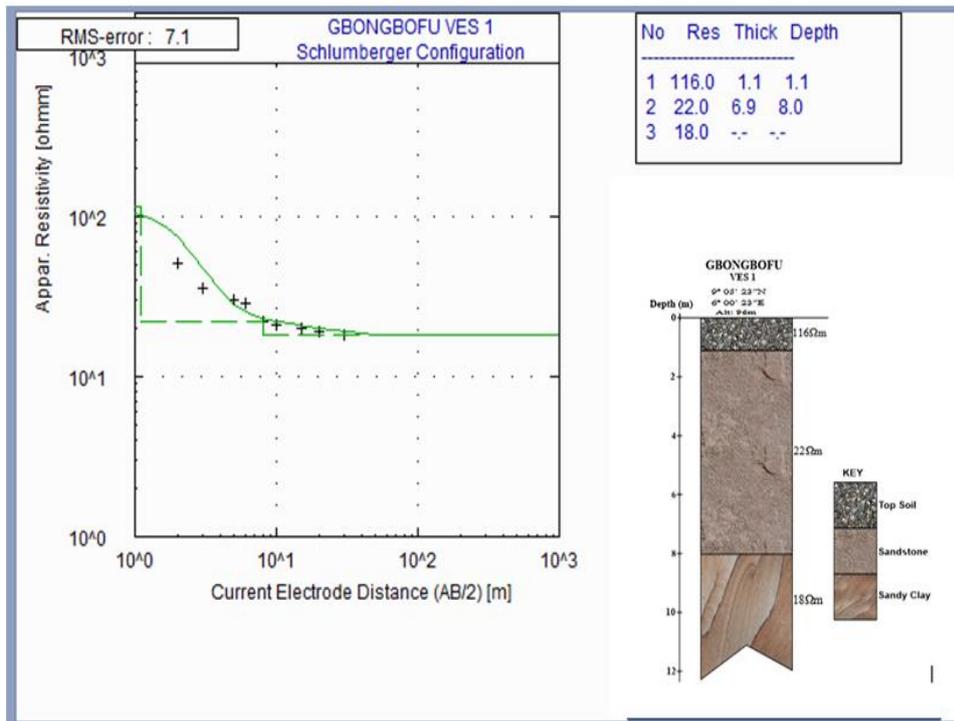
Figure 5: Vertical Electrical Sounding Curve at Gbongbofu Gully Erosion Site

Results of the 1D Vertical Electrical Sounding (Figure 5), reveals 3 geoelectric layers at Gbongbofu gully erosion site, which depicts the lithological units. The dominant curve type for the study area is Q type. The first geoelectric is the top soil, the second geoelectric layer is sandstone formation while the third geoelectric layer is sandy-clay/clayey-sand formation. These 1D geoelectric layers correspond to the 2D electrical sounding that was carried in the same study area. Top-soil is the first layer followed by second geoelectric layer, which are the gullible layer as a result of saturation and intensity of groundwater flow and heavy rainfall enhances the erodibility of the second layer. The first and second geoelectric layer are susceptible to erosion because of lack of binding/cementing materials. The third layer may be slightly resistant to erosion due to the presence of clayey materials which are completely absent in the first and second layer (Figure 5).

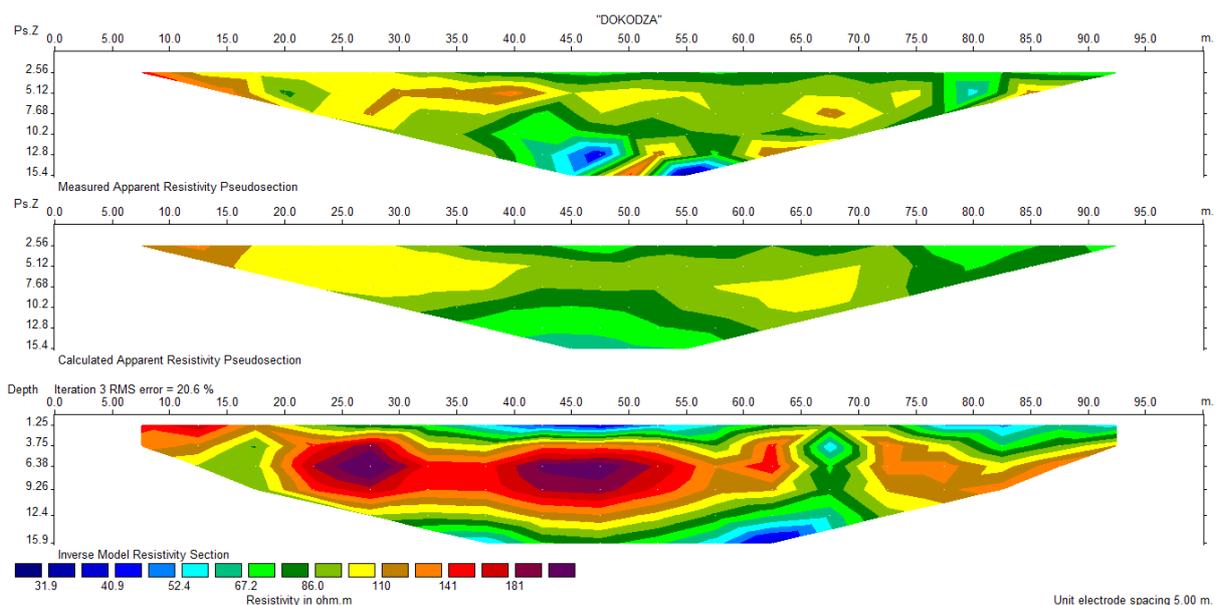
Figure 6: 2D Transverse at Dokoza Gully Erosion Site

The inverted 2D resistivity sections of Dokodza show intermediate to high resistivities at the surface in the first part of the section in the profile distance interval of 5m to 60m (Figure 6). This portion of the profile corresponds to fine to medium grained sandstone. These formation could provide rapid infiltration paths and hence increased vulnerability of the sediments to surface runoff. Underlying the high to intermediate resistivities is the layer flanked by zones of significantly lower resistivities indicating zones of sandstone saturated with water. At the profile distance between 65m to 70m there exist an intermediate resistivity of about 67 Ωm corresponding to silty-sand/clay-sand formation. The soils at the first and second layer are prone to erosion because of its lack of cohesiveness (non-plasticity and friable).

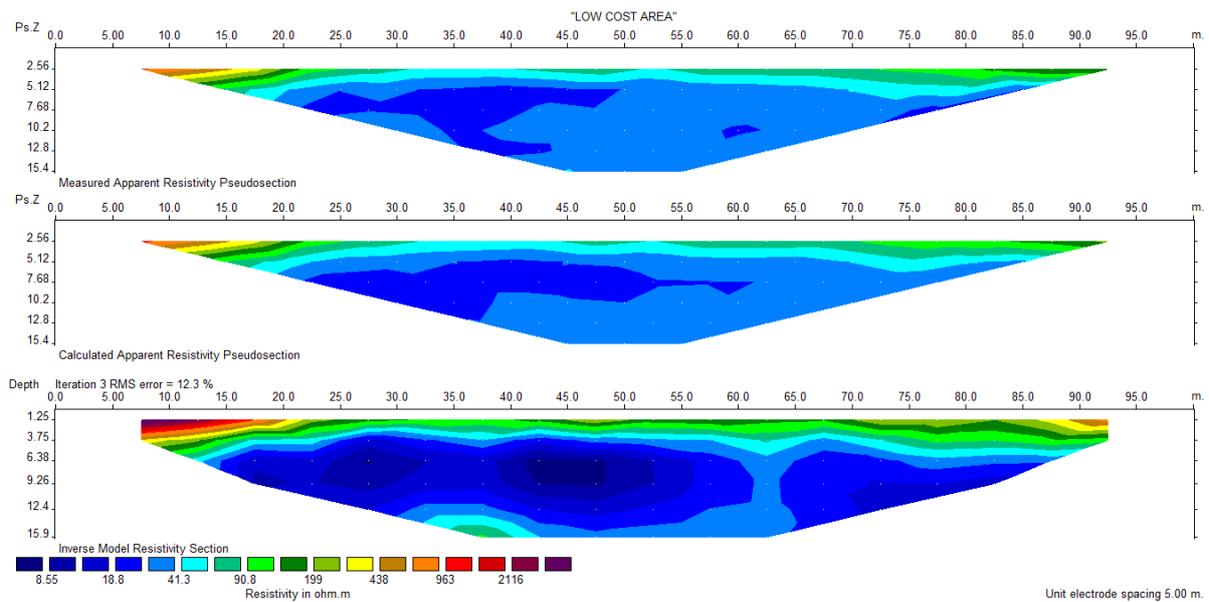
Figure 7: 2D Transverse at Low-Cost Gully Erosion Site in Bida Town

The 2D pseudosection and inverted resistivity sections of the Low-Cost (Figure 7) show moderate resistivity value of 90 Ωm at the surface indicating loose sand. A region with low resistivities range of about 8 Ωm to 50 Ωm , corresponding to groundwater saturated zone, is visibly underlying the surface layer with depths reaching over 15 m. This is the region the highest vulnerability to gully erosion due to the friable top soil formation is been grasually eaten up by the high intensity of groundwater flow from the saturated zone which is directly overlain by the top-soil. The problem is further compounded by high rainfall arising from climate change as well as lack of drainage system in the study area.

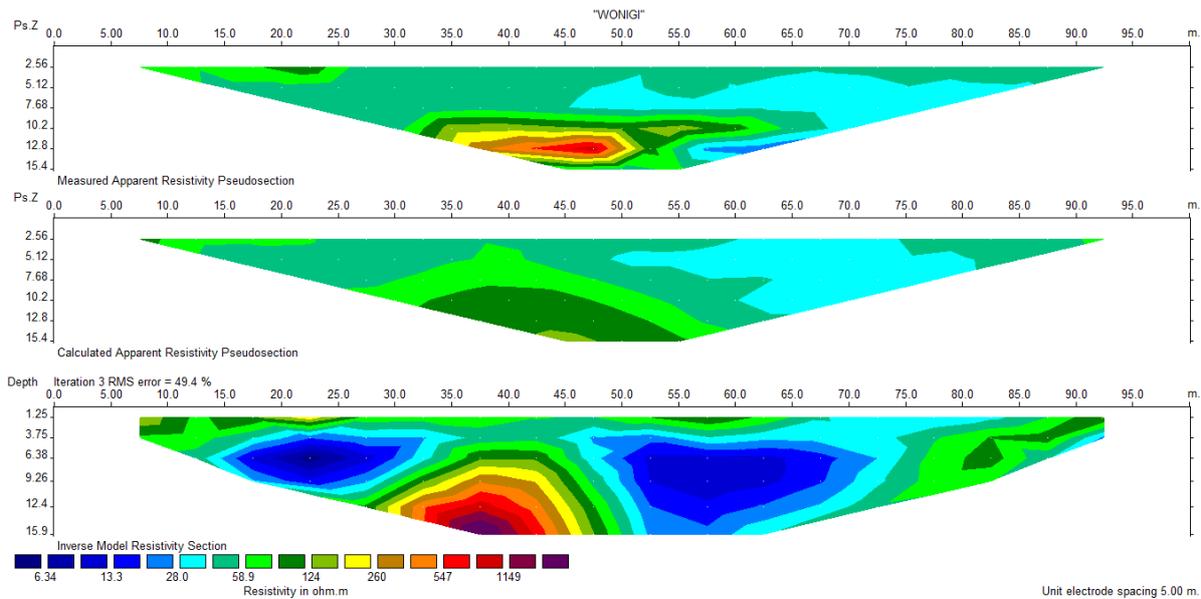
Figure 8: 2D Transverse at Wonigi Gully Erosion Site in Bida Town

The 2D inverse model resistivity section of Wonigi profile (Figure 8) shows a well-defined highly resistive anomaly at the profile distance of 30m to 45m intruding two low resistivity portion at the 5m to 30m and 45m to 80m on the surface profile. The significantly lower resistivities of 6 Ωm to 20 Ωm extending to the depth range of 3.7m to above 15m are indicating zones of saturated formation. This findings further justify the results of the pseudosection, sieve analysis, moisture content, Atterberg limits, maximum dry density and optimum dry density. The synergy of these geoscience techniques (geological, hydrogeological, geotechnical and geophysical) in geohazard (erosion) studies has been efficiently and effectively demonstrated in this study.
