INTEGRATED GEOLOGY, MINERALOGY AND GEOCHEMISTRY INVESTIGATIONS OF THE MINNA-TEGINA- MAKERA ROAD NORTH WESTERN NIGERIA: IMPLICATION ON FAILED PORTION

ABSTRACT

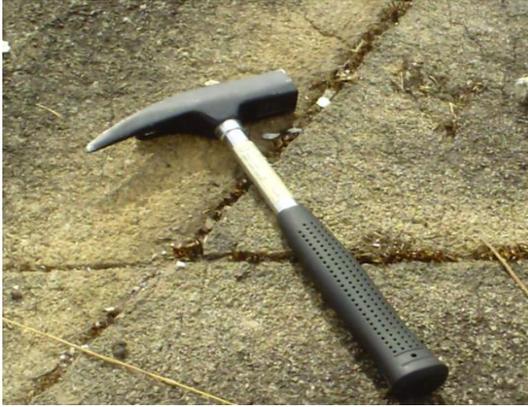
Figure 3: Jointed granite in Maikunkele area

are open jointed (Figure 3) and in some areas dissected by quartzo-feldspartic veins. The granitic rock underlies about 45% of the study area while phyllite, schist and amphibolite schist are about 45% and sandstone 5%. Schist is strongly foliated ranging from muscovite schist to biotite schist, trending in NE - SW and occurred mostly in the northern section of the study road network. In hand specimen the schist varies from leucocratic to melanocratic, the leucocratic show effects of chemical weathering (Figure 5). Amphibolite schist occurred in Zungeru inter-layered with quartz schist and mylonite, this rock is restricted to Zungeru area and a times seen intruding the schist (Figure 6). Phyllite are also common in the northeast and northwest sections of the study area and are closely associated with schist, characterized by a silky sheen on the cleavage surface and show evidence of intensive weathering at the surface where they outcrop. Field evidence along the study road network show that the failed road section is underlies by mica schist, porphyritic granite and phyllite. The fairly stable section is underlain by granite while the stable section is underlain by medium graine granite/granite-gneiss, amphibolite schist and sandstone.
