DAM PERFORMANCE AND SAFETY EVALUATION

**A CASE STUDY OF LOWER USUMA DAM, USHAFA, BWARI L.G.A,
ABUJA-FCT**

**A PROJECT REPORT SUBMITTED TO POSTGRADUATE SCHOOL
IN PARTIAL FULFILLMENT OF THE REQUIREMENT FOR THE
AWARD OF POST GRADUATE DIPLOMA IN AGRIC ENGINEERING
(SOIL AND WATER OPTION).**

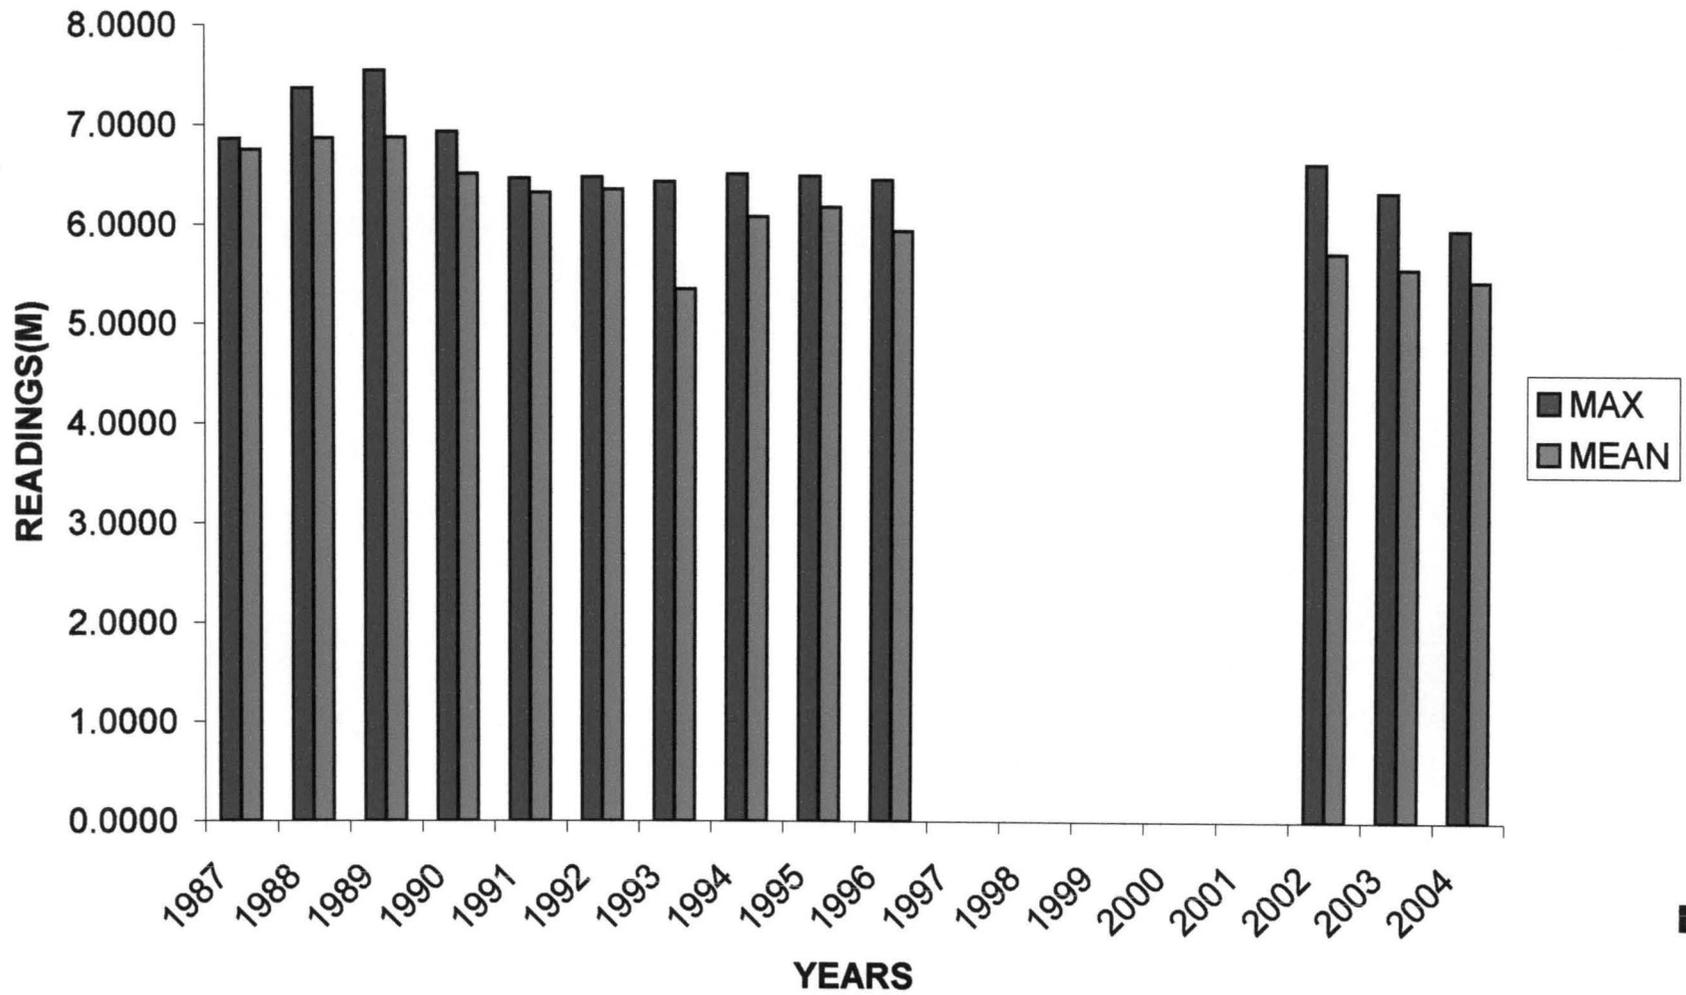
FIG. 4

The piezometer readings give the groundwater level in the embankment. Generally, a level of between 5 to 6 meters forms the range in groundwater level of the dam for the years under review. The maximum groundwater level is 7.53m recorded in the month of August 1989, while the minimum groundwater level is 4.59m recorded in the month of September 1993. See fig. 4 for maximum and mean piezometer readings. This change in groundwater level is principally a function of rainfall. The results obtained for 2002, 2003, and 2004 also followed the trends for the previous years records established; therefore the dam is safe against the action of ground water.

BAR CHART OF MAX AND MEAN PIEZOMETER READINGS

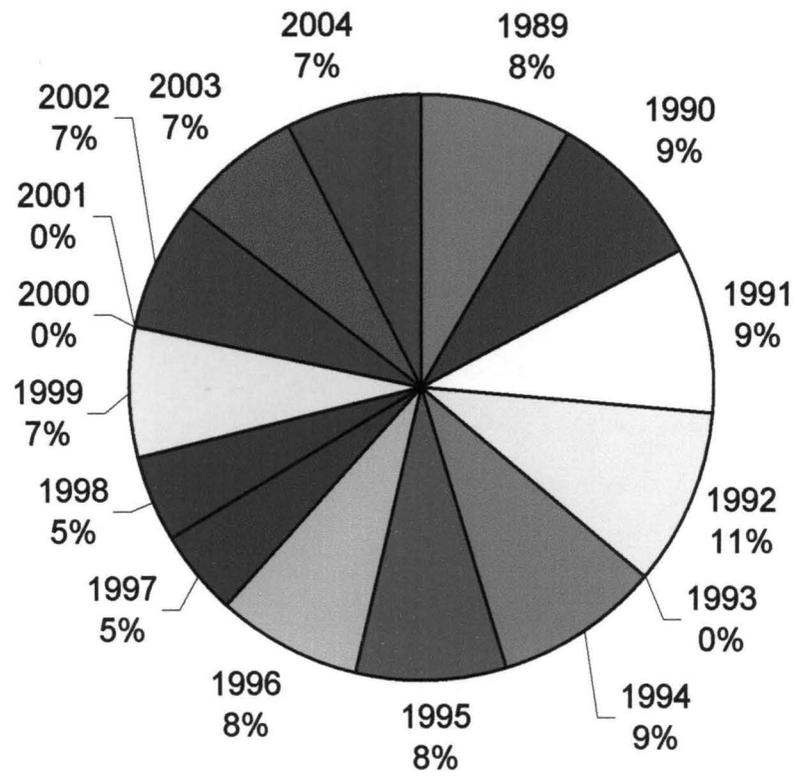
FIG. 5

PIE CHART SHOWING PERCENTAGE OF TOTAL SEEPAGE(M3/S)

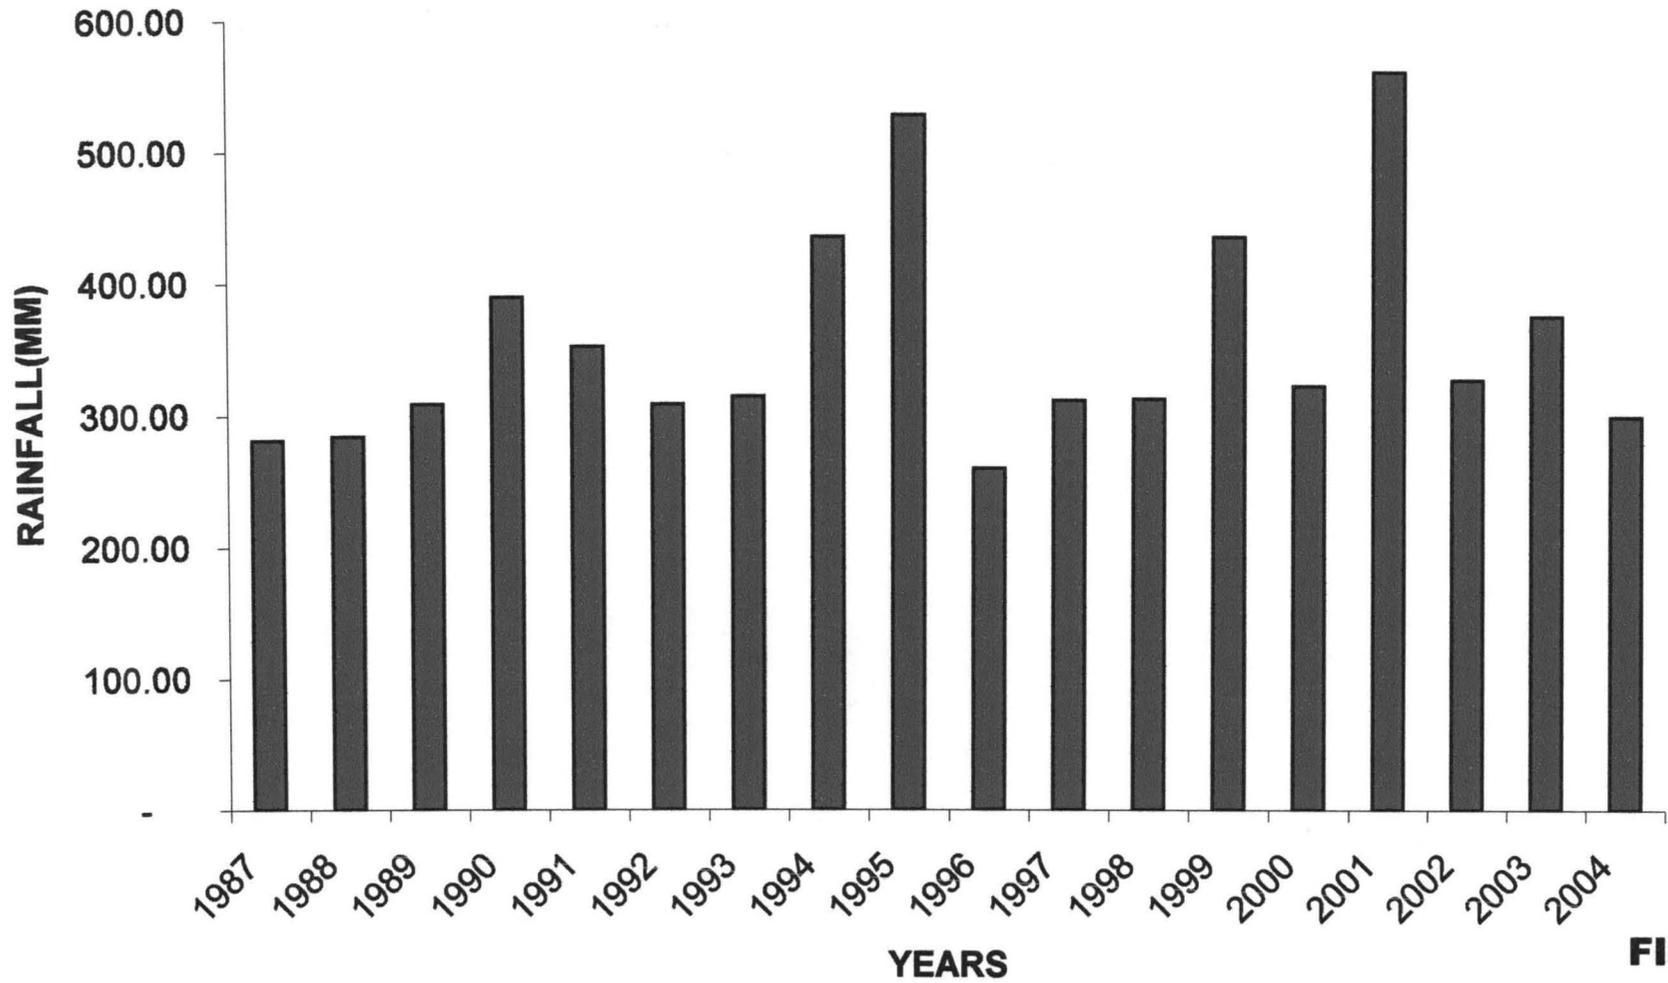
FIG. 6

Considering Table 3, it was observed that the maximum rainfall in years under review is 528.30mm recorded in August 1995. While the minimum rainfall stood at 0.5mm recorded in February 1981 and January 1992 respectively. The total rainfall drop from 1,466.97 and 1,477.49 as recorded in 2002 and 2003 to 1,385.70 in 2004. Due to this drop in total rainfall in 2004, there is a sharp corresponding drop in water level presently in the dam. This can therefore be seen as one of the major cause of the acute shortage of water currently experiencing in the dam since rainfall is the main source of recharge to the dam. The sharp drop in rainfall can be seen in a bar chart of maximum rainfall shown in fig. 4 in the appendix. Also in the appendix is a line chart of minimum, maximum, total and mean rainfall from 1981 – 2004.

BAR CHART OF MAX. RAINFALL FROM 1987-2004

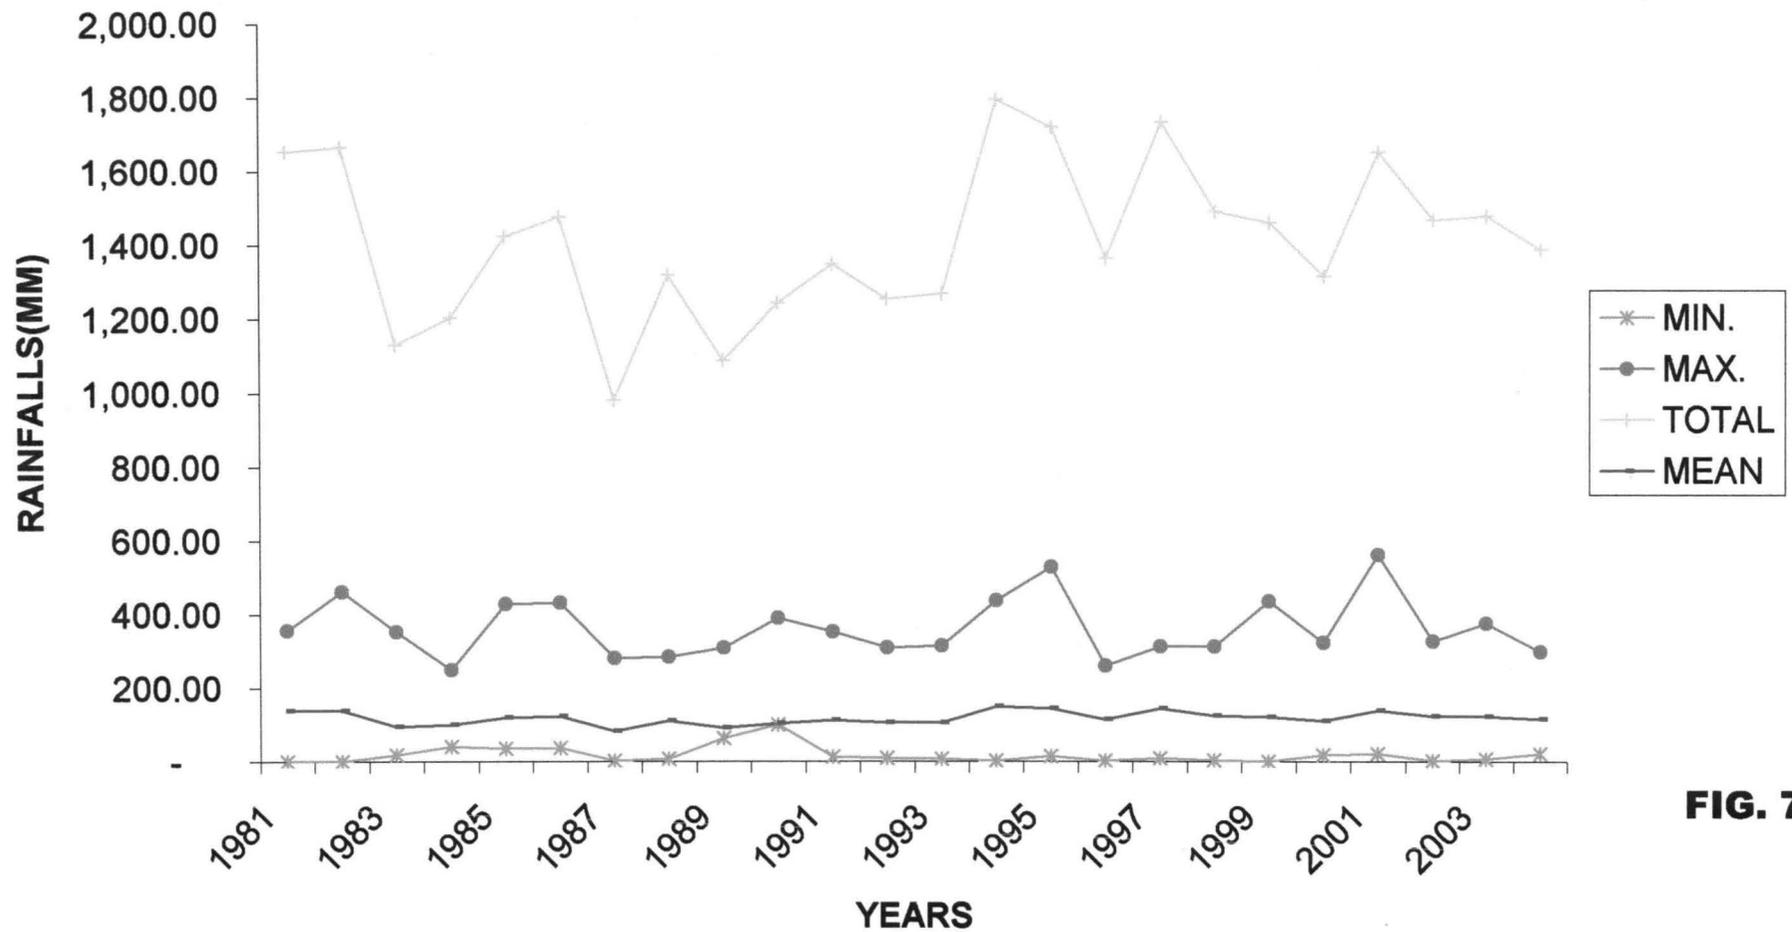
FIG. 7

A LINE CHART OF MIN, MAX, TOTAL AND MEAN RAINFALL FROM 1981-2004
