# School of Environmental Technology International Conference Proceedings

# Exploring the Circle of Consumption Around Reused Construction Demolition Waste: Evidence from Construction Sites

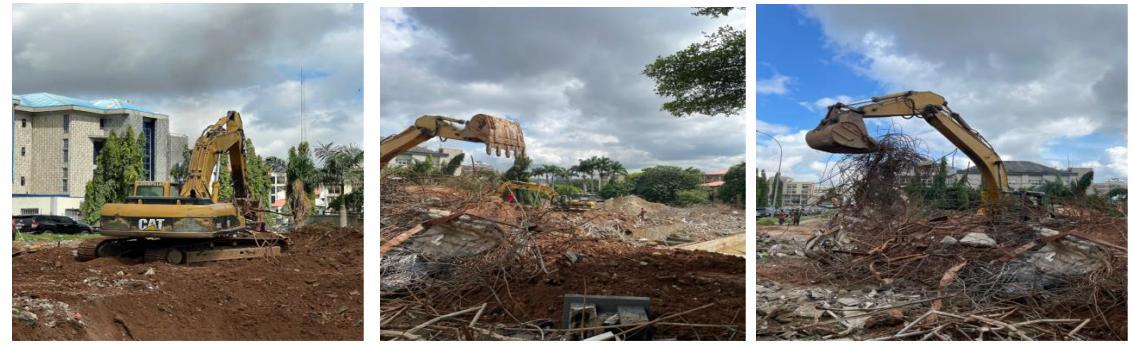
Figure 1, 2 and 3: Pictures showing two operators with the backacter excavators demolishing and clearing

In July 2024, the owner of the fourstorey building hired a construction firm to demolish further the collapsed structure and clear the site. The firm sent a builder and an engineer to execute the demolition. These two professionals disconnected the supply of water and electricity to the collapse structure to avoid electrocution and hired two operators with backacter excavators and 15 labourers to assist the operators in tearing apart the debris of the collapse building i.e., concrete columns, slabs and beams that were scattered on the ground.

This statement shows that there was not enough room for the team of professionals on site to dismantle or deconstruct carefully the many components before the building collapsed. Due to the unexpected collapse of the structure, many reusable components that were fragile were damaged and scattered on site such as glass windows, aluminium frames and electrical fittings. They operators used the arm of the backacter and discharge bucket to dig into the collapse debris, break further the concrete elements into rubble and move the reinforcements to a set location with the assistance of the labourers. This is evidenced in figure 3 below. The fragile or shattered component such as broken glass, broken blocks, broken tiles and concrete rubble were packed together and heaped at the designated places on the site. This is evidenced in Figure 1 and 2 below.
