IMPACT OF DAMS/RESERVIOR ON THE ENVIRONMENT

(A CASE STUDY OF JEBBA DAM.)

**THE DEPARTMENT OF AGRICULTURAL ENGINEERING
SCHOOL OF ENGINEERING AND ENGINEERING
TECHNOLOGY,**

DATE: FEBRUARY 1999.

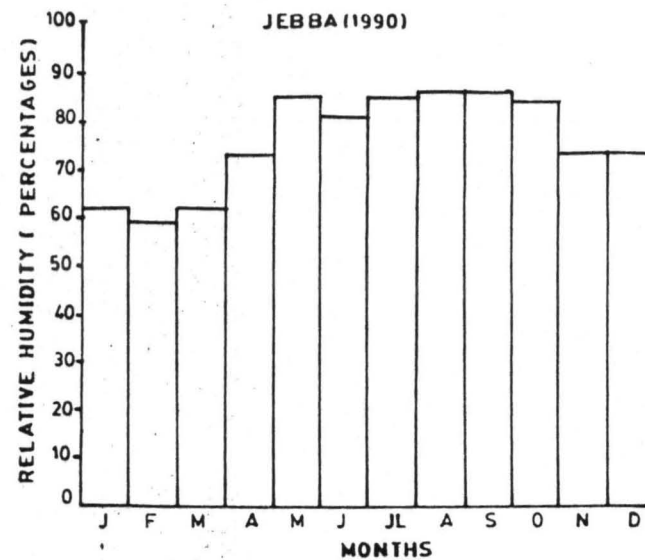
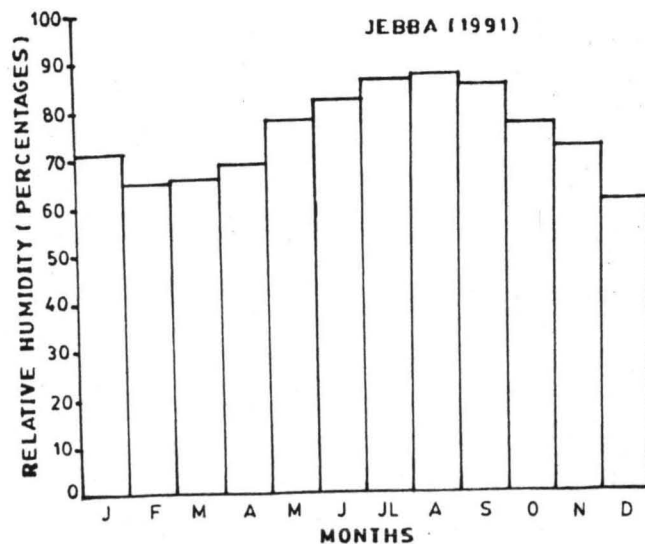
These data were collated and analysed and the mean monthly relative humidity from January to December every year were worked out. Figures 9A – J shows the histogram of the relative humidity a pictorial representation of the mean monthly relative humidity figures for the study area.

Fig. 9(a) HISTOGRAM OF RELATIVE HUMIDITY AT JEBBA DAM

It was glaring that there was a great modification and alteration to the relative humidity of the study area. About 82 – 89% mean monthly relative humidity was recorded as against what it use to be before the projects, 1982 – 85 (see table (1).

This was attributed to the mere fact, that vegetative cover play a significant role in modifying weather. During the construction period, a large track of land was cleared making the whole environment to look bare for some years. The bareness made it possible for wind to deflect the air that is moisture laden even though the humidity is very high. See figure 10(a) – J.

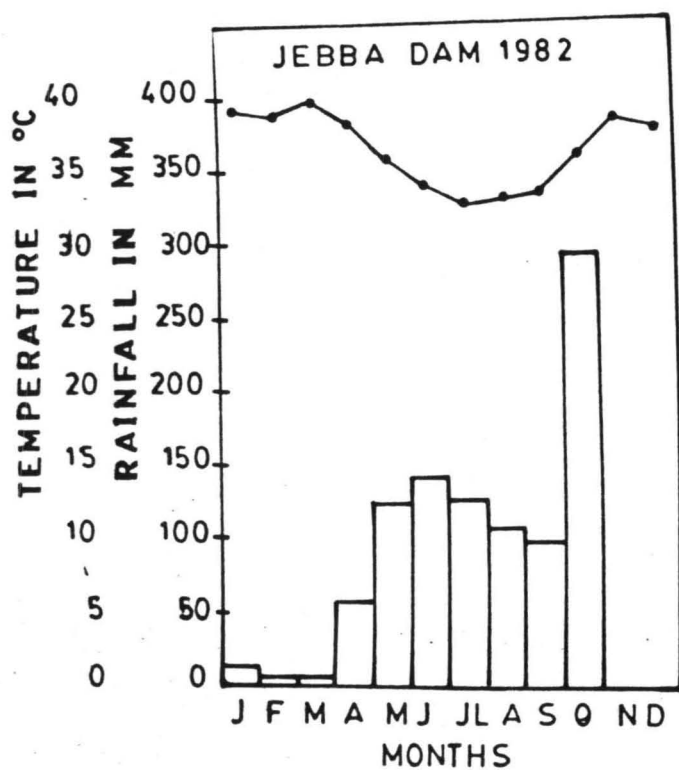
Fig. 10a-h

AVERAGE MONTHLY MAXIMUM TEMPERATURE (°C) AT JEBBA DAM
(POST DAM)

The highest temperature was recorded in the months of march and April due to low humidity and cloud cover. The lowest temperature was recorded in the months of July, August and September due to high humidity and heavily cloud cover.

The figure 11 (a – h) below shows the graph of the mean average

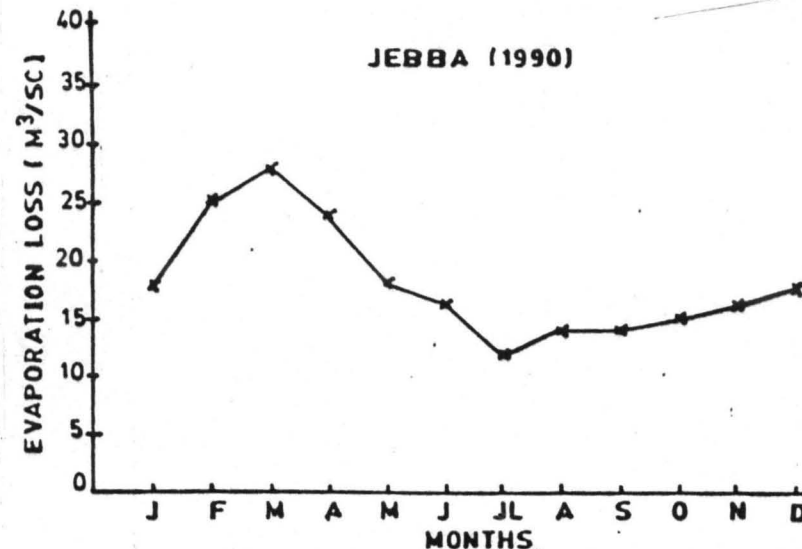
In line with the high temperature there was a high evaporation from the water surface in the reservoir. The average monthly reservoir evaporation loss (m3/sec graph shows that the months of March and April respectively has the highest evaporation loss. See figures 12 (a) – (j) the graph of reservoir evaporation loss (M3/sec) plotted for a period of ten years 1989 – 1998.

The peak of the evaporation loss is in March and there is a decline from the month of May to October due to high humidity. These parameters are viable in determming and designing storage facilities in terms of types, materials to be used, time and location. There is a relationship between temperature and evaporation, high temperature leads to high evaporation loss while low temperature will equally lead to low evaporation loss.

Fig-12a EVAPORATION LOSS (m³/sc) AT JEBBA DAM
